**TECHNICAL SERVICE BULLETIN, VIN:
SB-77 RV Door Latch may experience a lock-out condition**

September 22, 2025

Technical Service Bulletin

TSB102

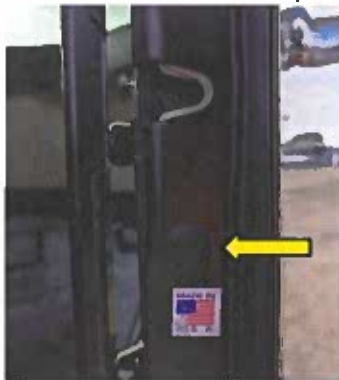
Figure 1 – Solid plastic plug, needs to be replaced

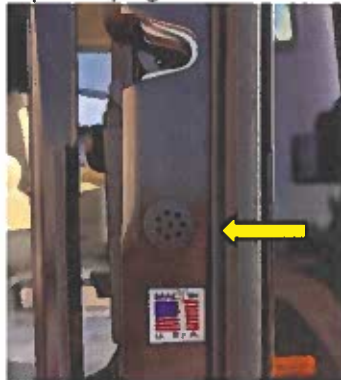
Figure 2 – Plastic plug with holes, already replaced

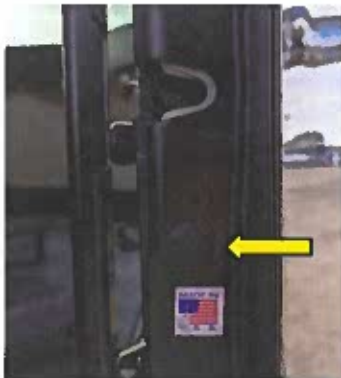
Figure 1 – Solid plastic plug, needs to be replaced

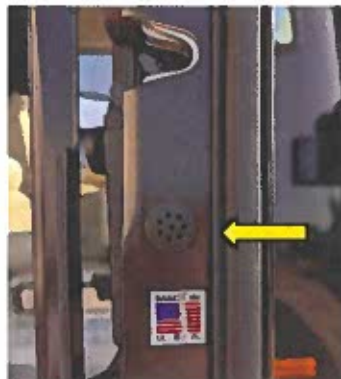
Figure 2 – Plastic plug with holes, already replaced

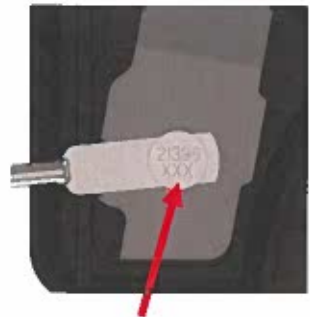
Part Number and Date Code hardware.

Step 6: Verify the part number stamped on the inside release as **21396** and the date code is between (32U through 52U) or (01V through 24V). If it is, continue to Step 7.

If the part number or the date code is something other than **21396** and date code is not in the range listed above, this door is not included in this campaign, follow Step 10b and reassemble the

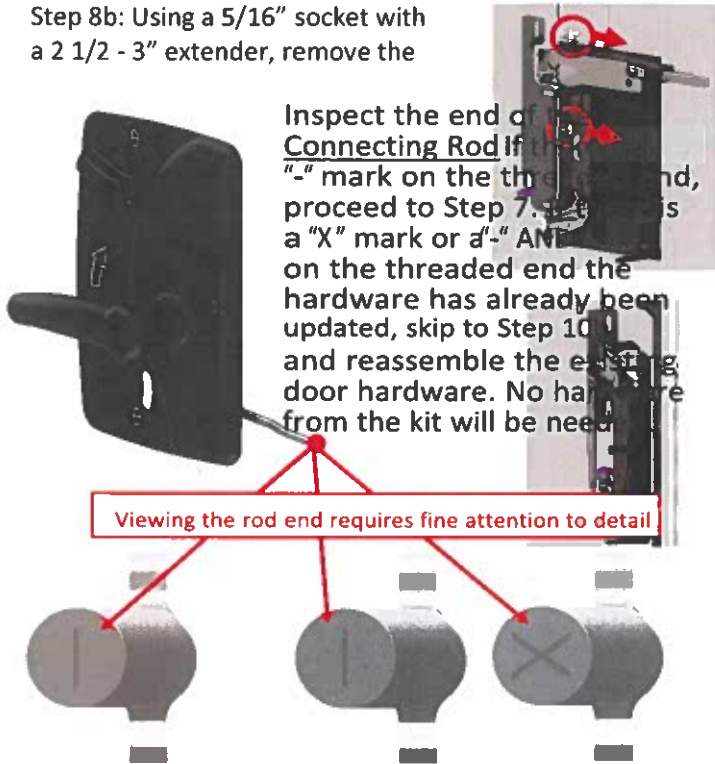
Inspect the end of Connecting Rod for a "-" mark on the threaded end, proceed to Step 7. If there is a "X" mark or a "-" mark on the threaded end the hardware has already been updated, skip to Step 10 and reassemble the existing door hardware. No hardware from the kit will be needed.

Viewing the rod end requires fine attention to detail
