Service Bulletin

Bulletin No.: PIP6086

Subject: 8L45/90 No Movement After Valve Body Replacement

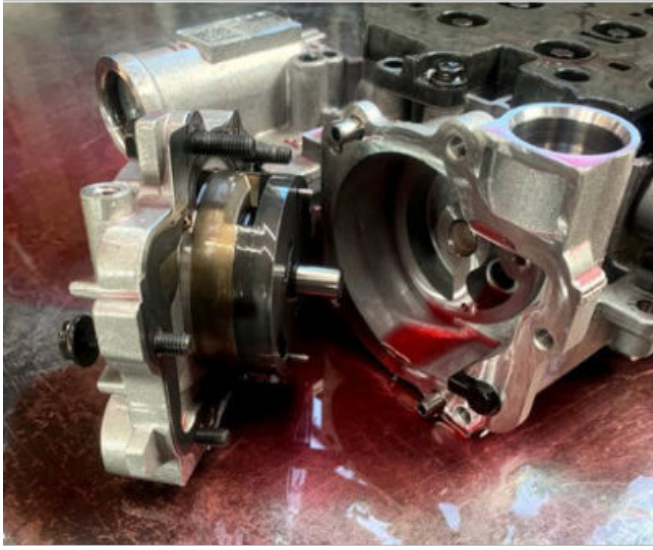
7000789

This may be caused by a missing pump gasket on certain remanufactured valve bodies.

Pump Rotor Gasket Missing

If a missing pump rotor gasket is found please take a picture of the PUN number off the bag or valve body, start a TAC Case and upload the pictures order a pump seal kit and install the missing gasket and re-evaluate.

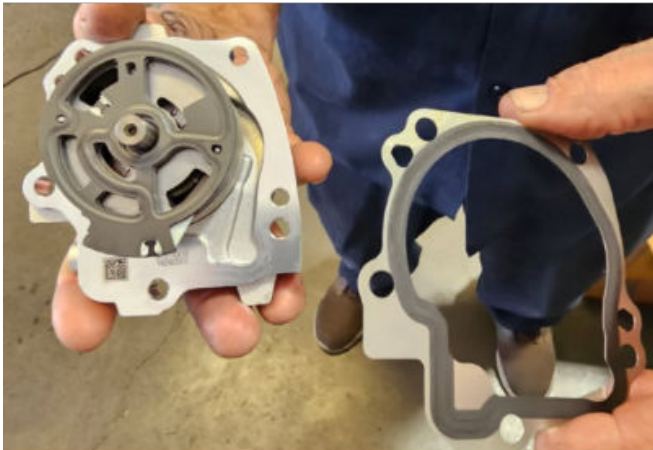
7000790

Pump Rotor Gasket Present
