September 2023 production of 2024 model year to June 2025.

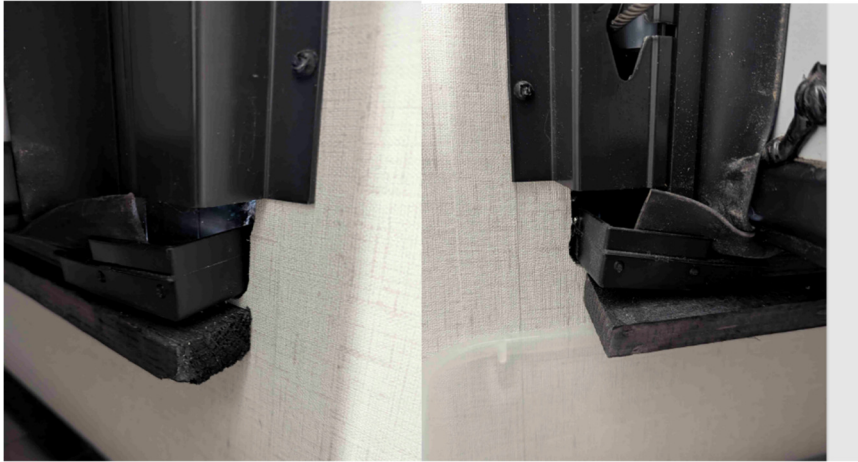
Please inspect the wood support under the slide out on the interior of the unit. If the wood support is wet/warped or not installed high enough, it could cause the drip cups to angle downward and allow water to drain inside the unit.

Recommend removing the 1x2 piece of wood painted black under the pan and replacing it with the metal bracket we currently use, reinstalling it slightly higher to ensure proper water drainage. Additionally, while the wood is removed, inspect the cups and ensure the premask putty tape is properly secured. The cups should be firmly attached to the pan, and if not, you should be able to seal those.
