Coolant leak at expansion reservoir level sensor connection

| Topic number | LI20.30-P-078666 |
| Validity | Model year 2025 GLE and GLS-class vehicles |

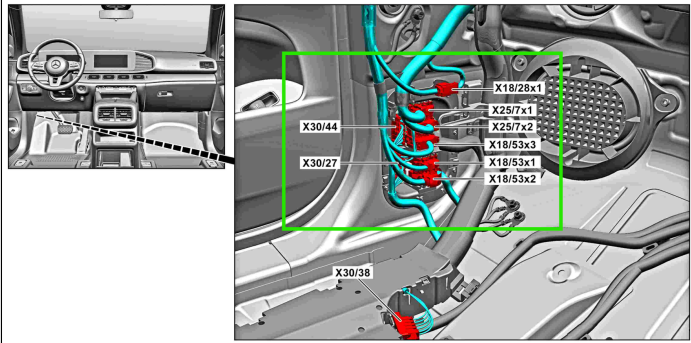
| File | Description |
|---|---|
| <a href="#">A-pillar connectors.png</a><br> | |

- 1- Inspect expansion tank level sensor electrical connection for missing contacts. Additionally the triangular sticker may not be present on top of reservoir. See example of OK and NOK part.
- Replace the expansion reservoir if contacts are found to be missing. A TIPS case is not needed.
  - Proceed to step 3.
- 2- With contacts present, inspect coolant level sensor electrical connection for leakage past contact seals. Visible coolant at the connection indicates leakage.
- Capture photos if leakage is identified and create a TIPS case with the Powertrain team.
  - Replace the expansion reservoir.
- 3- Repair any damage to wiring or electrical contacts on wiring harness from S41 to N10/6.
- Check the front SAM N10/6 for coolant contamination and replace if necessary.
  - Inspect electrical connectors at base of A-pillar for contamination and repair/replace as necessary.

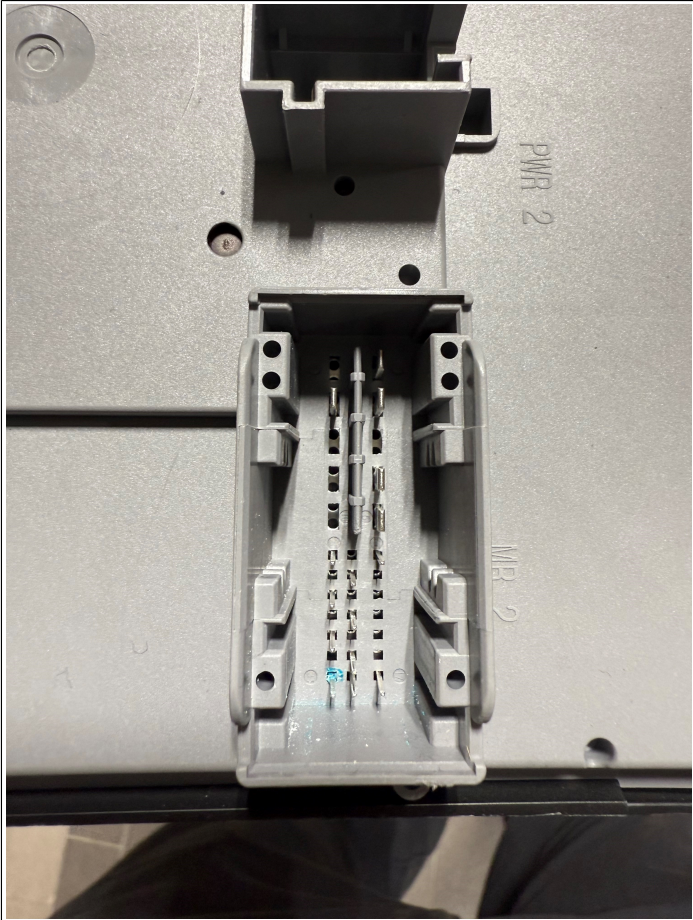
Level sensor connection.jpg

Coolant wicking through electrical contacts, or level sensor electrical connections not present in expansion reservoir.

Example of coolant at level sensor connection
