Customer Service Notification

GranTurismo BEV Battery Fuse Box Retaining Nut Inspection

DATE: September 26, 2025

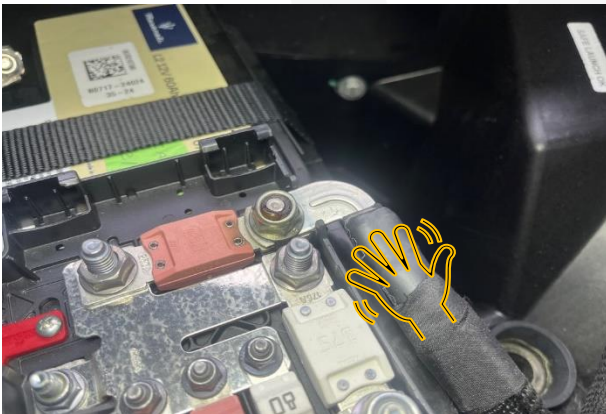
Darkened pin connection caused by loose connection

NOT OK

6. If no issues are found, verify torque:
 - Using a torque wrench, tighten all large retaining nuts to 11 Nm.
7. If any visible damage is present on pins, fuses, or nuts:
 - Replace the entire Battery Distribution Unit (BDU) per Op. Code 8.20.016.
8. Reassemble components by reversing the disassembly procedure.
9. Procedure: complete the release of the vehicle.

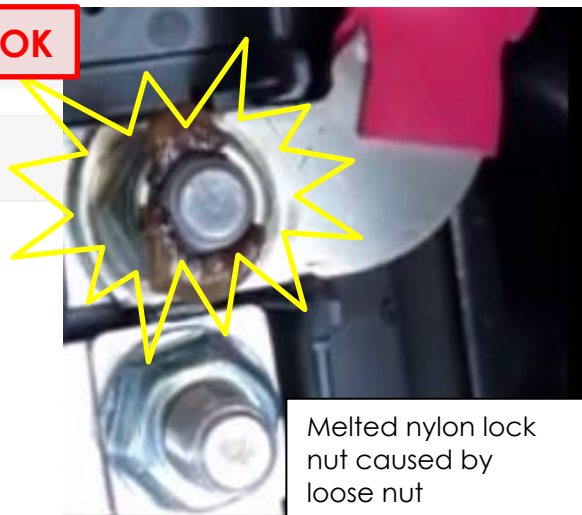
Melted nylon lock nut caused by loose nut
