Preview Solution CBR-2408-13

## **Air Production Modulator (APM) DTC C10129B - High/Excessive Flow - VN (4) - PR (4)**

Published 9 September 2025

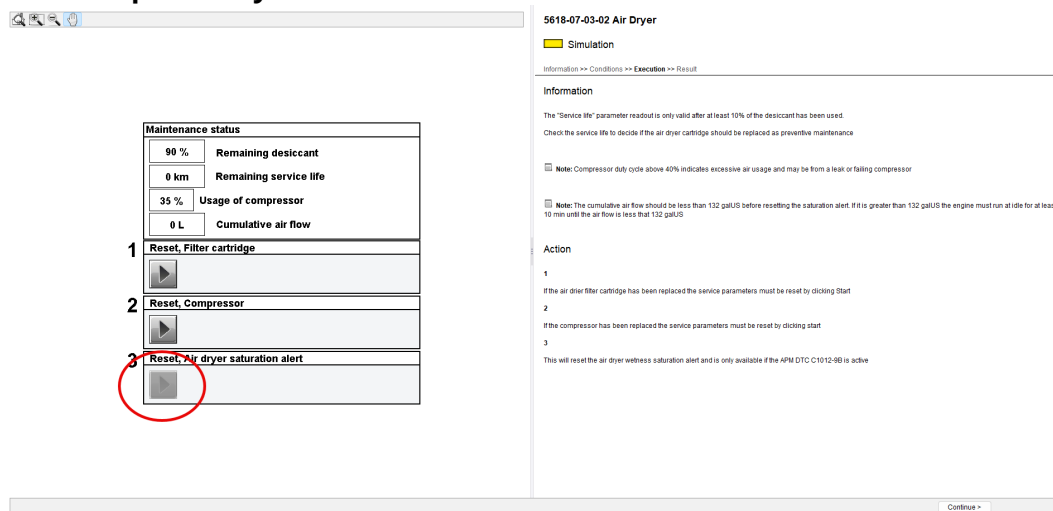
**5. Begin TT operation 5618-07-03-02 Step 3.**

**Note: Step 3 is only available if code C10129B is active.**
