## Preview Solution CBR-2500-4

### Versa Table Repair - VN (4), PR (4)

Published 17 September 2025

Volvo Chassis - VN (4)

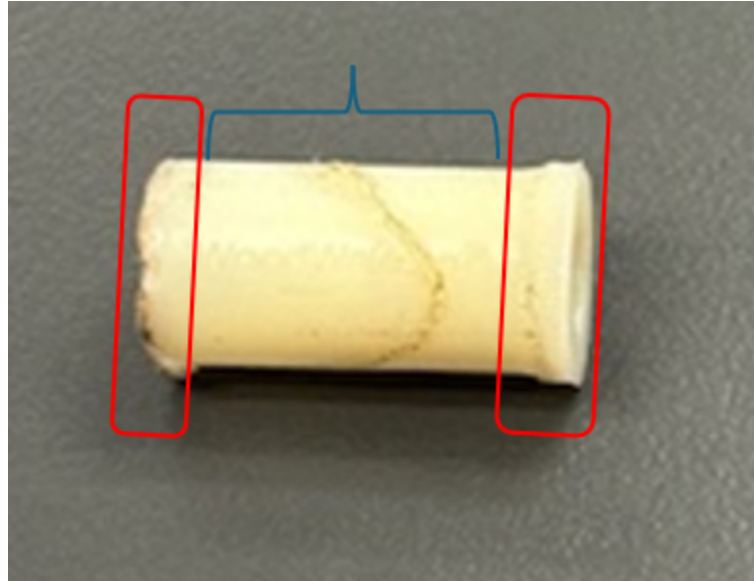
1. Remove insert from screw.

**NOTE:** To remove screw: Grip insert in central region (Blue Bracket) with slip-joint pliers to prevent damage to the interfacing surfaces(red boxes).

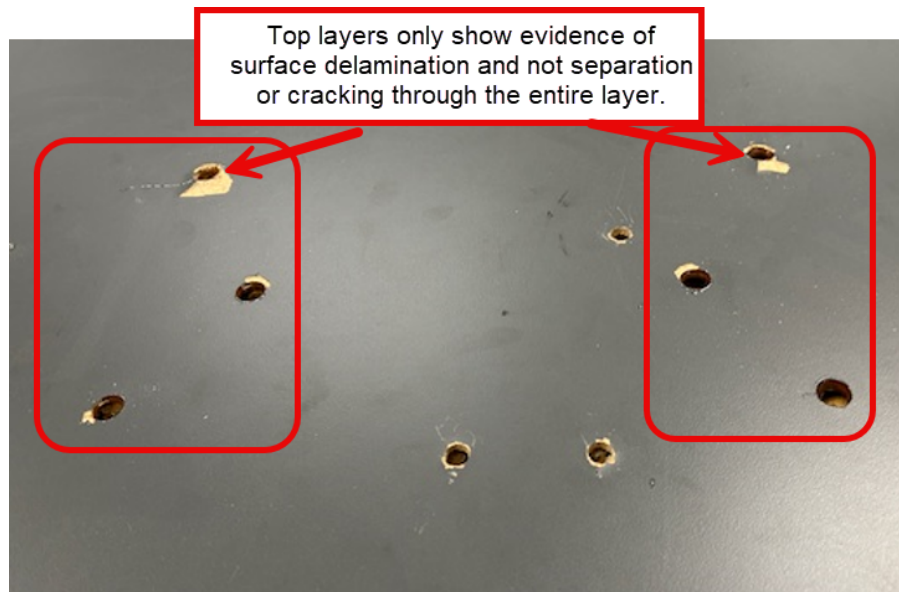
This procedure describes the standardized method for repairing failed inserts pulled out of a table surface. It applies only when the receiving hole is not significantly damaged. Acceptable conditions include surface fraying or peeling at the painted layer only, with no full-depth cracking.

2. Confirm hole condition is suitable for repair (surface delamination only, **see image below**).
