Preview Solution CBR-2506-2

Battery Electric Vehicle (BEV) - Cooling Package Crash Structure Crossbar Interference with Static Coolant Fill Hose

Published 30 September 2025

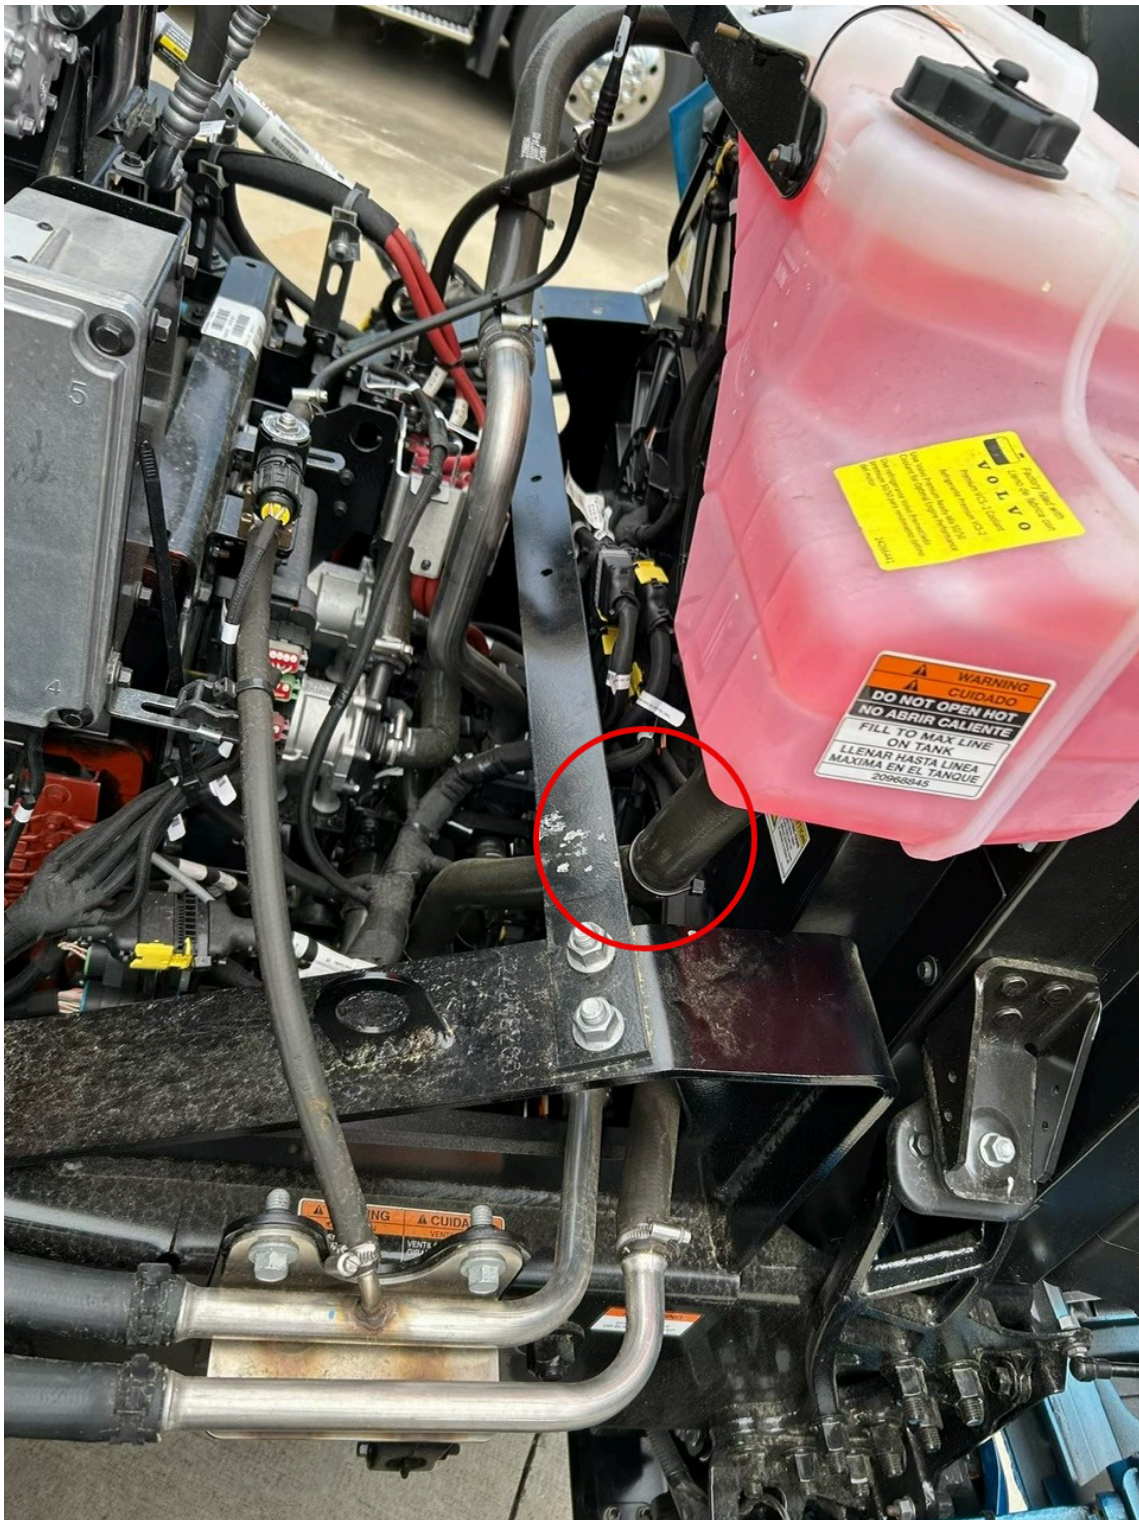
It has been identified that the crossbar on the cooling package crash structure is in direct contact with the static coolant fill hose. This interference creates a risk of hose chafing, which may result in coolant leakage over time.

To eliminate the interference and mitigate the risk of future coolant leakage, the crossbar can be safely removed. This modification has been reviewed and confirmed as an acceptable corrective action.
