## Incorrect Center Bearing Mounting Hardware

Service Category: Service Department

Section: Function Group 453

| Year | Model |
|---|---|
| 2026 | AN, PI, GR |

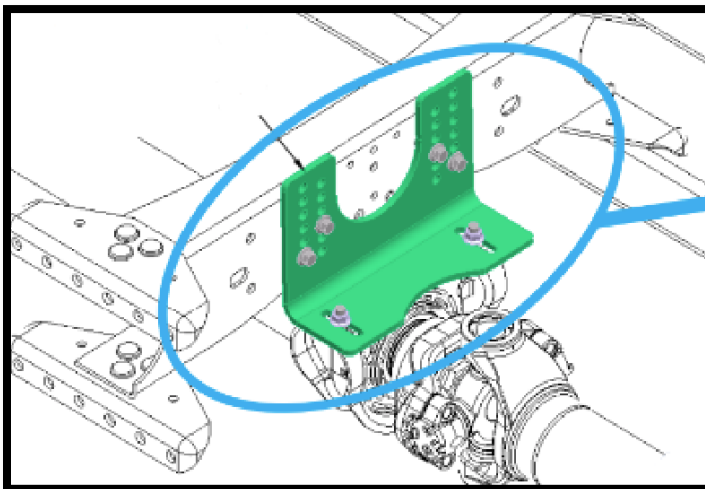
5. Locate the center bearing bracket.

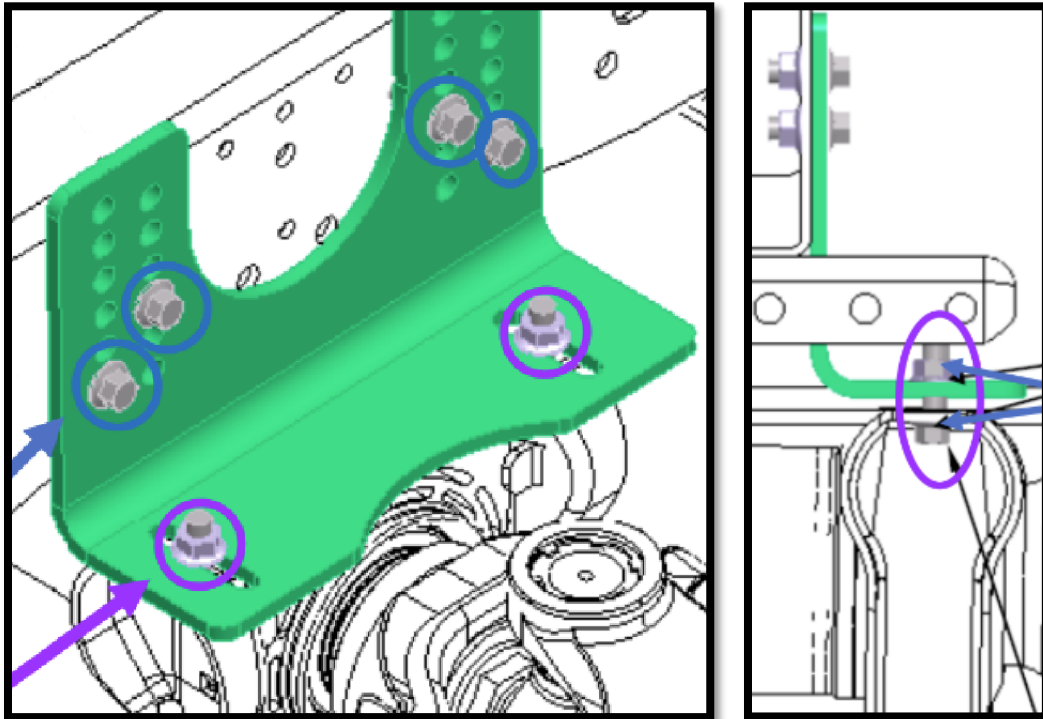
Mack Trucks has identified that certain truck models may have been assembled with incorrect center bearing mounting hardware and could have been torqued incorrectly. Improper torque can increase the risk of hardware failure. To address this issue, please follow the instructions in this document to replace and correctly torque the center bearing and center bearing mounting bracket hardware.

6. Remove and install one fastener at a time for the bracket and discard all removed hardware. Install top and bottom washers for the bottom bracket connections.

7. Torque nuts to specification.

| Tightening Specification |
|---|
| 106 N-m (78 Ft-lbs) |
