Service Bulletin

Bulletin No.: 23-NA-122

Subject: Engine Oil Leak

Brand:	Model:	Model Year:		VIN:		Engine:	Transmission :
		from	to	from	to		
Buick	Encore GX	2020	2024	—	—	1.2L Turbo (RPO LIH)	—
	Envista	2024					
Chevrolet	Trax	2024					
	Trailblazer (VIN M)	2021

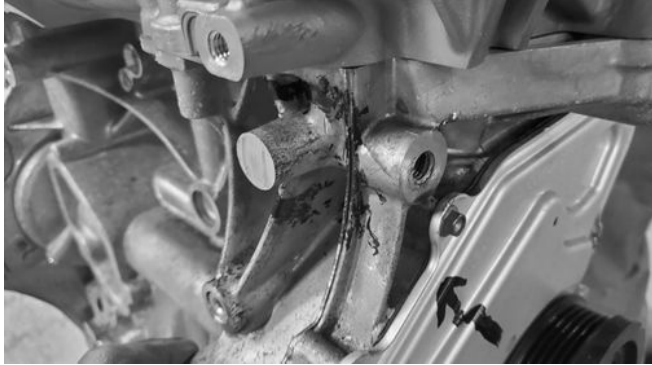
6373157

Involved Region or Country	North America
Condition	Some customers may comment on oil leak between the engine front cover and turbocharger heat shield.
Cause

<p>This condition may be caused by porosity from the engine block bolt holes. Important: Do Not replace the engine for this condition.</p>

Remove the cylinder head bolt to apply Loctite® 565 to a new bolt. Refer to the Service Procedure.

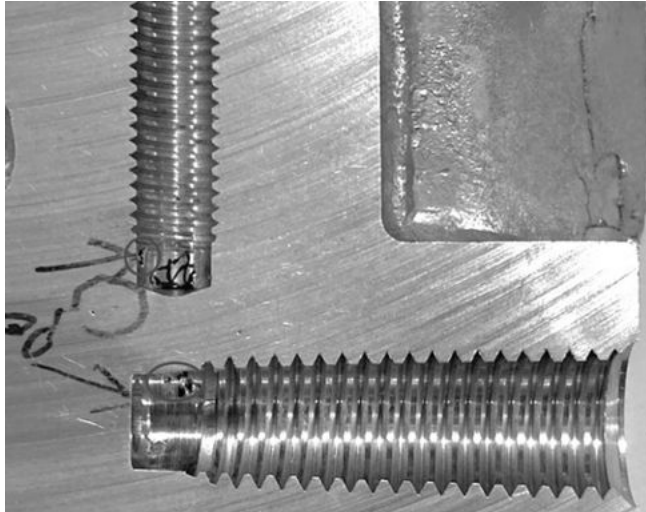
6373160

- Oil leaking was found to be coming from porosity between the cylinder head bolt hole and the engine mount boss, bolt hole.

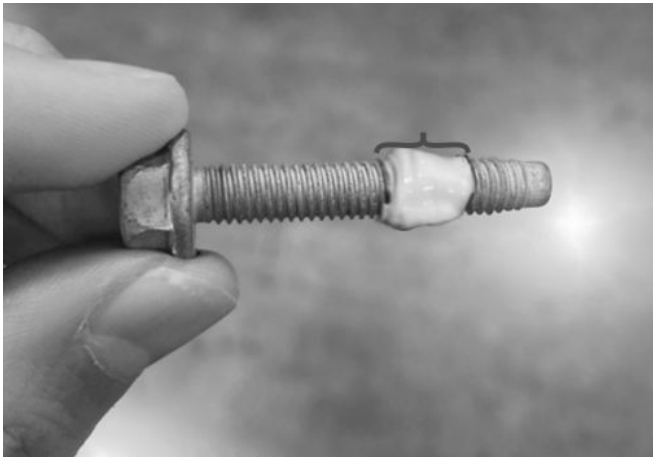
6373161

Important: Do Not apply Loctite© to the end of the bolt. Damage to the engine block may occur.

3. Apply 565 Loctite© to a new cylinder head bolt as indicated in the graphic above.
4. Install the bolt into the cylinder head and torque to 14.5 N•m (10.7 lb ft). Refer to *Fastener Specifications*.
5. Install the exhaust camshaft sprocket. Refer to *Camshaft Exhaust Sprocket Replacement*.

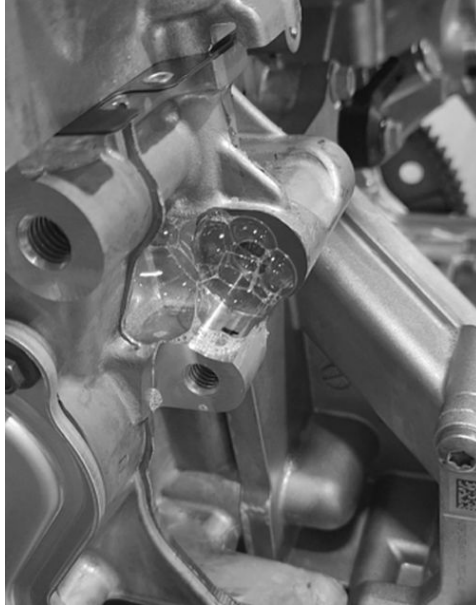
6898293

A leak may also be located on the other side of the engine block between cylinder head pinch bolt and the generator mounting area.

If this is the case, the camshaft does NOT have to come out of the engine. If you remove the cam cover, there is socket clearance access to the pinch bolt in. It is recommended to use a magnetic socket so you don't drop the bolt down into the engine while removing it, but the bolt can be removed, Loctite can be applied, and the bolt can be retightened to 14.5 N•m (10.7 lb ft). Allow cure time before starting the engine again. It is easier than the pinch bolt on the other side which cannot be accessed without removing the camshaft.
