SERVICE BULLETIN

APPLICABILITY: 2020+ MY Legacy & Outback
 2022+ MY WRX (A/T Only)
 2019+ MY Ascent

NUMBER: 16-151-24R

SUBJECT: TR690 Chain Slip, Judder, Shudder, & Hesitation Concerns

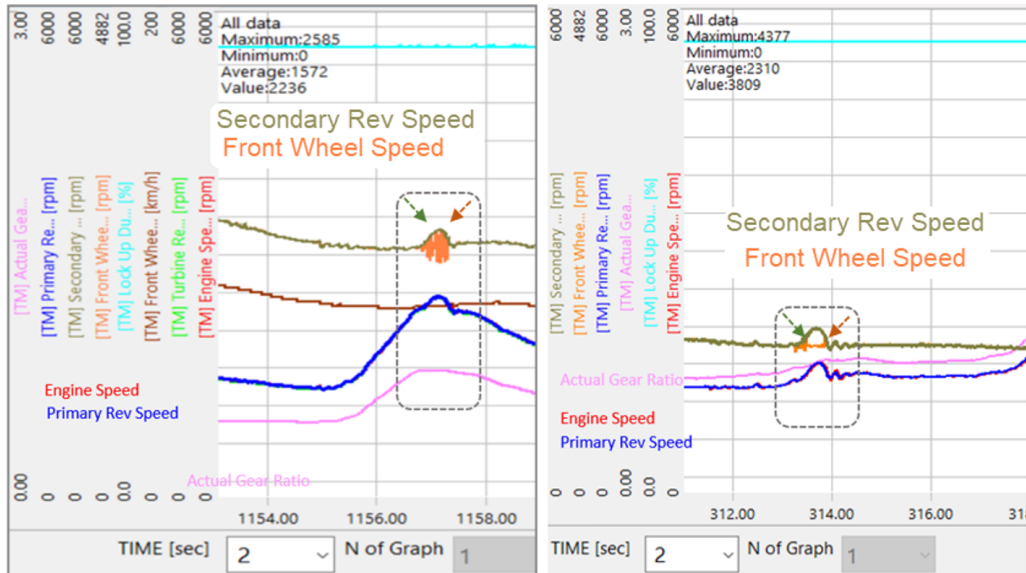
Examples Graph for Forward Clutch Judder:

Forward Clutch Judder Diagnosis Procedure:

The rotational speeds of the upstream and downstream sides of the forward clutch do not synchronize during driving.

Upstream side of the forward clutch: Secondary Rev Speed

Downstream side of the forward clutch: Front Wheel Speed

Forward Clutch Judder: CVT Fluid (p.n. 31333AA160) replacement and TCM software reprogramming (newest software available).

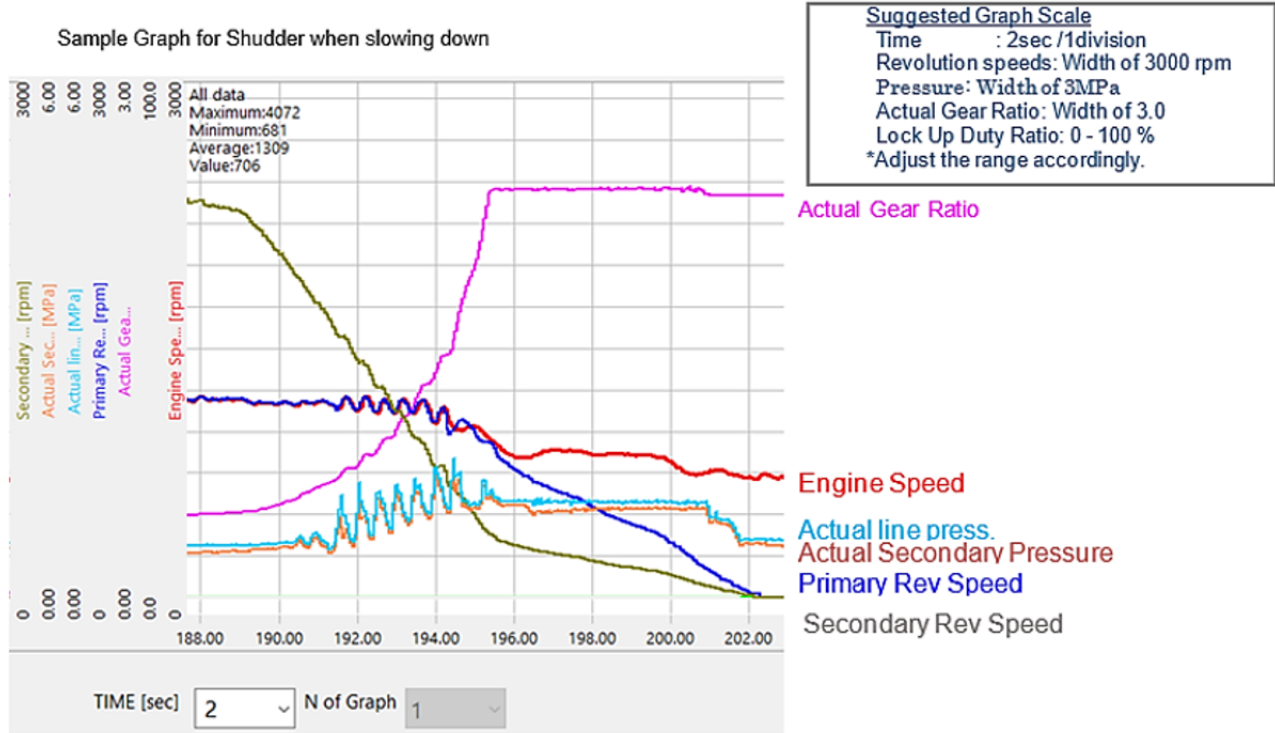
A jerk or judder sensation felt from the powertrain during braking with the air conditioning on.

IMPORTANT: 2023-24MY Legacy & Outback 2.4L, 2023-24MY Ascent, and 2023-24MY WRX vehicles, refer to TSB 16-150-24

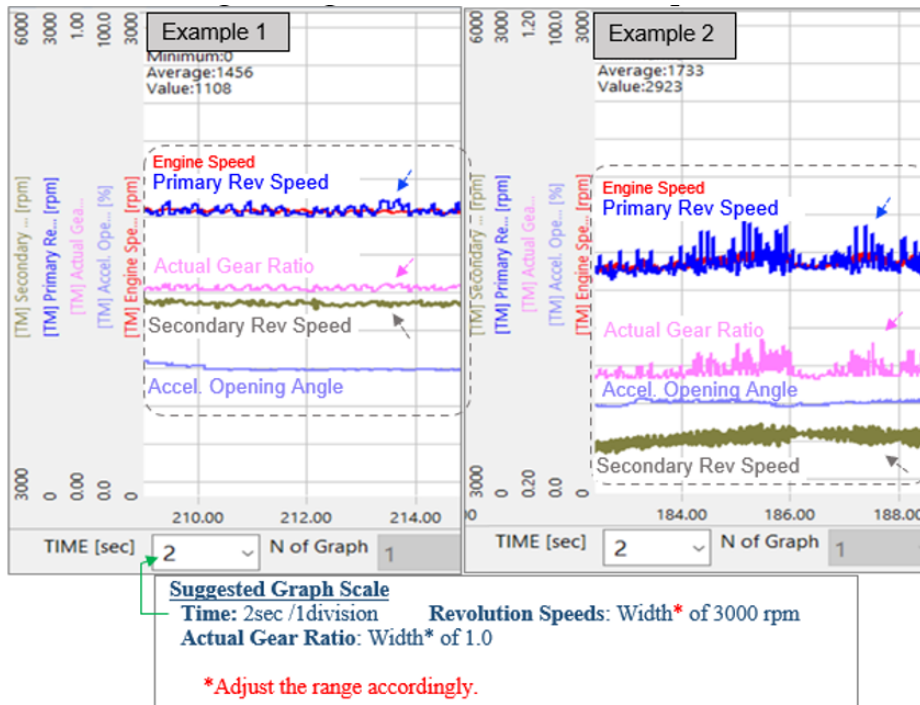
Examples of the data monitoring during Continuous Micro-Slip:

1. Continuous Micro-Slip

During a continuous micro-slip, while the Accelerator Opening Angle monitor displays a stable value for more than one second, there are fluctuations in the Actual Gear Ratio monitor:

Peak to Peak > 0.02

Frequency > 3 cycles per 1 second

There are fluctuations in the Primary Rev Speed and/or Secondary Rev Speed monitor:

Peak to Peak > 50 rpm

Using Subaru Select Monitor (SSM), check and record data monitors and compare to the three examples listed below. If the recorded data from the vehicle matches the examples below, the CVT will require replacement. The SSM data will be required for claim submission. A QMR containing the same information will also be required.

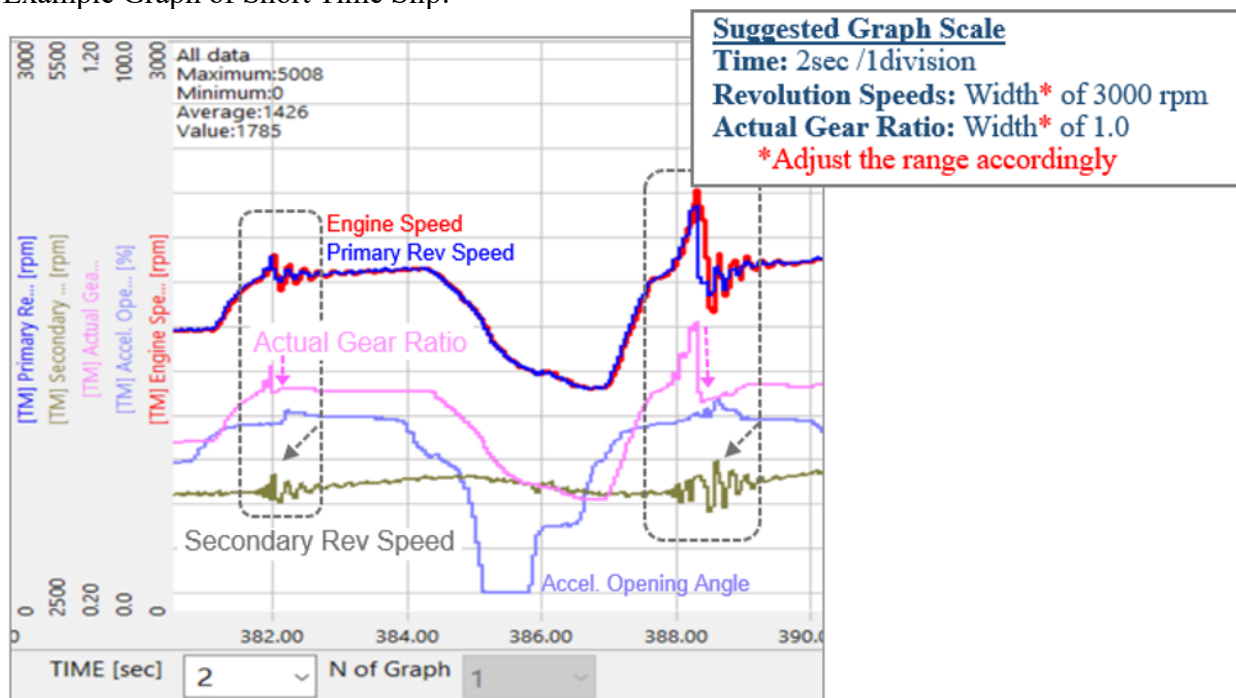
Example Graph of Short Time Slip:

2. Short-Time Slip

When a short-time slip occurs, the changes in the Actual Gear Ratio monitor will be larger than 0.1 per 0.1 second. After the Actual Gear Ratio monitor resumes to stable conditions, distinct fluctuations in revolution speed continues.

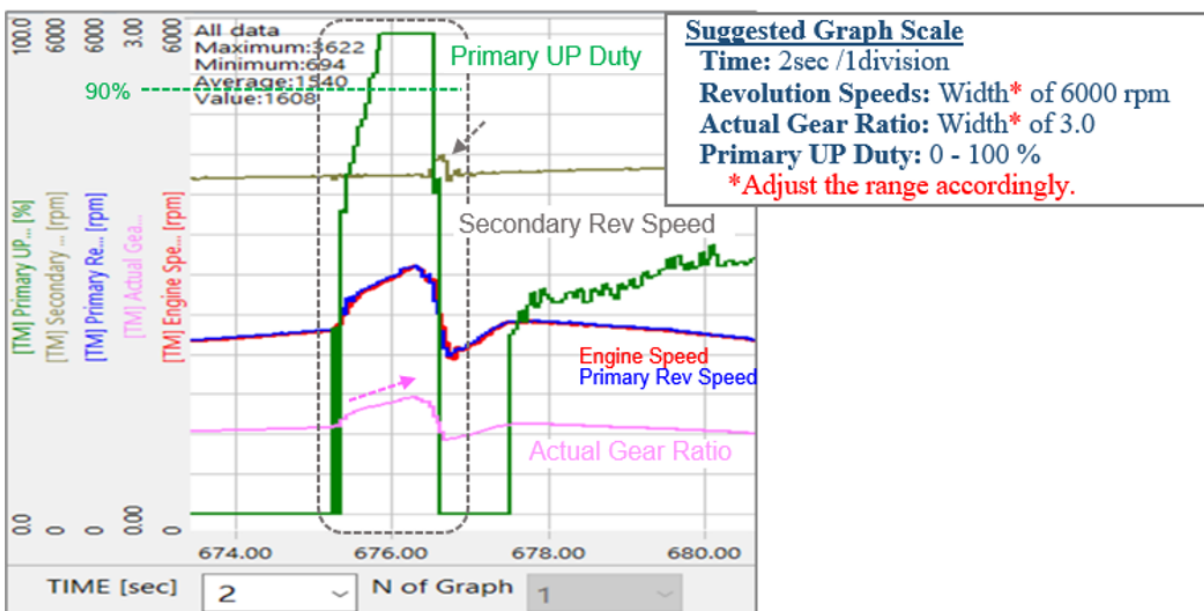
3. Long-Time Slip

When a long-time slip occurs, the Primary UP Duty monitor will be larger than 90% and the Actual Pulley Ratio monitor lowers for a duration of 0.5 seconds or more. Even after the Actual Gear Ratio monitor resumes to stable conditions, distinct fluctuations in revolution speed continues.

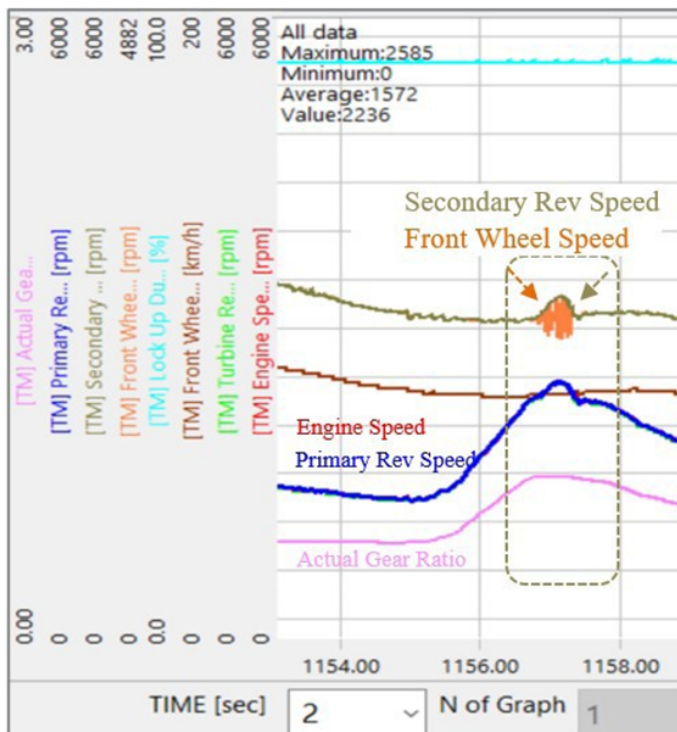
1. Forward Clutch Slip Shock

The rotation speeds for the upstream and downstream sides of the forward clutch do not synchronize when driving.

Example for
2.4L Turbo or 3.6L NA equipped vehicles

This shock can occur when the forward clutch slips. If this situation is reported, reprogram the TCM with the newest software available.
