SERVICE PROGRAM BULLETIN

APPLICABILITY: 2023 MY Legacy
2023 MY Outback

NUMBER: WRI-22R

SUBJECT: Telematics DCM Replacement

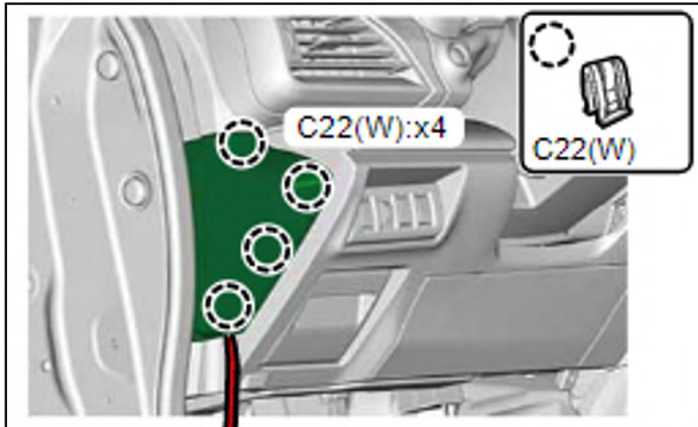
STEP 3: Release the four mounting clips securing the driver side instrument panel side cover. Once released, remove the cover.

NOTE: If a **GREEN** sticker is present, STOP. This vehicle has the latest DCM, and is not affected by the WRI-22 service program.

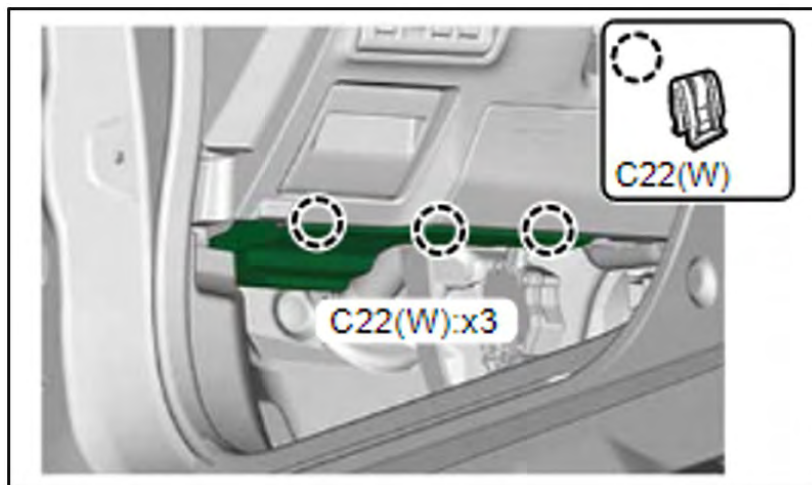
STEP 4: Release the three mounting clips securing the driver side front under cover. Once released, remove the cover.

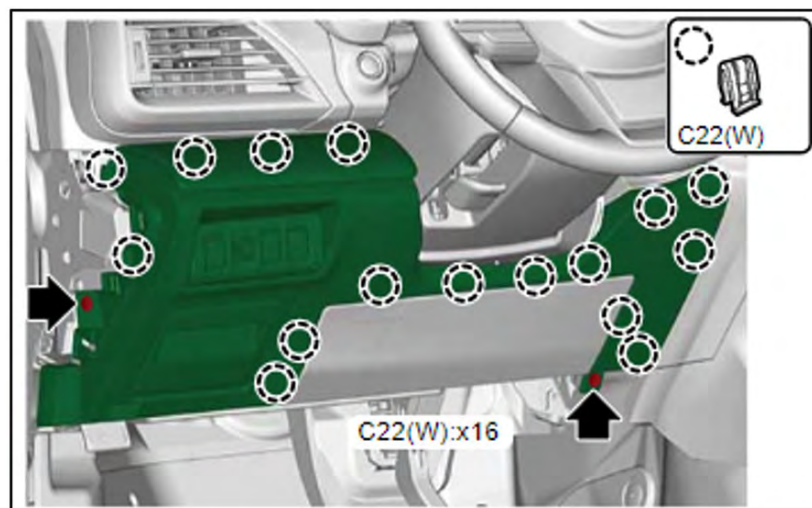
STEP 5: Remove the two mounting screws securing the lower driver cover. Once removed, pull the cover in a straight direction toward the rear of the vehicle to release the mounting clips.

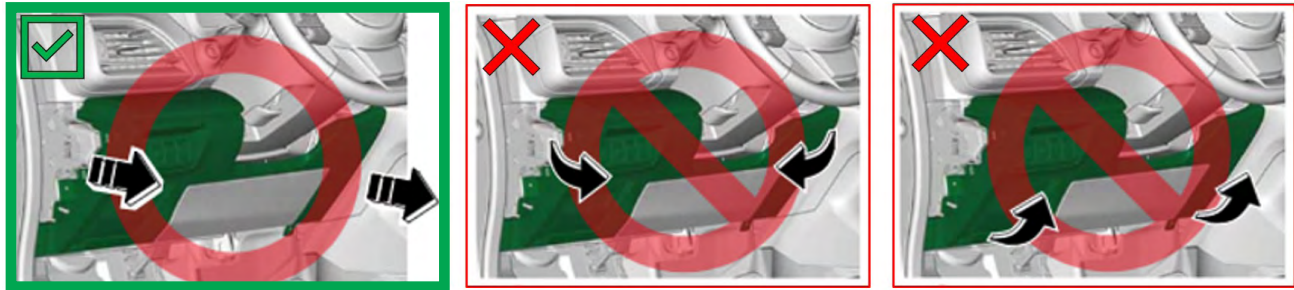
CAUTION: When removing the lower driver cover, **ALWAYS** pull the cover in a straight direction. Pulling in a lateral or upward direction may cause damage to the lower driver cover.

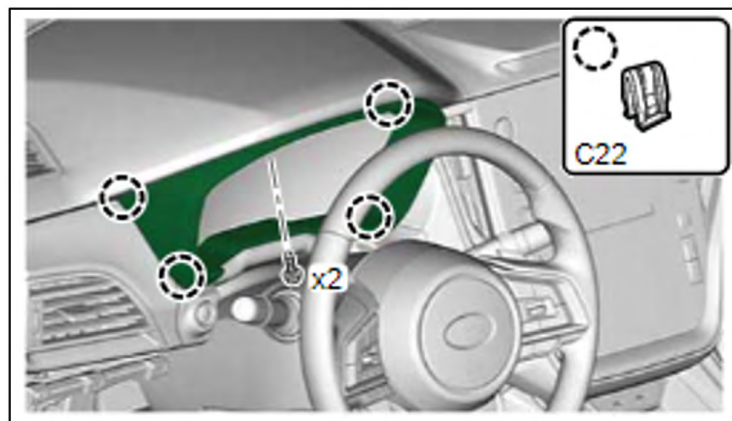
STEP 6: Release the steering column lock, adjust the steering wheel to the lowest level and pull it outward to its full extent. Lock the steering in this position. Using a small screwdriver, remove the two mounting screws for the combination meter trim panel. Release the four mounting clips securing the panel. The panel can then be removed.

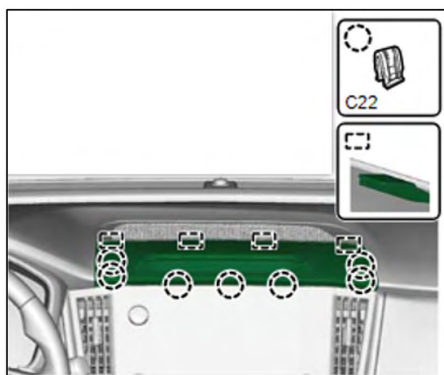
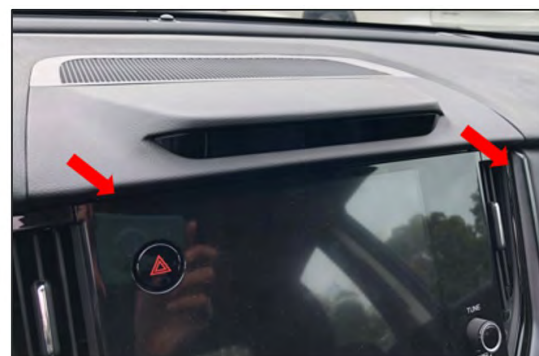
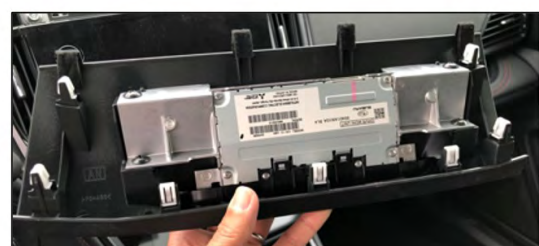
STEP 7: Release the 7 mounting clips from the driver monitoring unit. Once released, pull the unit toward the rear of the vehicle in a straight direction. Release the electrical connection and remove the unit from the vehicle.

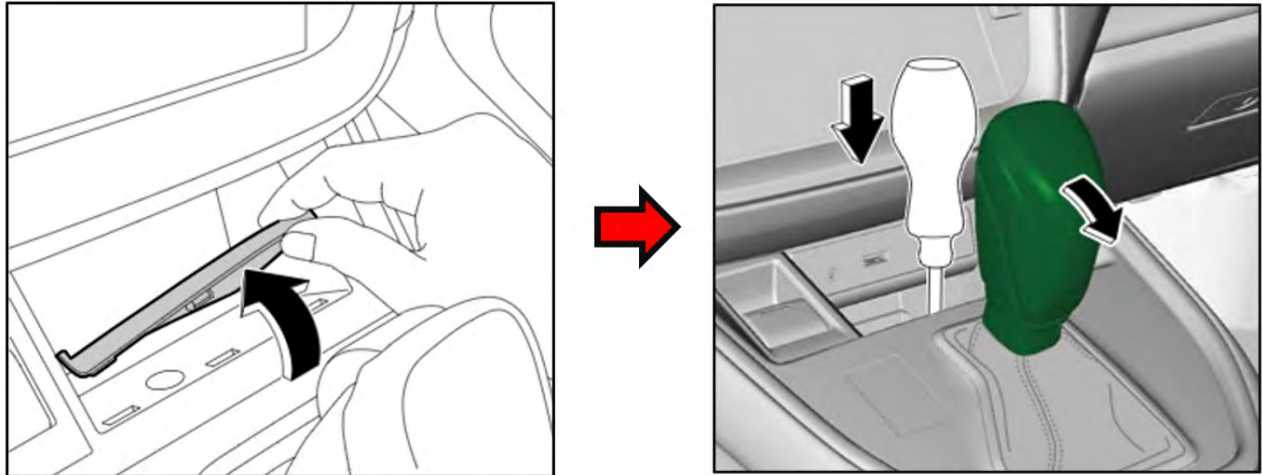
STEP 8: Remove the rubber grip mat from the center tray. Using a screwdriver or suitable tool, release the shift lock and shift the lever into the neutral position.

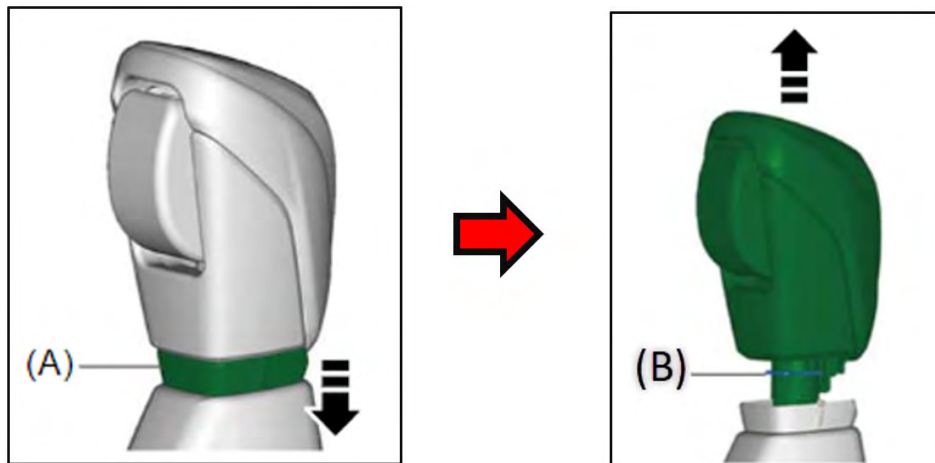
STEP 9: Detach clamp (A) from the shift knob. Release clip (B) from the shift knob and remove the knob from the lever. ALWAYS maintain proper shift rod alignment when reinstalling (detailed information can be found in the September 2021 TechTIPS article).

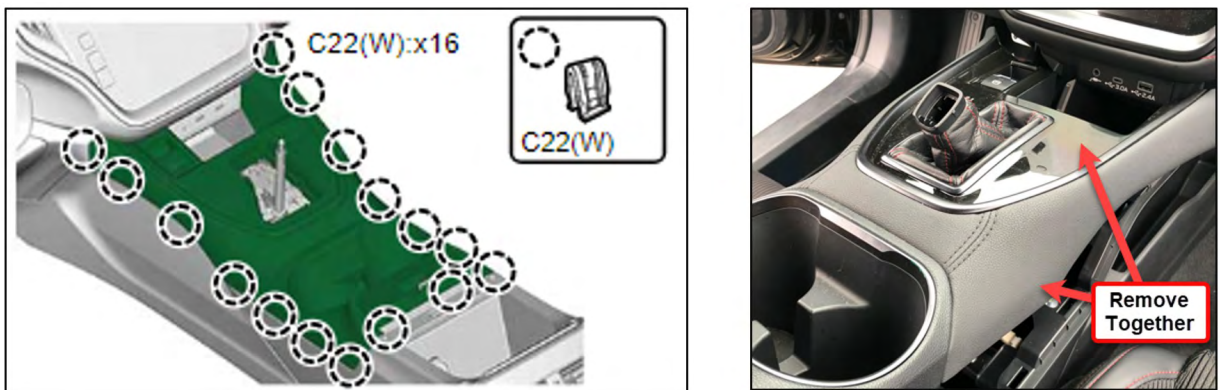
STEP 10: Release the center console cover mounting clips and remove the cover with the shift boot/bezel attached.

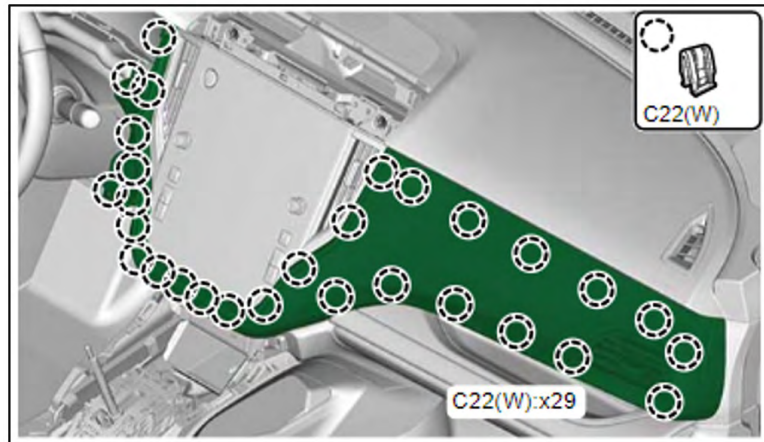
STEP 11: Release the mid passenger ornament panel mounting clips and remove the panel.

NOTE: Vehicles equipped with push button start will require the push button ignition switch to be disconnected prior to removal.

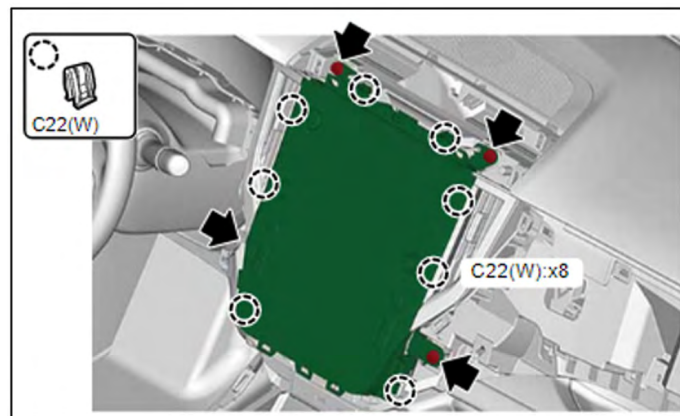
STEP 12: Remove the four screws securing the Center Information Display (CID) assembly. Release the mounting clips and CAREFULLY pull the assembly out far enough to disconnect the electrical connections. Once all the connectors are disconnected, the CID assembly can be removed. Use caution when handling, the display can be easily scratched.

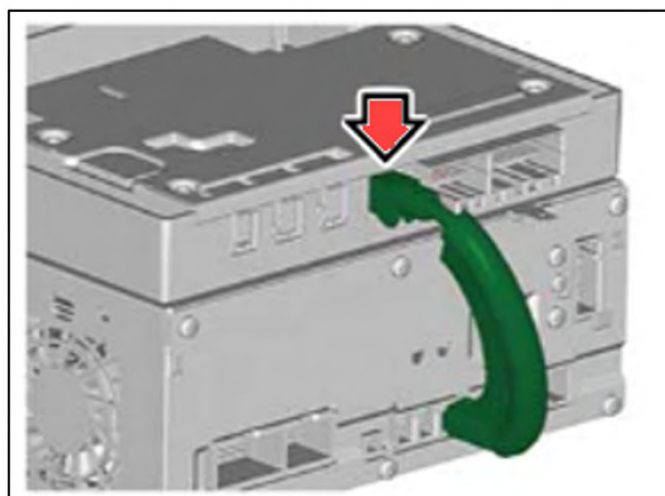
STEP 13: Place the CID assembly on a secure flat surface. Disconnect the Data Communication Module (DCM) cable.

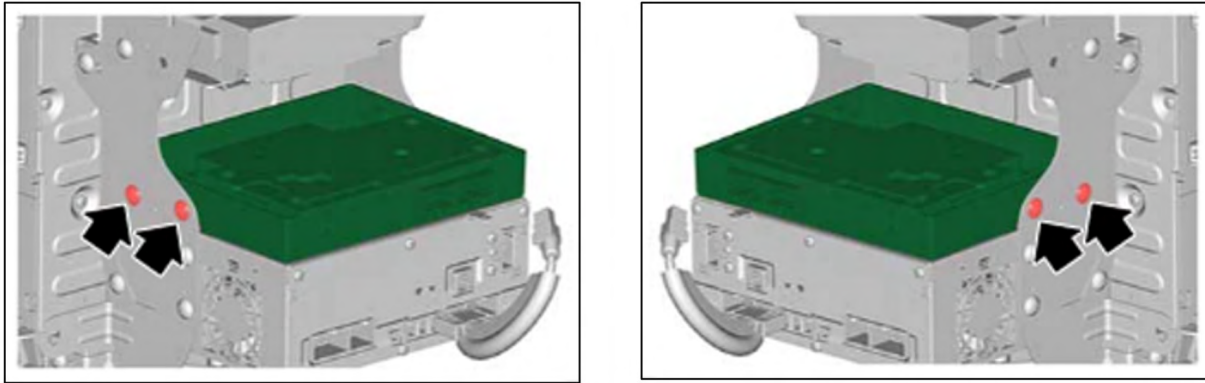
STEP 14: Remove the four DCM mounting screws located on the left and right side. The DCM can then be removed.

CAUTION: DO NOT apply any impact to the CID assembly or DCM during this process.

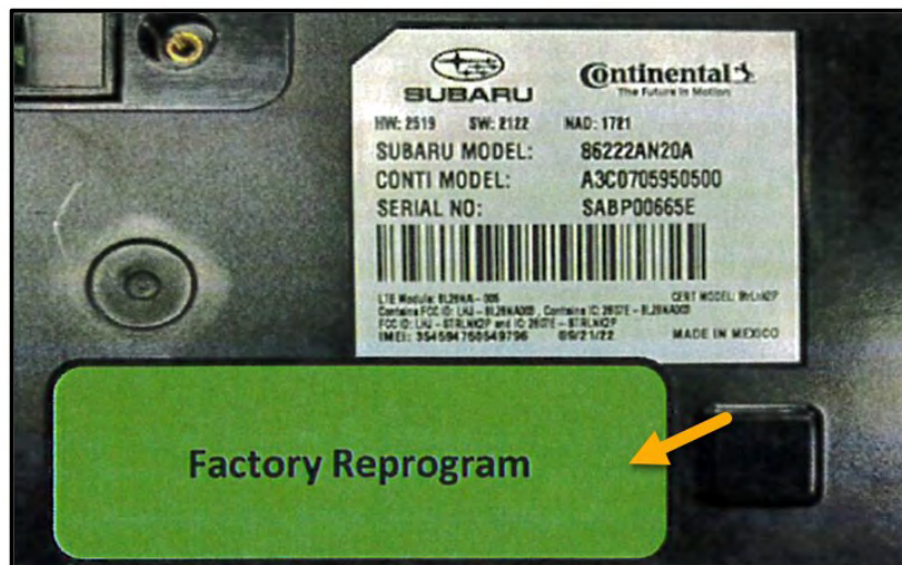
NOTE: If a **GREEN** sticker is present, STOP. This vehicle has the latest DCM, and is not affected by the WRI-22 service program.

STEP 15: Read and record the serial number of the replacement DCM. Replace the DCM. Reinstall all parts in the reverse order of removal.
