PRODUCT CAMPAIGN BULLETIN

APPLICABILITY: 2019-20MY Ascent
 2020-21MY Legacy 2.4L (turbo models)
 2020-21MY Outback 2.4L (turbo models)

SUBJECT: CVT Chain Guide Breakage

NUMBER: WRK-21/22R

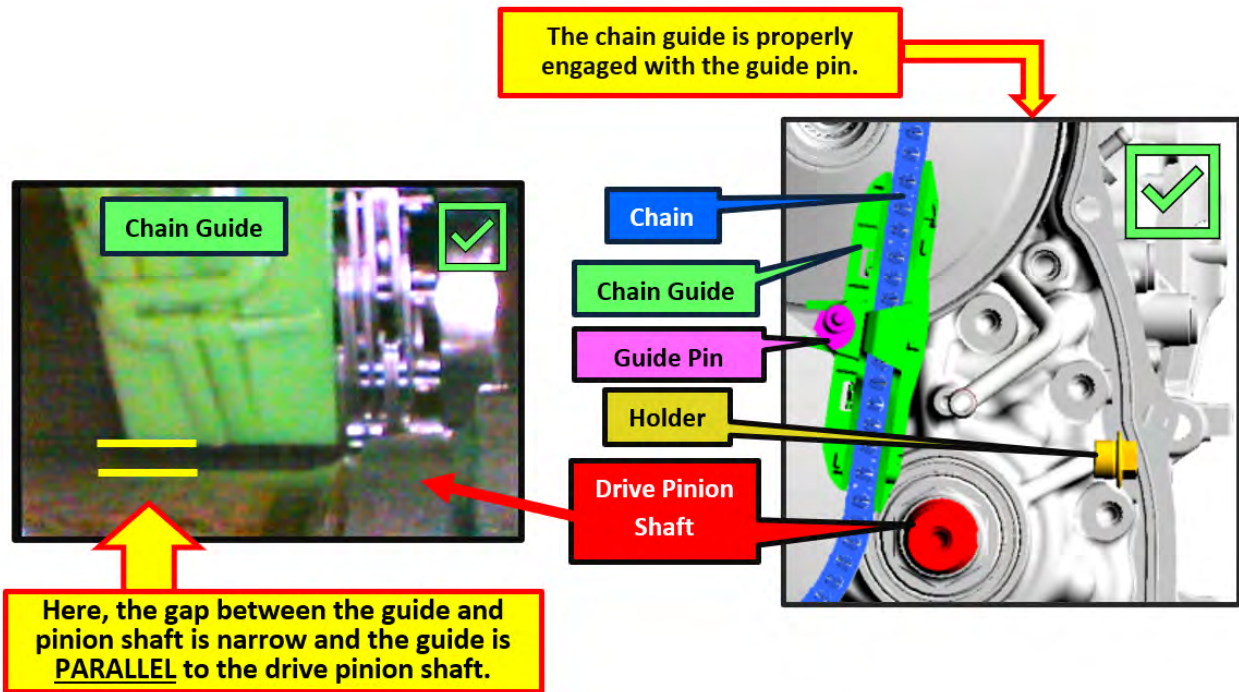
CORRECT GUIDE POSITIONING:

STEP 3E: Inspect the position of the lower end of the chain guide rail and the drive pinion shaft.

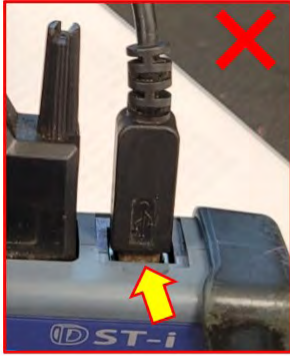
Corroded Connection

Confirm the PC being use for reprogramming is connected to a known good power source. Turn off any screen saver settings. Make sure the PC is not in power saving mode and is set to the normal power mode. Always inspect the DST-I/DST-010 and PC cables prior to programing. Confirm the cables are CORRECT and there is no exposed wiring, corroded connections, or loose fitment. See the example images below.
