SERVICE BULLETIN

APPLICABILITY: 2019-24MY Ascent

NUMBER: 17-20-24R

SUBJECT: Second Row Seat Belt Indicator Inoperable

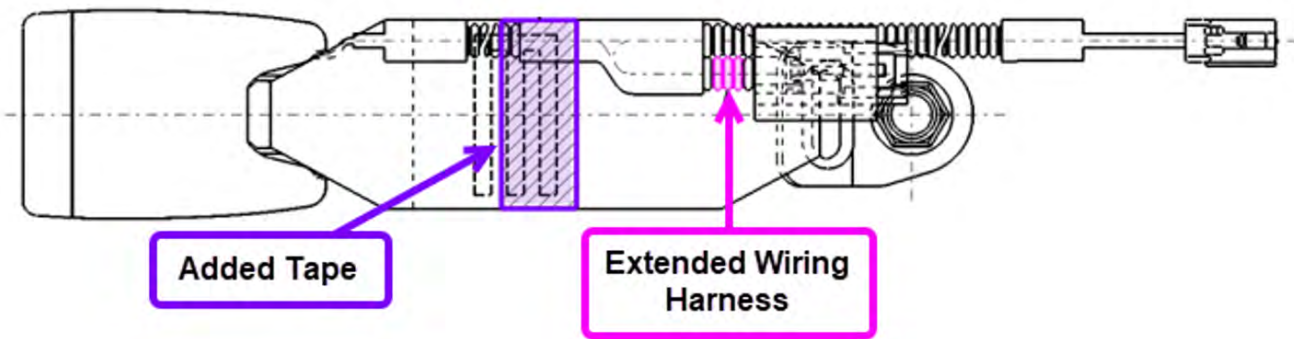
DESCRIPTION OF DESIGN CHANGE:

This bulletin announces a design change made to the second row inner seat belt buckle assembly to address cases of the seat belt indicator warnings not turning off after the buckle is fully latched. Free play in the seat belt buckle’s wire harness can cause excessive wear and result in a possible open circuit. The new buckle assembly has an extended wiring harness with tape added to reduce harness stress. If a customer experiences the seat belt warnings staying active after confirming the second row seat belt is fully latched, replace the affected inner seat belt buckle assembly using the information supplied in this bulletin.
