To: All Subaru Retailers
From: Subaru of America, Inc. – Service Quality
Date: September 12, 2025
Re: *WRD-25 Solterra HVAC ECU Reprogramming Safety Recall and Stop Sale – Stop Sale Procedure*

We are happy to provide an update regarding the WRD-25 25 Solterra HVAC ECU Reprogramming Safety Recall and Stop Sale.

STOP SALE SERVICE PROCEDURE INFORMATION

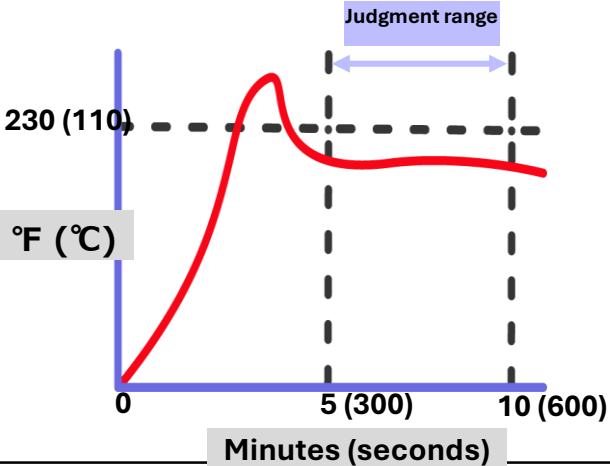
Did the Refrigerant Outlet Temperature reach 230°F (110°C) after 5 to 10 minutes?

Inspection Result	Next Step
<div style="background-color: #00b050; color: white; text-align: center; font-size: 2em; font-weight: bold; padding: 20px;">NO</div> <p style="text-align: center; color: green; font-weight: bold;">After 5-10 minutes the temperature never reached 230°F (110°C).</p>

<p style="text-align: center;">Minutes (seconds)</p>	<p style="font-size: 1.2em; font-weight: bold;">Proceed to Step 17</p>
<div style="background-color: #ff0000; color: white; text-align: center; font-size: 2em; font-weight: bold; padding: 20px;">YES</div> <p style="text-align: center; color: red; font-weight: bold;">After 5-10 minutes the temperature was over 230°F (110°C).</p>
