**PRODUCT CAMPAIGN BULLETIN**

**APPLICABILITY:** 2023-2025 MY Solterra **NUMBER:** WRD-25

**SUBJECT:** Safety Recall and Stop Sale: Solterra HVAC ECU Reprogramming **NHTSA ID:** 25V577

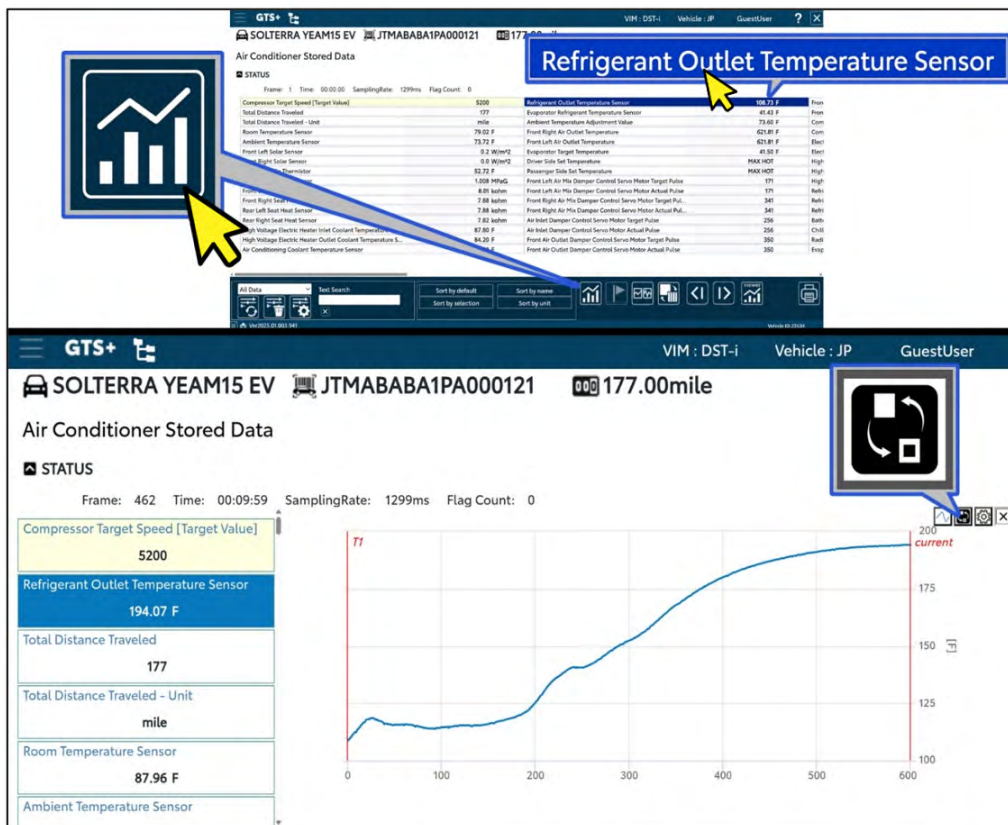
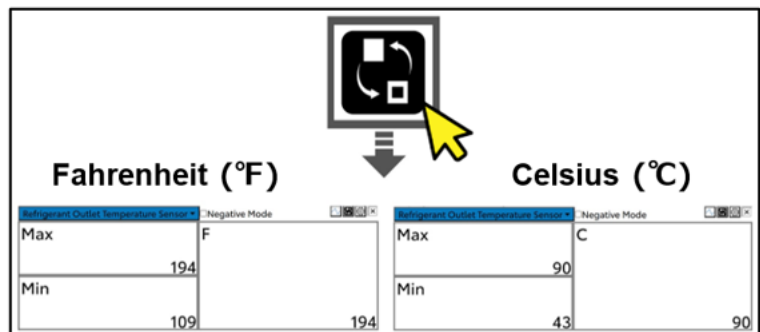
**STEP 15:** Select “Refrigerant Outlet Temperature Sensor” and then click the “Graph” button. This will allow the ten minute recording to be viewed.

**STEP 16:** Check the refrigerant outlet temperature and determine if the compressor requires replacement. Refer to the tables below.

JUDGMENT CRITERIA	
Inspection Mode	Inspection Method
<p><b>Over 77°F (25°C)</b> <b>A/C ON</b></p>	<p>Confirm Refrigerant Outlet Temperature <b>after 5 to 10 minutes.</b></p>
<p>Didn't the Refrigerant Outlet Temperature reach <b>230°F (110°C)</b> after 5 to 10 minutes?</p>	
Inspection Result	Next Step
<p><b>OK</b></p> <p>After 5-10 minutes the temperature never reached 230°F (110°C).</p> <p>Minutes (seconds)</p>	<p><b>Proceed to Step 17</b></p>
<p><b>YES</b></p> <p>After 5-10 minutes the temperature was over 230°F (110°C).</p> <p>Minutes (seconds)</p>	<p><b>TBD until part supply becomes sufficient</b></p>

JUDGMENT CRITERIA	
Inspection Mode	Inspection Method
<b>Under 77°F (25°C)</b> <b>A/C OFF</b>	Confirm Refrigerant Outlet Temperature <b>for 10 minutes.</b>
<b>Didn't the Refrigerant Outlet Temperature reach 239°F (115°C) within 10 minutes?</b>	
Inspection Result	Next Step
<div style="background-color: green; color: white; padding: 10px; text-align: center; font-size: 2em; font-weight: bold;">OK</div> <p>The temperature never reached 239° (115°C)F in 10 minutes.</p>	<p><b>Proceed to Step</b></p> <p style="text-align: center;"><b>17</b></p>
<div style="background-color: red; color: white; padding: 10px; text-align: center; font-size: 2em; font-weight: bold;">YES</div> <p>Within 10 minutes the temperature reached 239°F (115°C).</p>	<p style="text-align: center;"><b>TBD</b></p> <p style="text-align: center; color: blue;">until part supply becomes sufficient</p>
