## SERVICE BULLETIN

**APPLICABILITY:** 2012-23MY Impreza & Crosstrek  
2014-23MY Forester 2.5  
2013-19MY Legacy & Outback 2.5L

**NUMBER:** 16-156-25

**SUBJECT:** CVT Control Valve Body Design  
Change / P2757, P2762, & P06EF

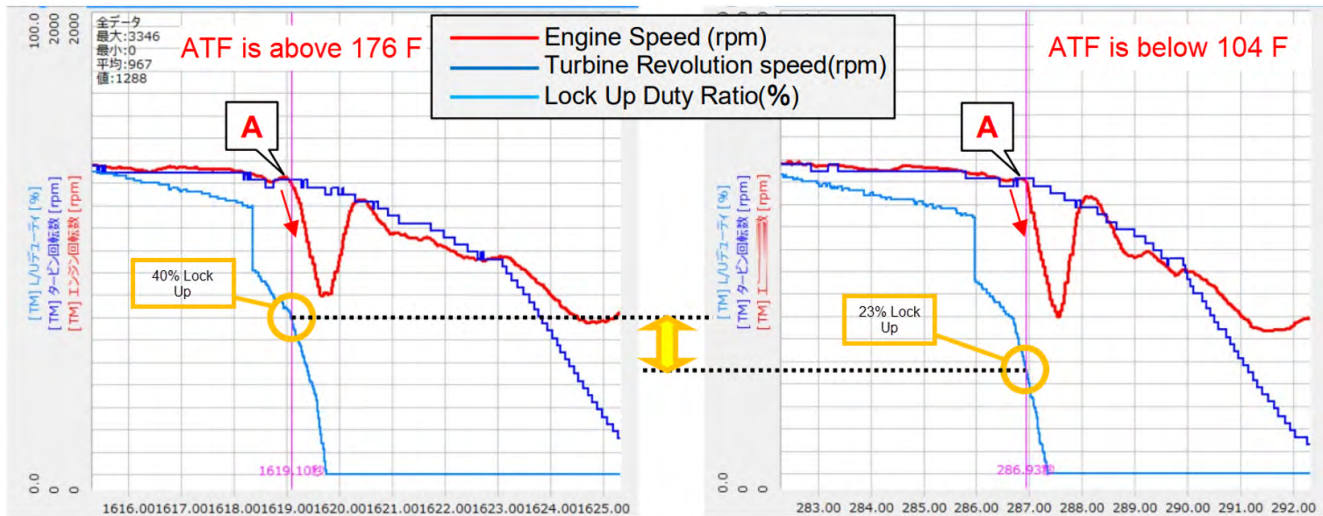
Perform a test drive while recording data using the Subaru Select Monitor, ensuring that all TCM data PIDs are captured. During the test, decelerate the vehicle from 25 mph to a complete stop twice when the CVT fluid temperature is below 104°F, and then twice more when the temperature is above 176°F. Graph the recorded data, set torque converter speed and engine speed range of 0 to 3000 rpm. Analyze the deceleration events where engine speed and torque converter speed no longer overlap on the graph (see example graphs below). At these points, determine whether there is a 10% or greater difference in the Lock-Up Duty Ratio (%) between the data recorded at 176°F and 104°F, specifically when the torque converter clutch is released.

NOTE: 'A' indicates a point where a difference occurs between the engine speed and the turbine revolution speed, marking the moment when the lock-up clutch is disengaged.

Example:  $40\% - 23\% = 17\%$

Note: To determine the difference of Lock-Up duty Ratio Subtract the Lock-Up Duty Ratio when ATF temperature is below 104°F from the Lock-Up Duty Ratio when ATF temperature is above 176°F.

**Yes** – Replace the valve body and go to step 7.
