Technical Journal Title Park Assistance System Enhanced Troubleshooting		Ref. No. TJ 37394.1.0	
Issuer (Dept.) PPASSAFA - Paige Passafaro		Issue Date 9/11/25	Status Date 9/19/25
Car Market United States and Canada	Partner 3 US 7510 Volvo Car USA	Function Group 3871	
Function Description Parking assistance		Page Page 1 of 4

Technical Journal 37394.1.0

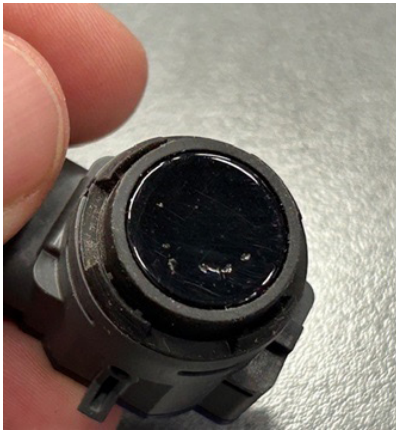
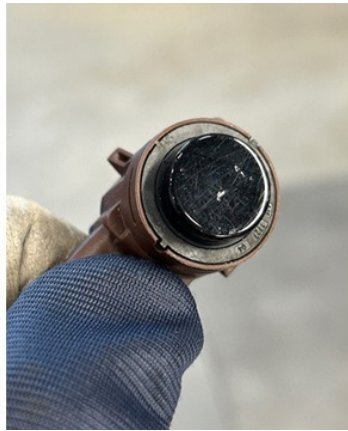
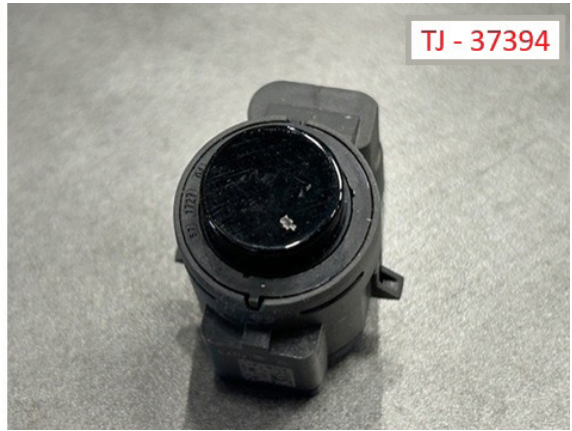
File Name	File Size
TJ_37394_1.jpg	0.1279 MB

- The sensor membrane can be damaged by stones/blasting, and corrosion can occur. This can cause an increased risk of false warnings or missing failure detection.
Remedied by painting or changing the sensor.

Note: Visible stone chip damage on the PAS-sensor is NOT accepted as warranty, check the attached photo as an example.
