## 2025 Can-Am Pulse Handlebar Clamping Force - 144622

### Article Detail

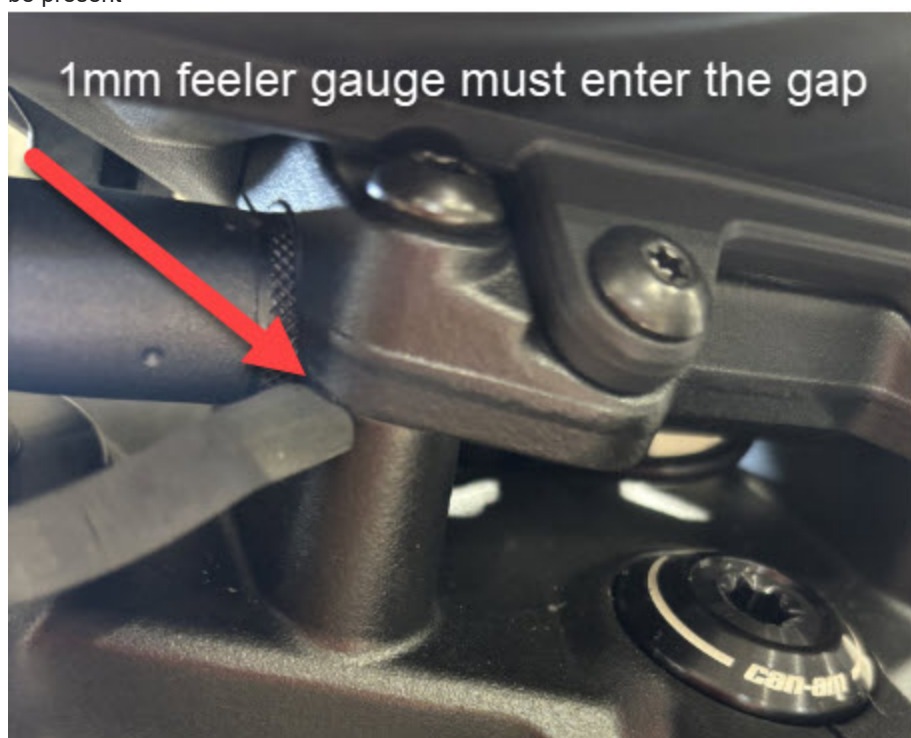
On some identified units the clamping force applied on the handlebar may be incorrect

Using a feeler gauge, inspect the clearance between the handlebar clamp and the triple clamp, a clearance of at least 1 mm must be present

If inspections shows no gap, replace the handlebar clamp with the one that was provided by BRP, if you need the part again please reopen the technical case that was opened on your behalf

Refer to the shop manual for the torque values
