Technical Service Bulletin (TSB)
R1H Radio U40.20 USB Software Update

REFERENCE:	TSB: 08-237-25 REV. A GROUP: 08 - Electrical	Date:	September 25, 2025	REVISION:	08-237-25
VEHICLES AFFECTED:	2021 - 2023 (WL) Jeep Grand Cherokee / Grand Cherokee L This bulletin applies to vehicles built equipped with one of the following radios: <ul style="list-style-type: none"> • Uconnect 5 Nav w 8.4" Display (JPN) (Sales Code UTL). ** (Japan Only)**. • Uconnect 5 Nav w 10.1" Display (JPN) (Sales Code UTN). ** (Japan Only)**. 		MARKET APPLICABILITY: <input type="checkbox"/> NA <input type="checkbox"/> MEA <input type="checkbox"/> SA <input checked="" type="checkbox"/> IAP <input type="checkbox"/> EE <input type="checkbox"/> CH NOTE: This bulletin applies to India & Asia Pacific market		
CUSTOMER SYMPTOM:	Customers may experience one or more of the following: <ul style="list-style-type: none"> • **Temperature displayed in the radio display and rear HVAC are mismatched.** • Wi-fi Software update pop-up is being triggered in non connected vehicles. • Radio freezes and then restarts. • Head Unit (HU) freezes and then restarts. • HU is taking more than one minute to start after starting the engine. • S

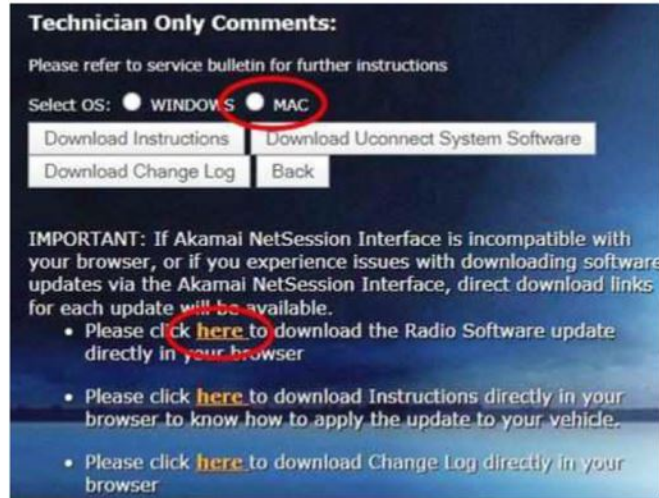
Fig. 2

MAC Radial Button

7. Download the software update file to your local PC's desktop. Make sure to select the "MAC" radial button for all downloads Fig. 2.
