| REFERENCE: | TSB: 08-266-25 REV. A GROUP: 08 - Electrical | Date: | September 25, 2025 | REVISION: | 08-266-25 |
| CAUSE: | Software improvements | | | | |

This bulletin involves inspecting and if required, updating the radio software level to ****U40.20****. Depending on the radio's current software level the radio may need a one or two USB update.

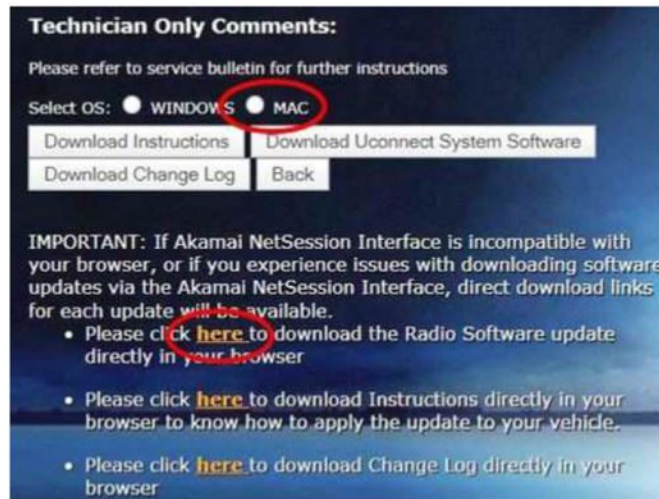
Fig. 2

MAC Radial Button

7. Download the software update file to your local PC's desktop. Make sure to select the "MAC" radial button for all downloads Fig. 2.

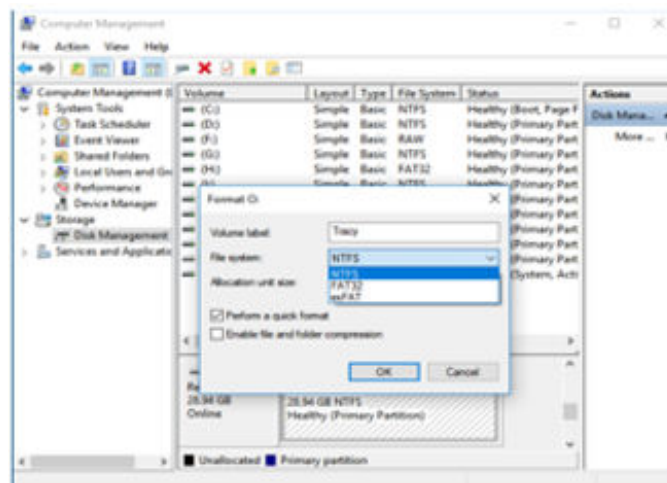
Fig. 3

Zip Folder

9. **There should only be one file on the USB root directory labeled as a "fca-my24-prod-signed-usb_update-U29.42.SPEECH.KR-fullupdate.zip" folder for the U29.42 update.
- For the 40.20 Update, download "fca-my24-prod-signed-usb_update-U40.20.SPEECH.KR-SYSTEM_ONLY.zip"*** Fig. 3.
