REFERENCE:	TSB: 23-033-25 GROUP: 23 - Body	Date:	September 27, 2025	REVISION:	—
VEHICLES AFFECTED:	2024 - 2025 (JL) Jeep Wrangler This bulletin applies to vehicles built on or after July 01, 2024 (MDH 0701XX) and on or before June 30, 2025 (MDH 0630XX).			MARKET APPLICABILITY: <input type="checkbox"/> NA <input type="checkbox"/> MEA <input type="checkbox"/> SA <input checked="" type="checkbox"/> IAP <input type="checkbox"/> EE <input type="checkbox"/> CH NOTE: This bulletin applies to India & Asia Pacific markets.	
CUSTOMER SYMPTOM:	<p>Customers must experience a Malfunction Indicator Lamp (MIL) illumination and the vehicle must exhibit/set one or more of the following Diagnostic Trouble Codes (DTCs):</p> <ul style="list-style-type: none"> ● U11E3-00 - TCM Lost Communication With ESM On DPT CAN. ● B15A1-00 - Media Port 1 Connection. ● U11C2 - Lost Transmission Message. ● U11E4-00 - CAN Communication Messages Missing. ● U120C - Lost Brake Booster Signal. ● U1216-00 - Lost Communication With DASM. ● U121E-00 - Lost Communication With Steering Wheel Cruise Control Switch. ● U1267-00 - No Valid Data From ESM On CAN-C Or CAN-DPT. ● U12A8 - Lost Communication With Master Cylinder Pressur

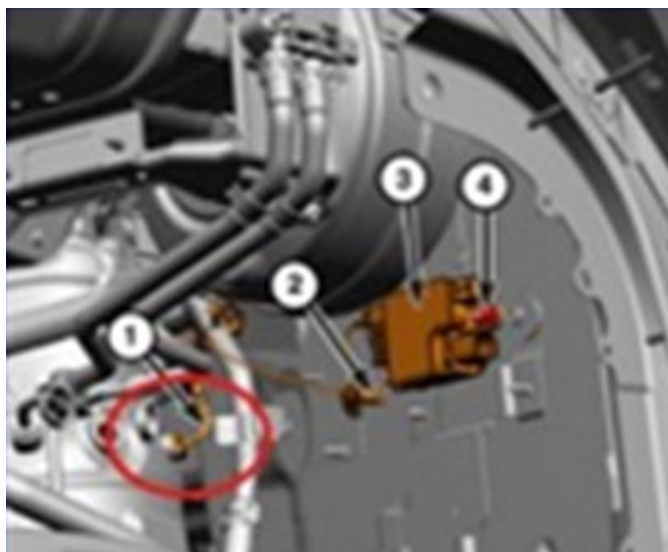
Fig. 1
Pinched Wire Harness Location

- NO>>> Replace the radio.
4. Does the Steering transfer motor set DTC C140A-11 or is the wiring harness routing incorrect with a wiring pinch?
 - YES>>> Proceed to [Step 5](#).

- 1 - EGT Sensor
 - 2 - Wire Harness Retainer
 - 3 - EGT Sensor Module
 - 4 - Nuts
-

- NO>>> Proceed to [Step 6](#).
5. Check the wiring harness routing and replace the steering transfer motor if found NOK with wire harness pinched [Fig. 1](#) and [Fig. 2](#). Refer to the detailed service procedures available in DealerCONNECT/Service Library under: Service Info> 08 - Electrical / 8E - Electronic Control Modules / Module, Drivetrain Control (DTCM) / Removal and Installation.

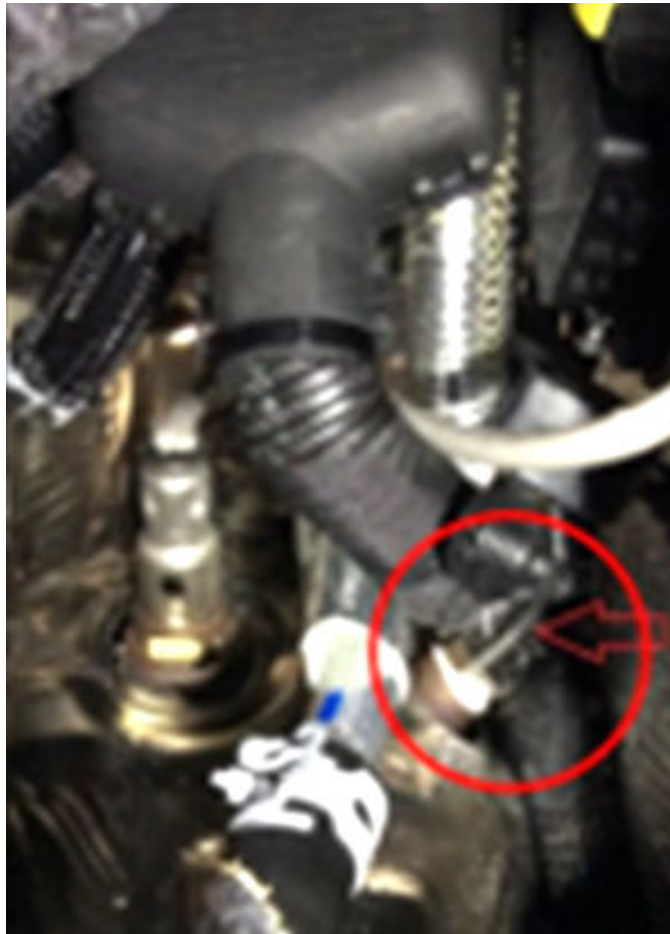
**Fig. 2**

Pinched Wire Harness Location

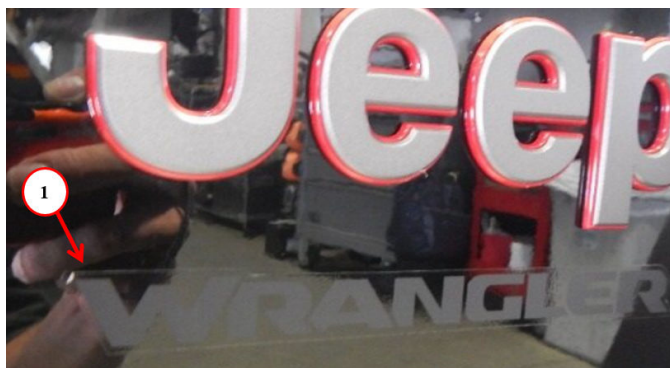
Fig. 3
Sticker Decal

10. Is the left or right side Wrangler sticker decal peeling off from either front fender [Fig. 3](#)?

1- Sticker Decal Peeling

11. Peel off and replace the sticker decal.

NOTE: The sticker surface must be cleaned and dry before applying the new sticker decal.

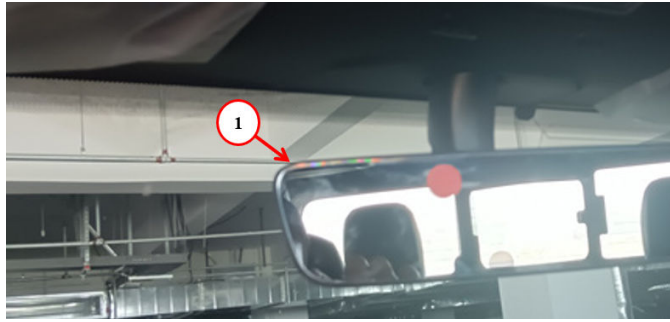
Fig. 4
Interior Rear View Mirror

18. Is the inside rear view mirror glass peeling / delaminating [Fig. 4](#)?

1 - Interior Rear View Mirror Delamination / Peeling

19. Replace the inside rear view mirror. Refer to the detailed service procedures available in DealerCONNECT/Service Library under: Service Info> 23 - Body / Interior / Mirror, Rearview / Removal and Installation.

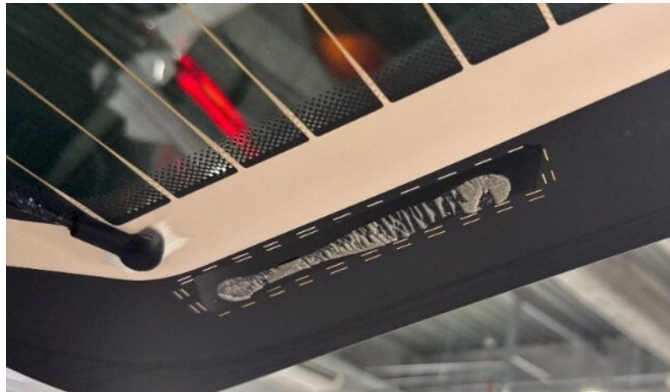
20. Is the liftgate glass damper mount peeling or has the damper come off from the mount [Fig. 5](#)?

Fig. 5
Liftgate Damper Location - Missing Damper

21. Replace the liftgate glass damper or, if required, the tailgate glass. Refer to the detailed service procedures available in DealerCONNECT/Service Library under: Service Info> 23 - Body / Stationary Glass / Backlite / Removal and Installation.

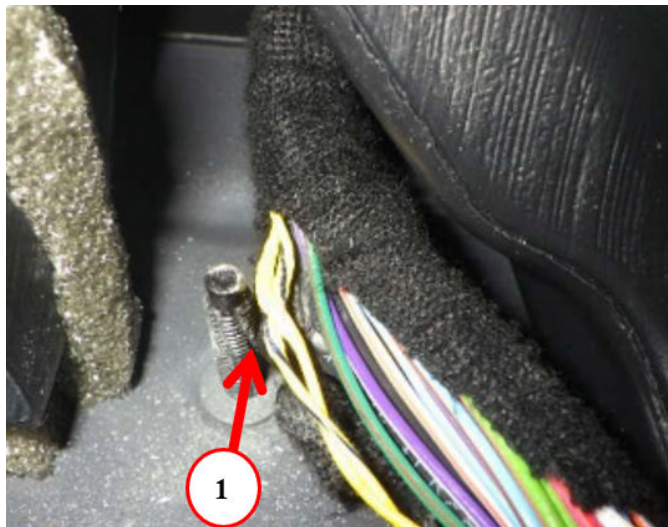
Fig. 6
Instrument Panel Wire Harness

29. Is the wiring harness fouling with the stud [Fig. 6](#)?

1 - Instrument Panel Wire Harness Contacting Stud Below Gear Lever Console Trim

30. Wrap the wires with Tesa tape and reroute the wiring harness, or if required, replace wiring harness.
