**Technical Service Bulletin (TSB)**  
**Gasoline Particulate Sensor Lines Incorrect Routing**

<b>REFERENCE:</b>	<b>TSB:</b> 25-001-25 <b>GROUP:</b> 25 - Emissions Control	<b>Date:</b>	September 26, 2025	<b>REVISION:</b>	—
<b>VEHICLES AFFECTED:</b>	<b>2023 (WL) Jeep Grand Cherokee / Grand Cherokee L</b> This bulletin applies to vehicles built on or before July 21, 2024 (MDH 0721XX) equipped with 2.0L I4 DOHC DI Turbo PHEV Engine (Sales Code ECX).	<b>MARKET APPLICABILITY:</b>		<input type="checkbox"/> NA <input type="checkbox"/> MEA <input type="checkbox"/> SA <input type="checkbox"/> IAP <input type="checkbox"/> EE <input checked="" type="checkbox"/> CH <b>NOTE:</b> This bulletin applies to the China market.	
<b>CUSTOMER SYMPTOM:</b>	<p><b>Customers must experience a Malfunction Indicator Lamp (MIL) illumination and the vehicle must exhibit/set one or more of the following Diagnostic Trouble Codes (DTCs):</b></p> <ul style="list-style-type: none"> <li>• P226D - Particulate Filter Deteriorated/Missing Substrate Bank 1.</li> <li>• P2453 - Particulate Filter Pressure Sensor "A" Circuit Range/Performance.</li> </ul> <p><b>Customers may experience the following:</b></p> <ul style="list

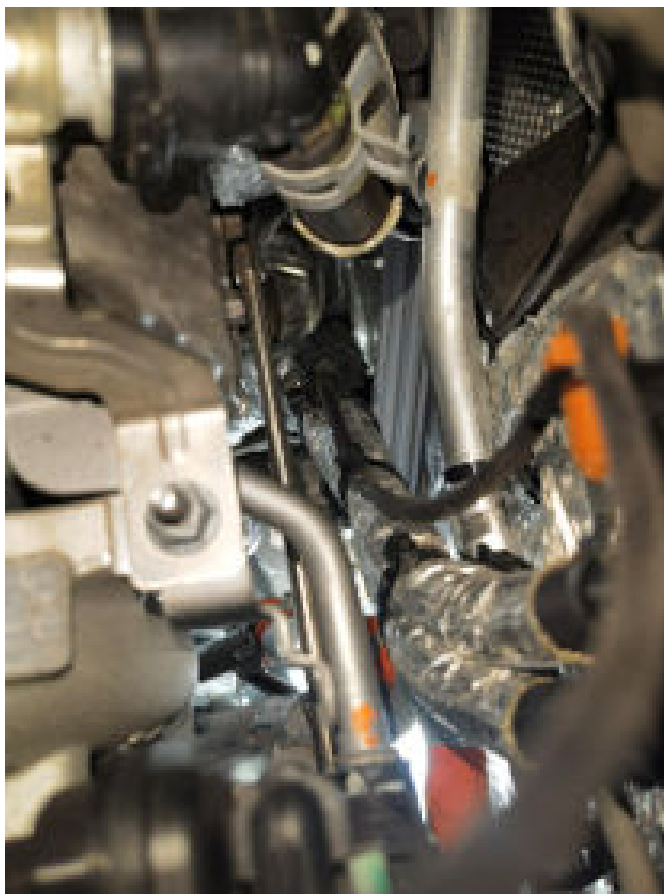
**Fig. 1**

Correct Orientation

1. Using wiTECH, select PCM and then the Data menu. Monitor the PFPS DELPRESS signal for changes when varying RPM.
2. Does the PCM -PFPS DELPRESS (PSI) signal vary with RPM?
  - YES>>> This bulletin does not apply. Use Inspect LOP (25-06-06-02) to close the active RSU.
  - NO>>> Proceed to [Step 3](#).
3. Return the gasoline particulate differential pressure sensor lines to the correct orientation. Refer to the detailed service procedures available in DealerCONNECT/Service Library under: Service Info> 11 - Exhaust System / SENSOR, Differential Pressure / Removal and Installation.

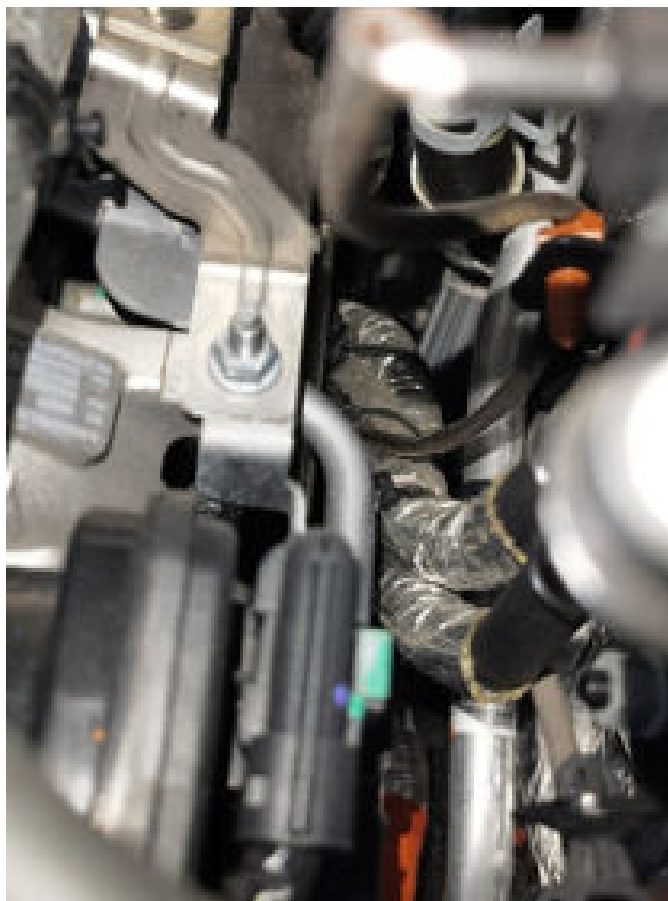
**Fig. 3**  
Incorrect Orientation

4. Re-test with wiTECH to verify.
5. Clear any DTCs that may have been set.
