STAR ONLINE PUBLICATION

Case Number: S2508000075 Rev. A

Symptom/Vehicle Issue: Integrated Trailer Brake (ITB) Switch Removal

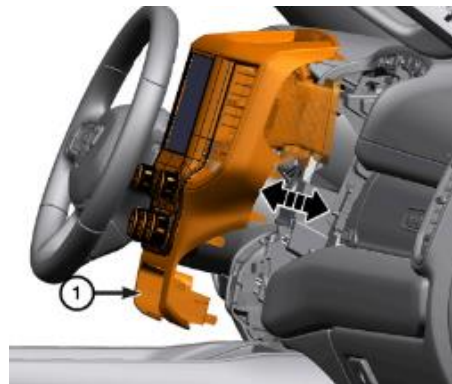
Do not pull the radio assembly from the bottom side

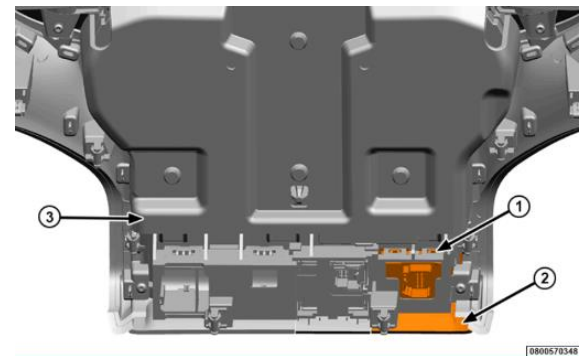
NOTE: DO NOT Pull down and straight from the front of the switch. It will end up breaking the switch

2. Using a trim stick disengage upper and lower tabs (1) from the ITB switch (2) and separate it from the radio assembly (3) Pushing forward
