Stalk Switch Left and Right Inoperative Due to LIN1 Power

Campaign SF715

Published: 8/29/2025

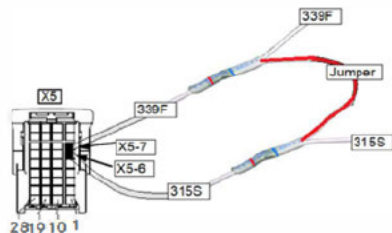
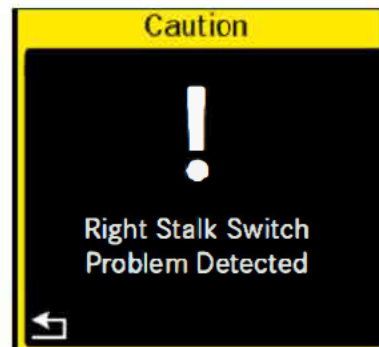
Western Star X-Series, M2 Plus, 108/114SD Plus and New Cascadia Vehicles built from 12/4/2024 to 2/5/2025 can exceed the LIN 1 power supply when built with specific Stalk Switch Left (SSL) and or Stock Switch Right (SSR) combinations. Symptoms can vary depending on the stalk switch applications, but two common symptoms associate with ignition activation are unintended wiper and hazard light activation.

- New stalk switches released, that testing did not capture intermittent over current issue that can occur during initial powering of the stalk switches. Capacitor change within both SSL and SSR was needed to resolve the issue.

- Service Solutions published on SS3162-FTL and SS 775-WST published on 2/3/2025. Solution provides a LIN 1 to LIN2 power bridge wiring containment, until new switches become available in the after market.

- Once new stalk switches with the capacitor change are available in the aftermarket, the long term containment is to publish a field campaign that would replace all "bad stalk switches" with the new and remove any wiring bridge between the power supplies of LIN1 and LIN2.
