M2+/SD+ Davco Fuel Water Separator – Fuse Panel Cover Incorrect

Campaign SF720

Published: 8/15/2025

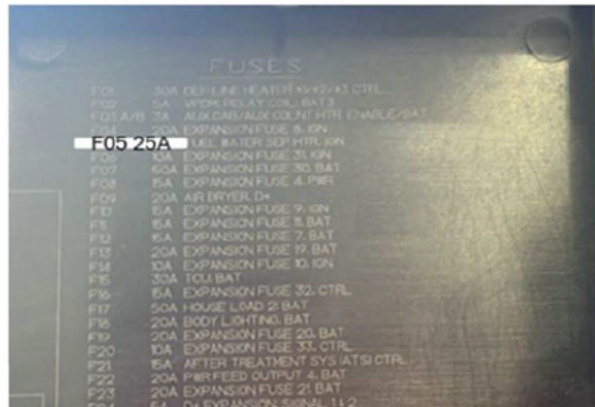
- The fuse panel covers have a 30 Amp specification for a location that is 25 amp.
- The Fuse itself is 25amp but the description on the cover is incorrect

- DAVCO changed the spec and the description on the panel was missed

- Release campaign to install the correct fuse panel covers.
