Technical Service Bulletin

Subject: NOISE FROM FRONT MAP LIGHT SURROUNDINGS	Bulletin No.: 09-015/25
	Last Issued : 09/15/2025

2024-2026 CX-90

2025-2026 CX-70

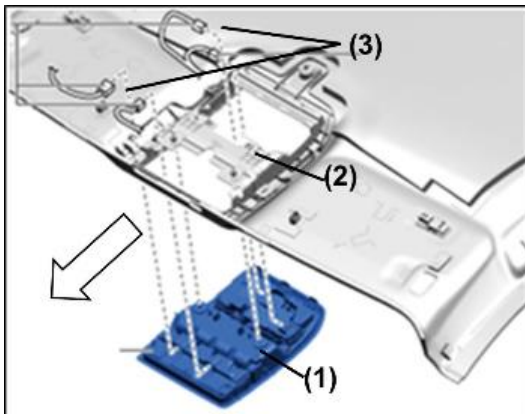
Some customers may complain about a rattle or vibration noise coming from front map light surroundings when driving on a rough road. This may be caused by the bracket for the map light. Due to heat or vibrations, the fastener fixing the front map light to the bracket may deform, making the joint loose. In such case, when the vehicle bounces, the bracket may oscillate and produce a rattling noise. To eliminate that concern, non-woven fabric will be attached to the headliner.

1. Front map light
2. Bracket
3. Connectors

The arrow is pointing to the front of the vehicle.

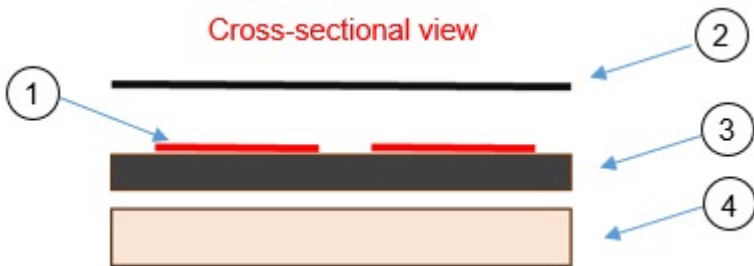
- (1) Non-woven fabric (backside of bracket)
- (2) Roof panel
- (3) Bracket
- (4) Front map light

NOTE: Attach (1) the non-woven fabric to the back side of the bracket, not to the front side.
