Technical Service Bulletin

Topic	15 Oil leak from the cylinder head - 2.9 and 3.0 TFSI only
Market area	United States 444 Volkswagen of America, Inc. (6444)
Brand	Audi
Transaction No.	2053278/10
Level	EH
Status	Released for publishing
Release date	Sep 30, 2025

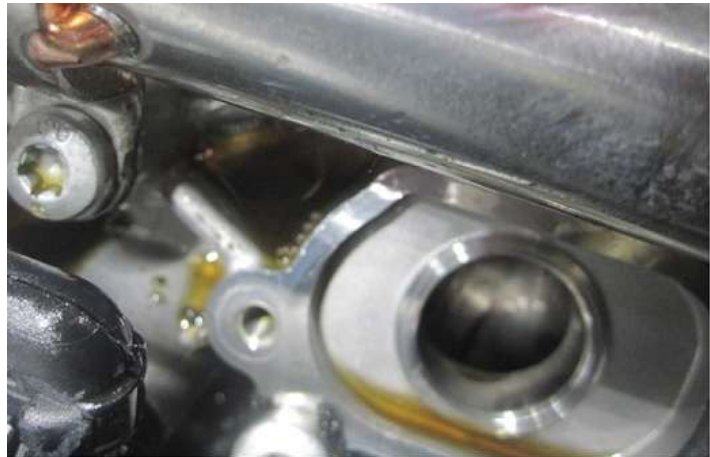
A. If there is a substantial quantity of oil below the Audi valvelift system actuator (illustration), the cause of the leak is the O ring of the Audi valvelift system actuator.

Figure 2. Oil in the Audi valve lift system.

Replace the Audi valvelift system actuator with an O ring, clean the engine compartment, and if necessary replace the noise insulation (if it is soaked in oil) (Figure 2).

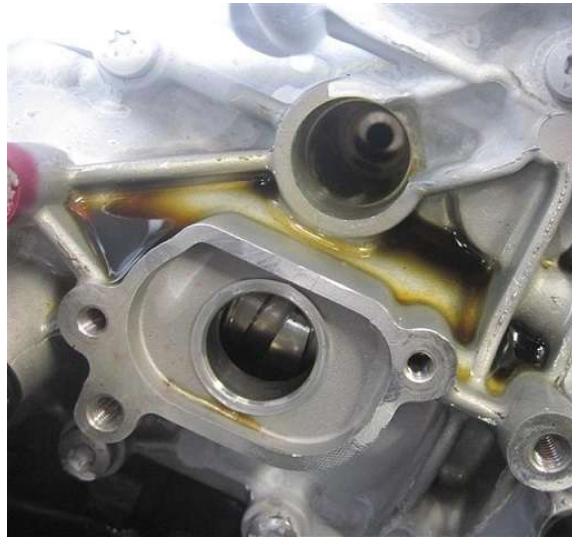
5. Locate the affected cylinder. Oil should have gathered in the area of the injector (Figure 3) and the noise insulation should also be soaked in oil.

Figure 3. Locating the affected cylinder.

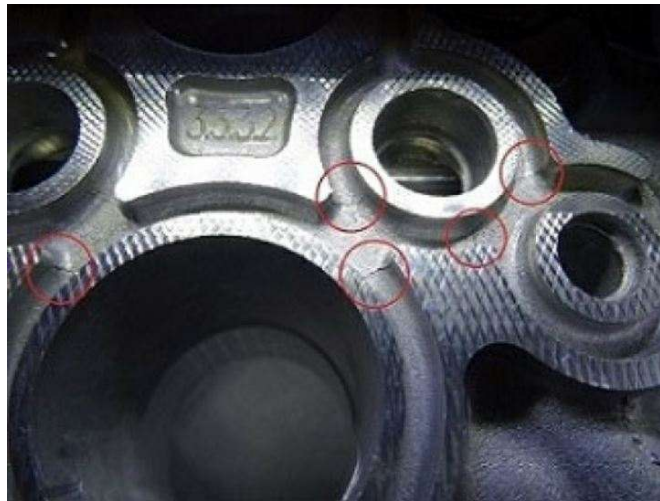
Casting residue/ particles produced during manufacture in sealing groove between cylinder head cover and the cylinder head.

Figure 5. Before the repair.

7. Inspect the gasket groove in the cylinder head cover and remove any casting residues with a suitable tool (Figure 5). The residues can be removed with a small flat screwdriver (Figure 6).

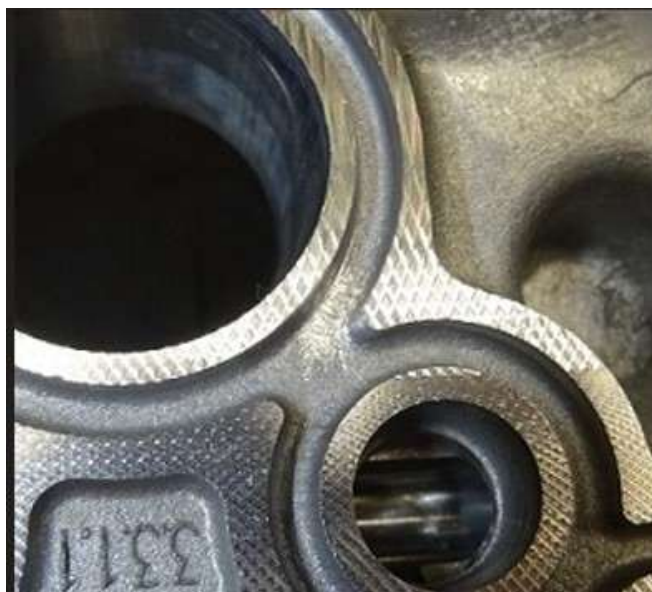
Figure 6. After the repair.

8. Install a new seal, re-assemble the camshaft cover, clean the engine compartment, and if necessary, replace the noise insulation (if it is full of oil).
