Technical Service Bulletin

Topic	34 Oil leak at the transmission connector
Market area	United States 444 Volkswagen of America, Inc. (6444)
Brand	Audi
Transaction No.	2058875/2
Level	EH
Status	Released for publishing
Release date	Sep 5, 2025

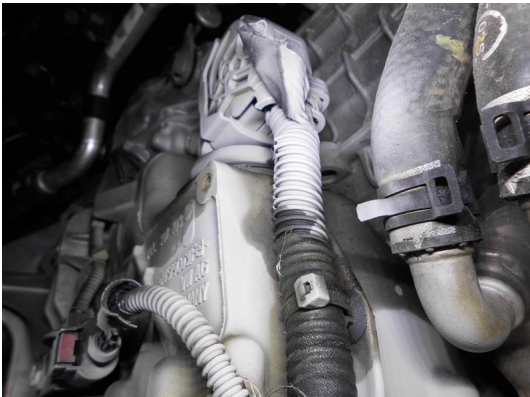
- Small traces of oil on the gearbox control unit from the seal under the gearbox connector.

Figure 1. Evidence of oil leak from the transmission control module seal.

1. Residual oil from the manufacturing of the transmission (lubrication of seal when installing the control module in transmission housing).
2. Overlap of seal on the transmission control module connector is not sufficient in all tolerances.

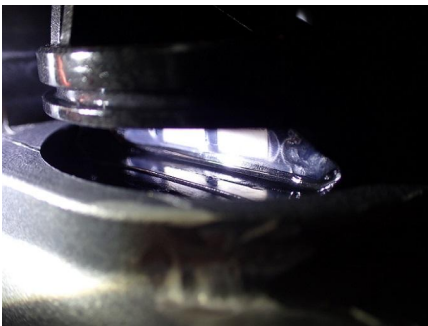
Figure 3. A thin film of oil in the cavity.

Oil traces (see Figure 3): assess whether there are traces of oil in the recess under the dust cap using workshop equipment (**there should only be a light film of oil as shown in Figure 3**). Clean the area thoroughly using workshop equipment and spray the affected area with talcum spray. Then perform an extensive road test and assess the oil traces again.

If there are no more traces of oil, it is not necessary to fit a new seal. Further measures listed in the TSB are therefore not effective in this case.

If oil traces are visible again, replace the seal of the gearbox control unit according to the Workshop Manual. Fit **two new seals** as part of this repair (**part number according to ETKA: 0CK927523**). As shown below in Figure 6.

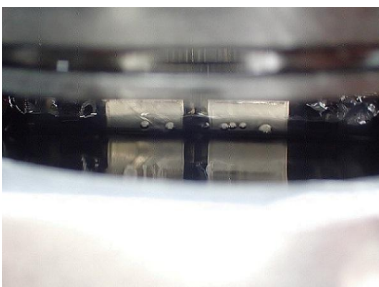
Figure 4. Oil accumulation -> oil is several mm high in the recess.

Oil accumulation (see Figure 4): assess whether oil is accumulating in the recess under the dust cap using workshop equipment (**there should be oil visible as shown in Figure 5**). If this is the case, attach a photo clearly showing the issue to the report. Then replace **the seal** of the gearbox control unit according to the Workshop Manual.

Fit **two new seals** as part of this repair (**part number: 0CK927523**). As shown below in Figure 5.

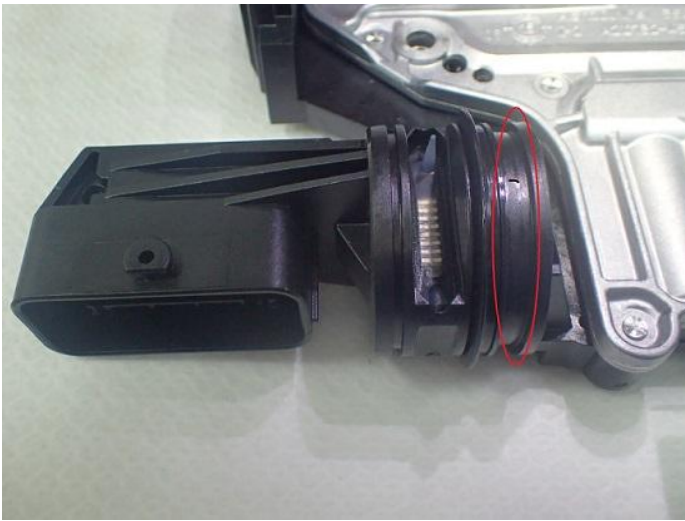
Figure 5. A seal fitted as standard
Modified state after performing TSB (Figure 6).

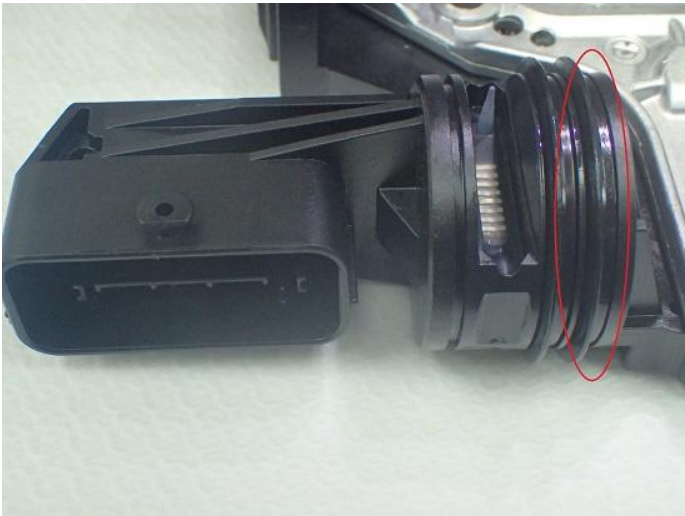
Figure 6. 2 seals fitted after performing the TSB.
