Technical Service Bulletin

Topic	66 Service info: paint peeling off black trims / trim strips
Market area	United States 444 Volkswagen of America, Inc. (6444)
Brand	Audi
Transaction No.	2074058/3
Level	EH
Status	Released for publishing
Release date	Sep 12, 2025

A3, S3, and RS 3

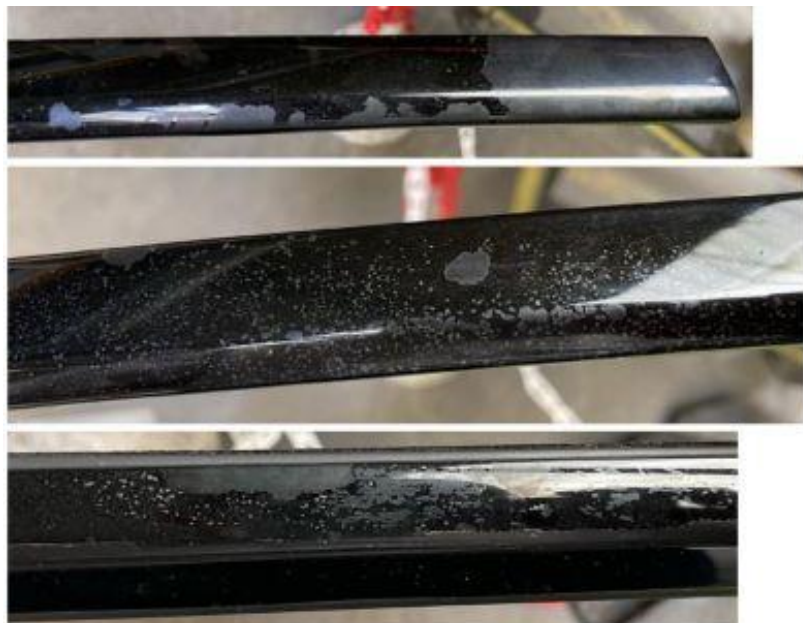
1. The following example photos show various damage on black trims / trim strips (Figure 1).

Figure 1. Examples of damage on black trims / trim strips.

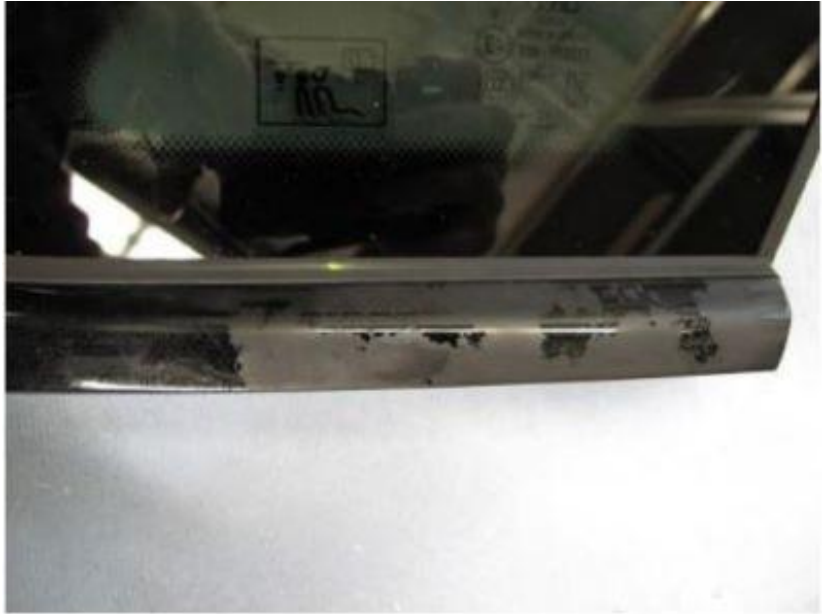
2. Coat peeled off (Figure 2).

Figure 2. Coat peeled off.

Based on the laboratory analyses, the cause of the complaint is the use of a cleaning solution that is too aggressive for the application, often in conjunction with the application of pressure, such as from a high-pressure cleaner. Cleaning solutions such as industrial dirt remover, or insect remover and the various consistencies of those solutions, can attack the additional coating. Depending on how the cleaning solutions are applied, the time they are applied to the components, as well as the subsequent cleaning using a high-pressure cleaner, they can cause irreversible damage to the coating. Using energy-dispersive x-ray analysis, the damaged surfaces were analyzed on a molecular level. Traces of phosphorus (P) and fluorine (F) were detected. These elements are not contained in the conventional anodizing and additional coating layers but can often be found in commercially available cleaning solutions, such as industrial dirt and insect removers, as well as wheel cleaners.

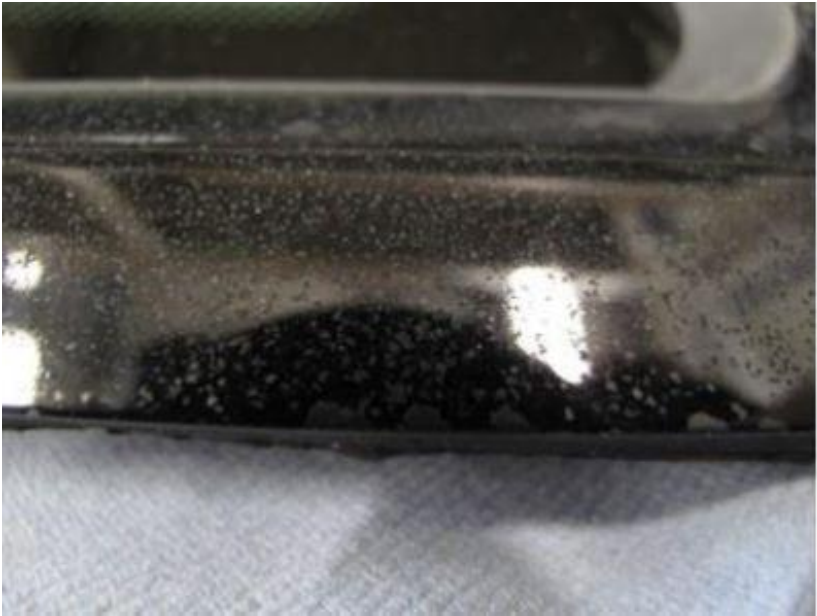
3. Spots of additional coating. A fine spray pattern caused by a cleaning agent can be seen (Figure 3).

Figure 3. Spots of additional coating.

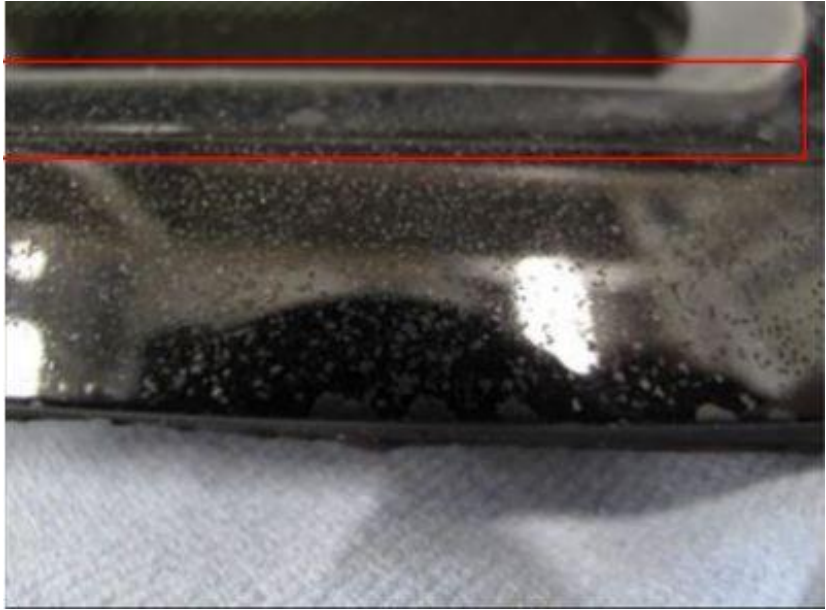
4. Figure 4 clearly shows marks forming on the neighboring rubber components, outside of the trim strips, caused by an applied liquid.

Figure 4. Marks forming caused by applied liquid.

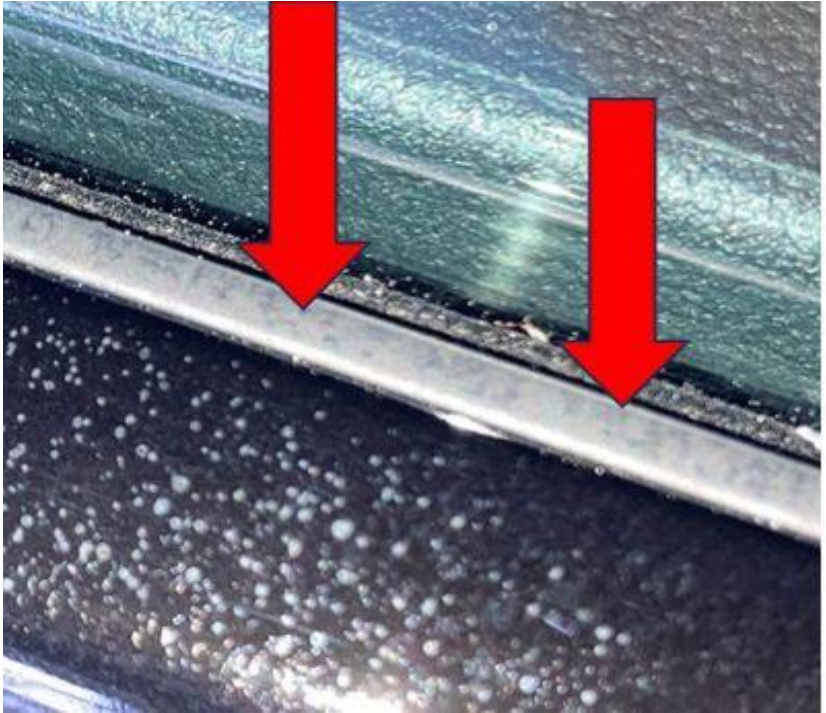
5. Figure 5 clearly shows marks forming on the neighboring rubber components caused by an applied liquid.

Figure 5. Marks forming caused by applied liquid.

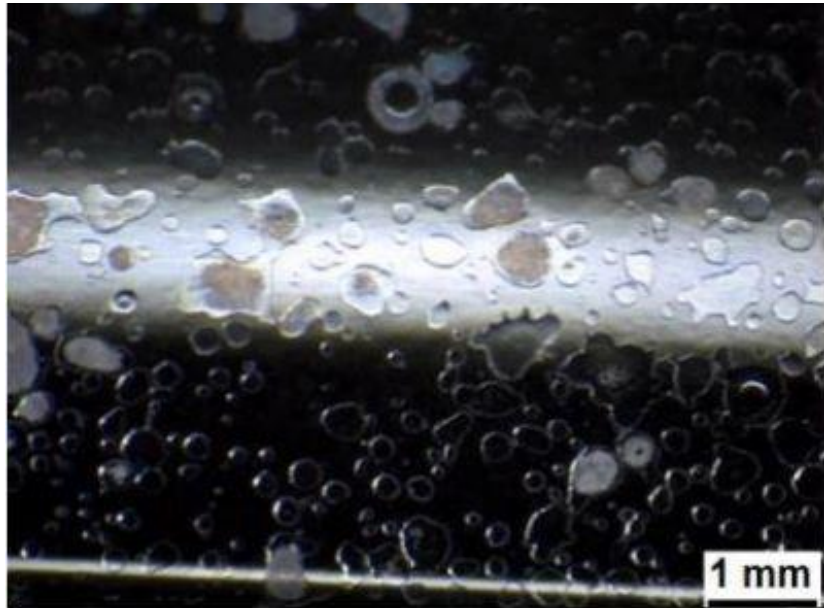
6. Figure 6 shows spots of swelling as viewed under a stereo microscope.

Figure 6. Spots of swelling as viewed under a stereo microscope.
