## Technical Service Bulletin

| <b>Topic</b> | 40 Noises from front end of vehicle when steering and/or when suspension compresses |
| <b>Brand</b> | Audi |
| <b>Transaction No.</b> | 2075251/3 |

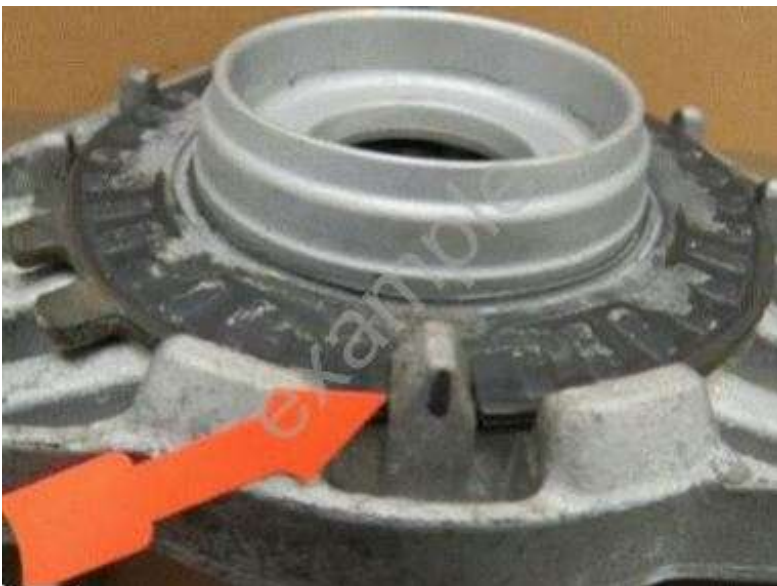
Under unfavorable conditions (overlapping of component tolerances), contact may occur between the positioning lug on the suspension strut mounting and the deep groove ball thrust bearing. This can cause a noise during steering and/or when driving over bumps (when the suspension compresses).

***Figure 2. Positioning lug on suspension strut mounting.***

- File down/shorten positioning lug on suspension strut mounting (see Figure 2, red arrow) by approx. 3 mm using suitable workshop tools (e.g. a metal file).

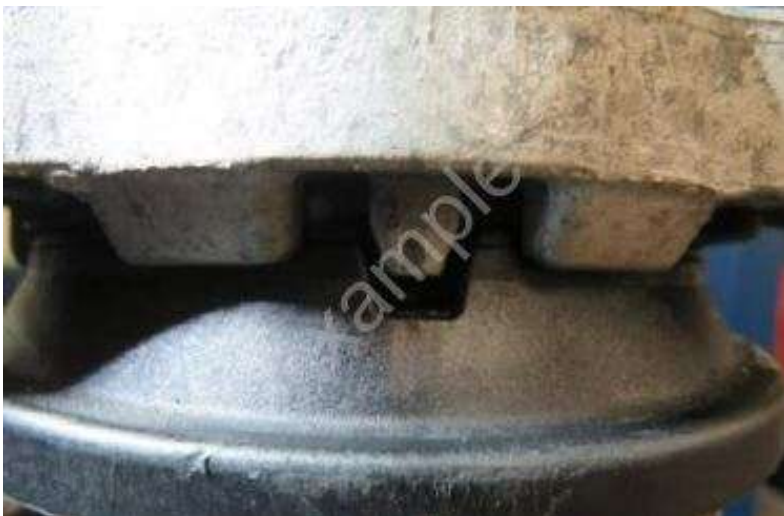
**Figure 3.** Example: sufficient clearance between suspension strut mounting and deep groove ball thrust bearing.

- Reassemble suspension strut mounting and deep groove ball thrust bearing and check that there is sufficient clearance (see Figure 3):
- If there is sufficient clearance, continue with the next step.
- If there is insufficient clearance, file down/shorten positioning lug on suspension strut mounting further as required. Then continue with the next step.
