Technical Service Bulletin

Topic	00 Combined software update 03.01.00/C (28.11.01) KD1**
Market area	United States 444 Volkswagen of America, Inc. (6444)
Brand	Audi
Transaction No.	2077960/5
Level	EH
Status	Released for publishing
Release date	Sep 24, 2025

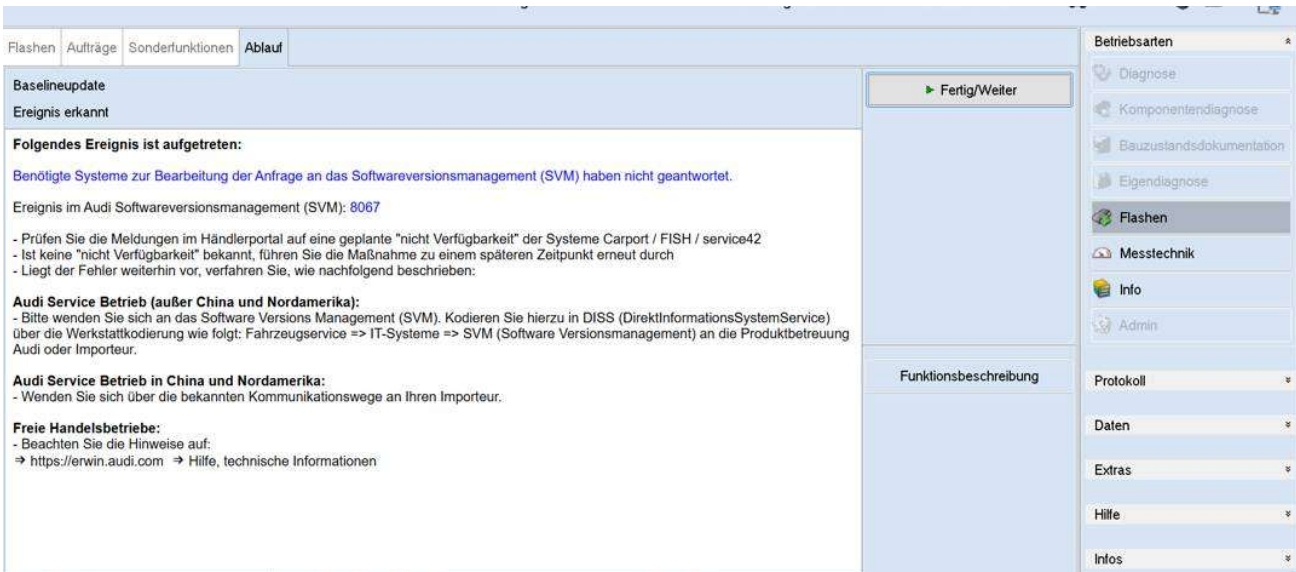
If the ODIS tester cancels the flashing procedure with error code **8067**, this measure does not apply to the vehicle.

Ereignis im Audi Softwareversionsmanagement (SVM): 8067

- Prüfen Sie die Meldungen im Händlerportal auf eine geplante "nicht Verfügbarkeit" der Systeme Carport / FISH / service42
- Ist keine "nicht Verfügbarkeit" bekannt, führen Sie die Maßnahme zu einem späteren Zeitpunkt erneut durch
- Liegt der Fehler weiterhin vor, verfahren Sie, wie nachfolgend beschrieben:
