Technical Service Bulletin

Topic	93 A6/Q6 e-tron: charging cable is shown as being connected; U01E400
Market area	United States 444 Volkswagen of America, Inc. (6444)
Brand	Audi
Transaction No.	2077962/3
Level	EH
Status	Released for publishing
Release date	Sep 23, 2025

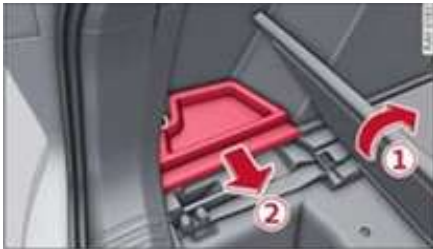
Remove fuse F39 (activation of charging flap and charging socket no.1) or F43 (activation of charging flap and charging socket no.2) for at least 10 seconds. The fuse is located in the luggage compartment (see following images).

Figure 1: Fuse carrier installation location: luggage compartment on left, open cover.

Reinsert the fuse in its position.

If the conditions specified above apply, replace the control unit for activation of charging flap and charging socket which **cannot be reached**.

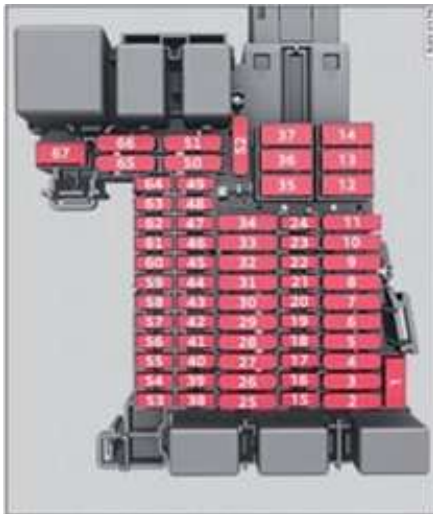
Figure 2: Fuse carrier.
