Technical Service Bulletin

Topic	91 Driver assist systems: failure of various driver assist systems, DTC "B201000: No basic setting" in DA 810B
Market area	United States 444 Volkswagen of America, Inc. (6444)
Brand	Audi
Transaction No.	2079136/1
Level	EH
Status	Released for publishing
Release date	Sep 5, 2025

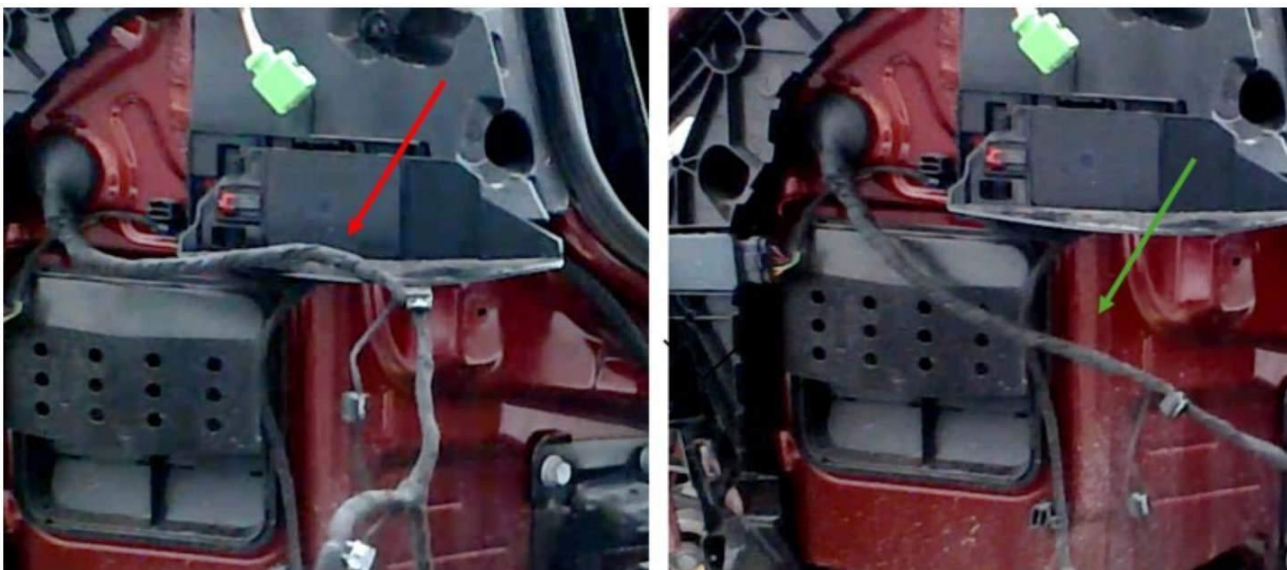
Potential incorrect cable routing of bumper wiring harness – causes harness to obstruct field of view of the sensor of lane change assist control unit -J770-. Please refer to the following images and the video provided in the TSB.

Figure 1 (left) shows incorrect cable routing of bumper wiring harness in field of view of sensor of lane change assist control unit -J770-

Figure 1 (right) shows the correct routing of the bumper wiring harness below the field of view of sensor.

Incorrect cable routing in the field of view of the sensor may be the cause of the event memory entry "**B201000: No basic setting (symptom number 1301)**".

Figure 1. Incorrect cable routing (left in image) and correct cable routing (right in image) of bumper wiring harness

Install the rear bumper cover and make sure that the bumper wiring harness is routed below lane change assist control unit 2 J770 (see Figure 1, right).

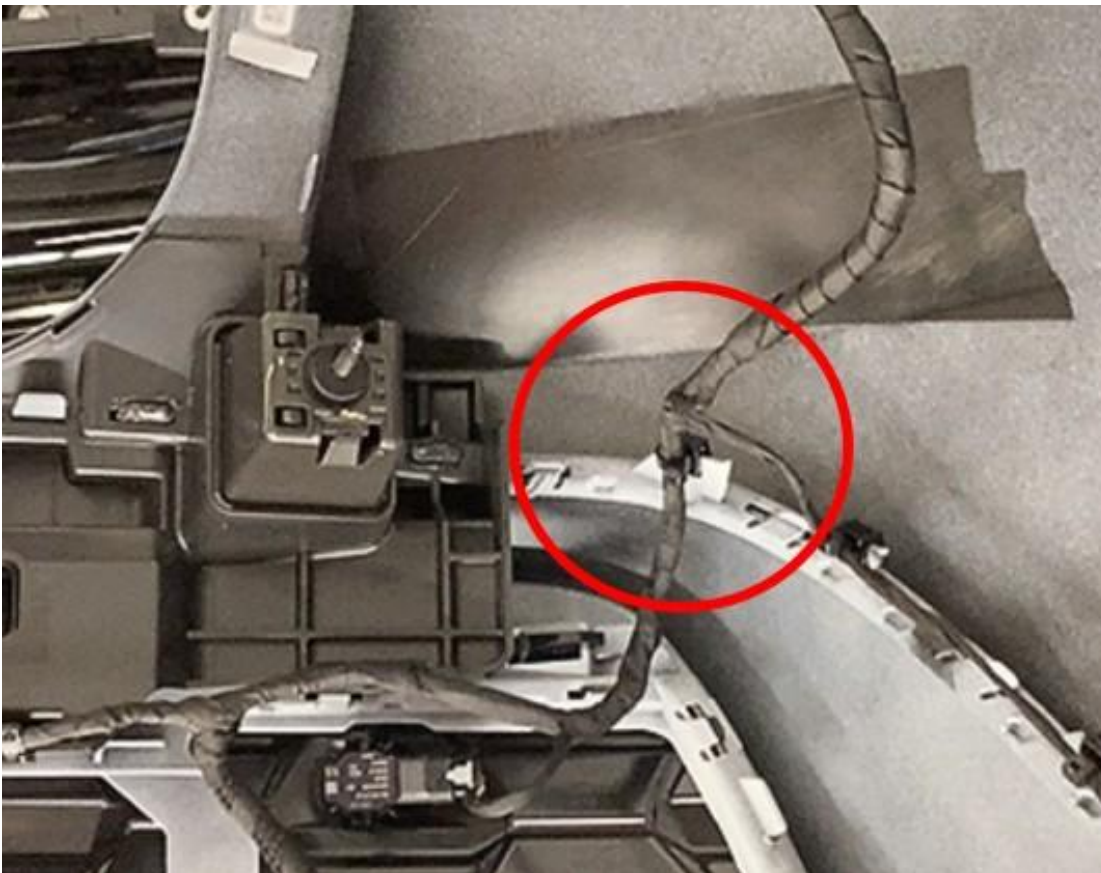
Figure 3. Position of cable tie with clamping base

Remove the rear bumper cover. Remove the wrong cable tie with terminal socket at the position shown (see Figure 3) and affix cable tie with terminal socket WHT 001 999 in its place.

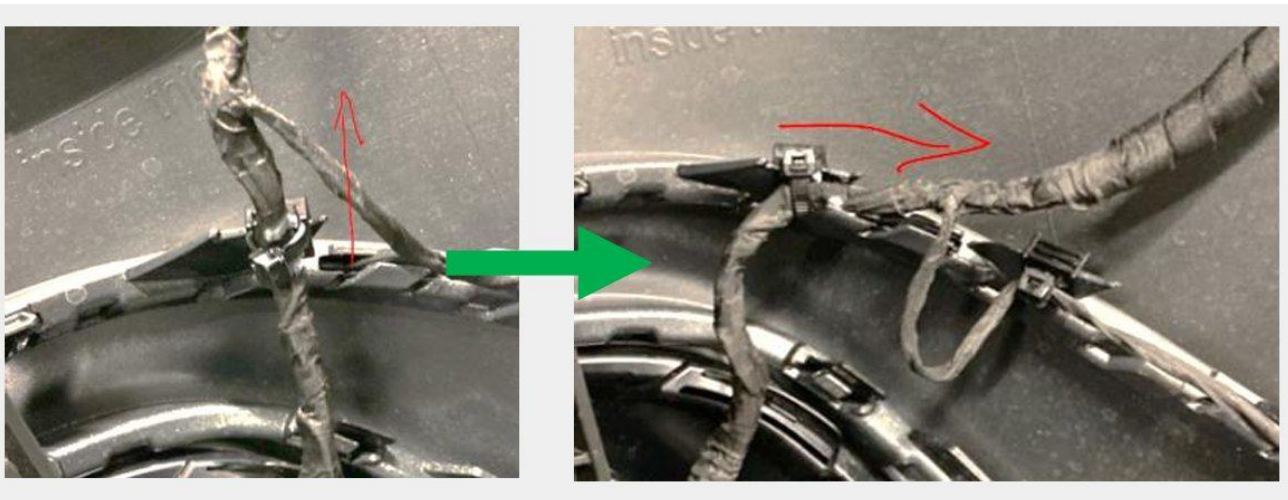
Figure 4. Left – previous cable routing. Right – new cable routing with cable tie with terminal socket WHT 001 999.

The new cable tie enables the cable to be rotated 90° and makes it easier to route the cable (see Figure 4).

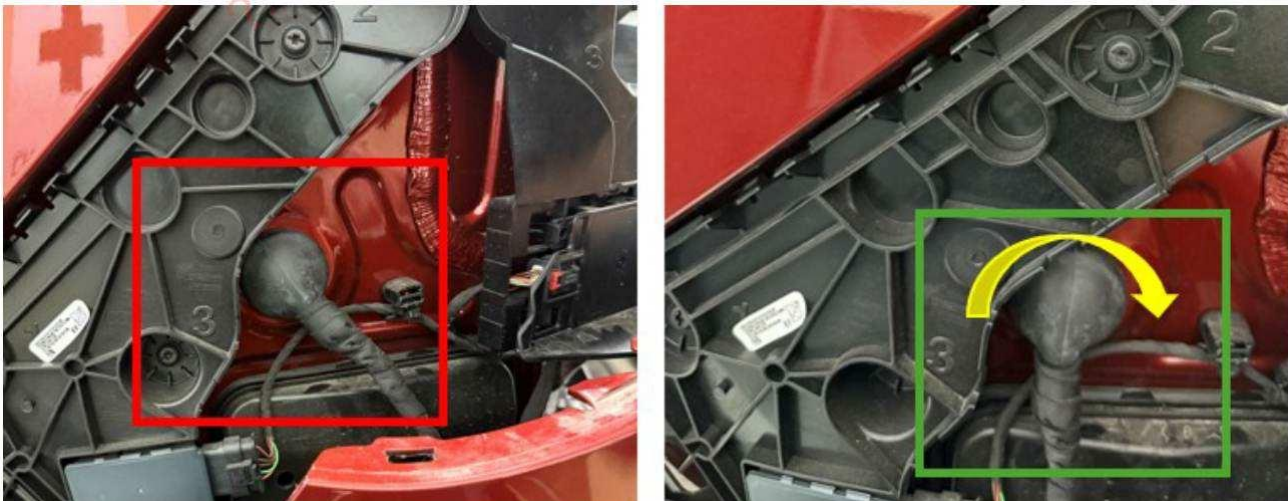
Figure 5. Left – factory grommet orientation. Right - bumper wiring harness grommet in 6 o'clock position.

Then turn the bumper wiring harness grommet downwards in the 6 o'clock position. Removal is generally not necessary (see Figure 5).
