Technical Service Bulletin

Audi A6 e-tron

Transaction No.: **2079218/1**

87 Creaking noise from dash panel while adjusting air conditioner flaps

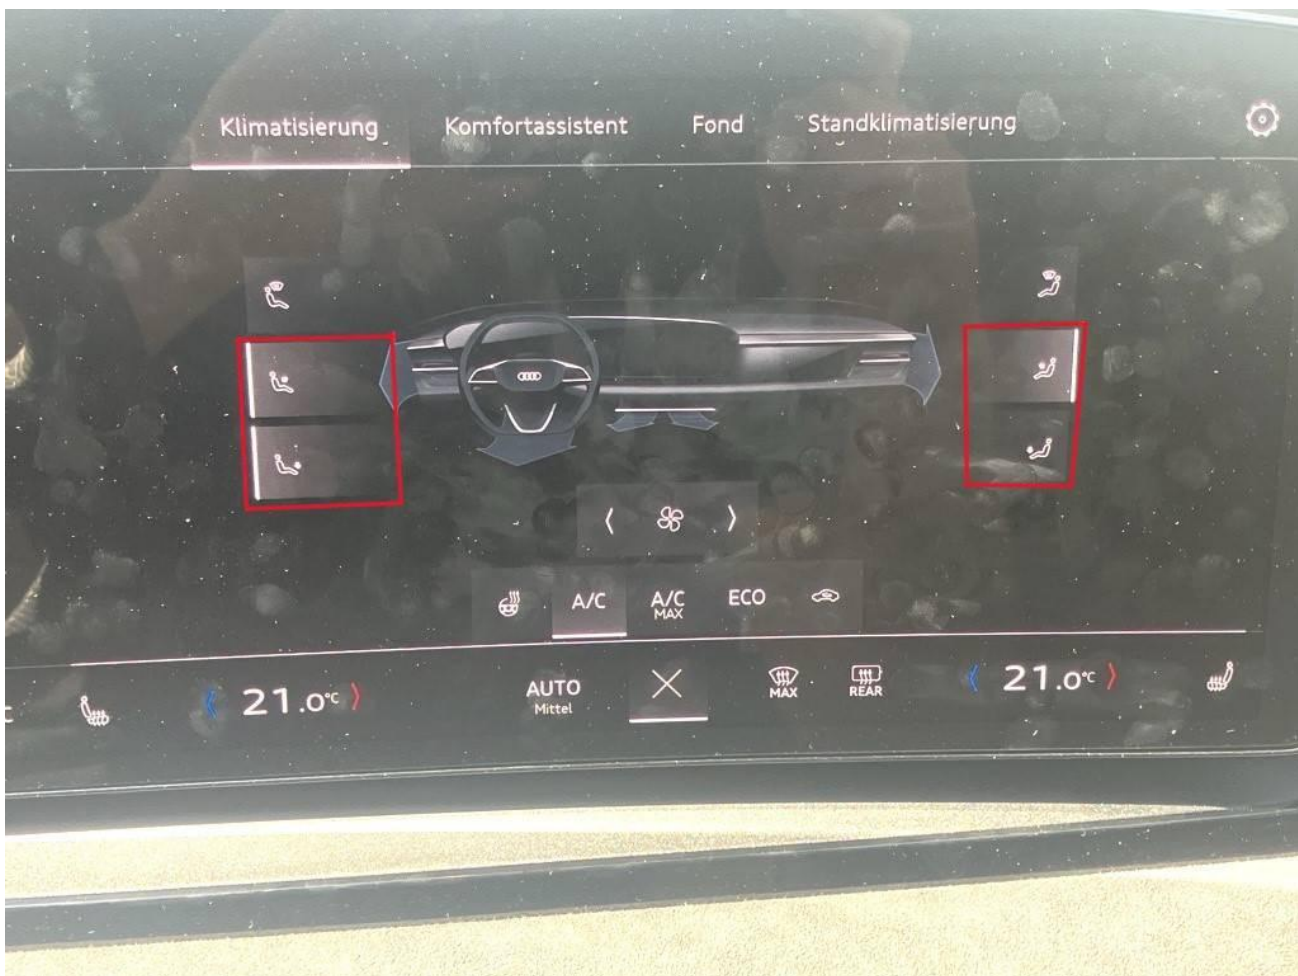
The complaint can be reproduced in the workshop. The noise can be reproduced by manually activating and adjusting the flaps for the chest and footwell air vents, as shown in Figure 1. The noise can also be heard when the affected flap moves when switching the ignition off and on again.

Figure 1. Footwell air vent adjustment buttons.

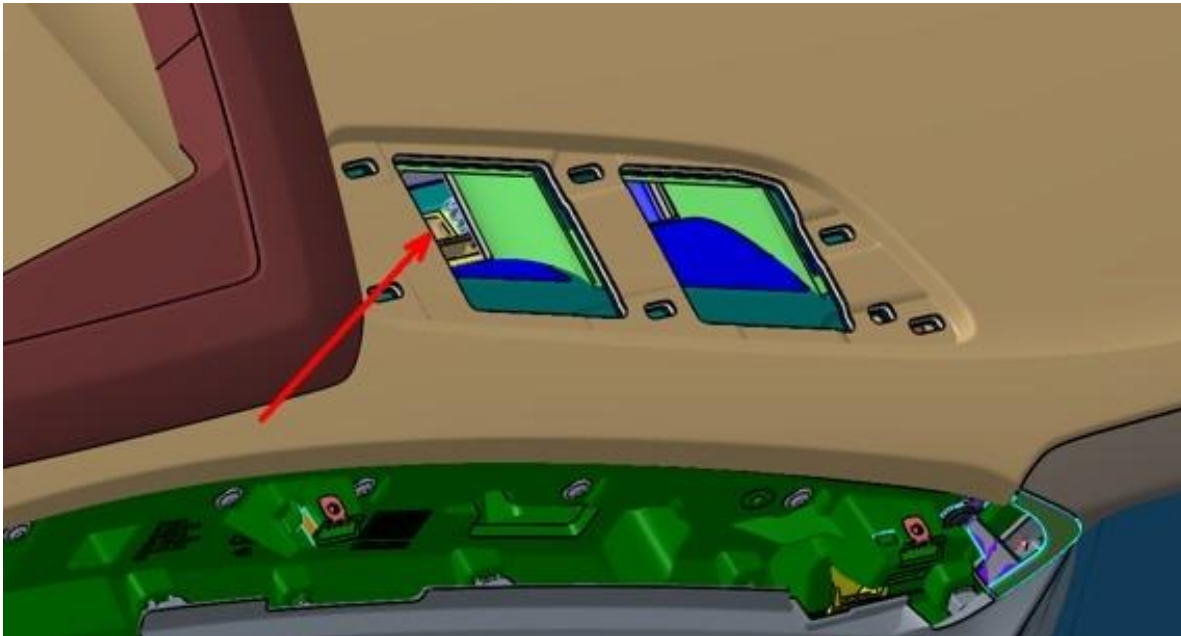
Bearing point on flap jams, resulting in noises in air conditioning unit.

Figure 2 shows the bearing which needs to be lubricated for the affected flap (in installation position). Further details about the affected flap are provided in step 2.

Figure 2. The bearing that needs to be located is indicated by the red arrow.

Step 1: Removing ventilation grille on dash panel to access affected flap (behind MMI display)

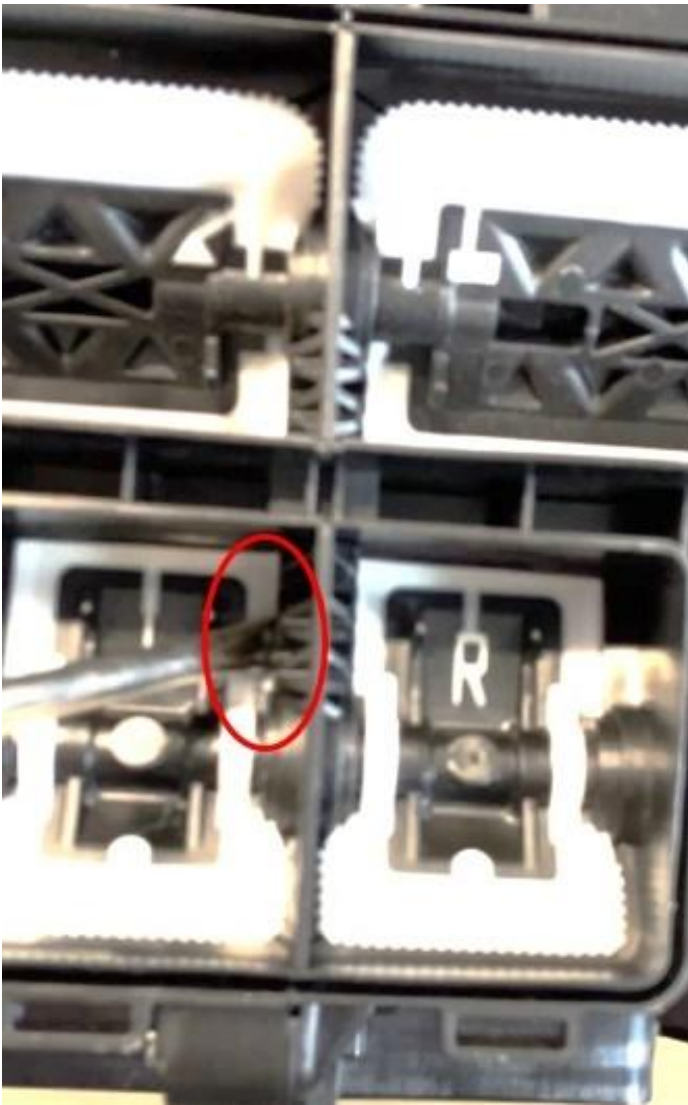
Figure 3. *The area where the soft flap components should be pierced, or moved out of the way is circled in red.*

Then use the screwdriver (thin side of blade) to pierce the soft flap components (white border) or push them out of the way (as shown in Figure 3).

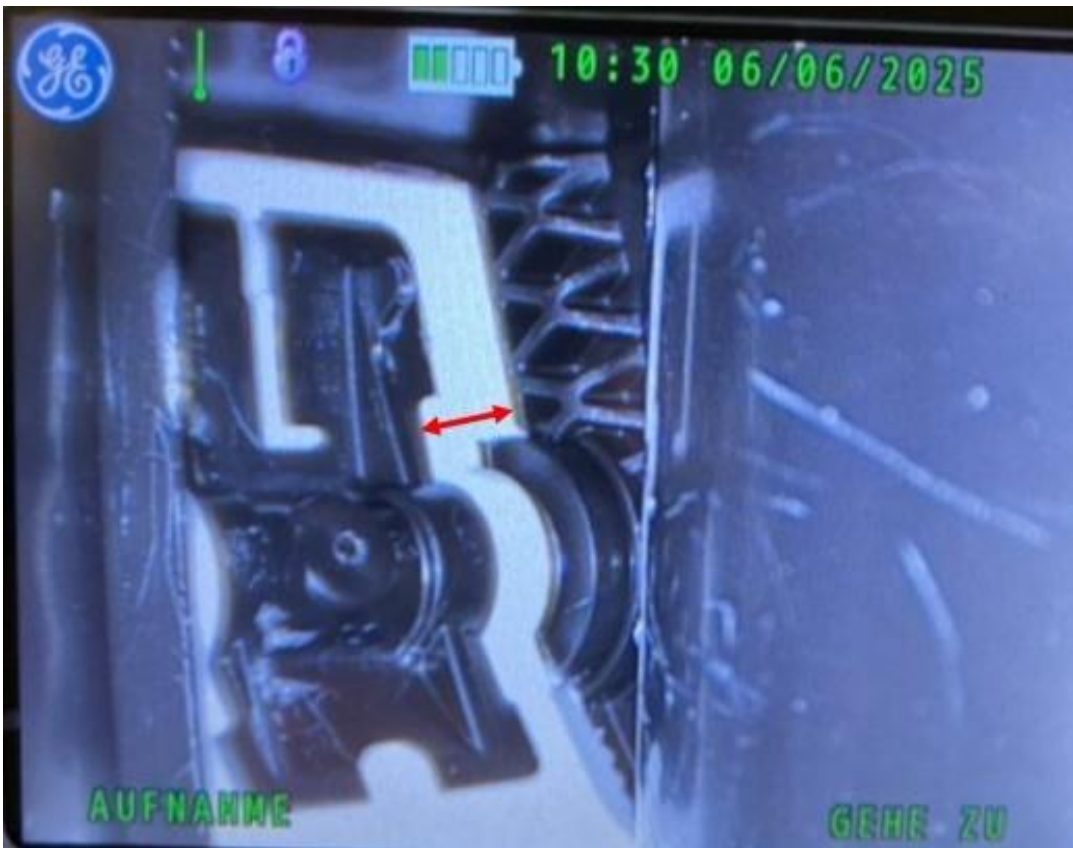
Figure 4. The affected flap is visibly moved to the left ~2-5 mm.

Once the screwdriver is in a suitable position at the soft components, it can be turned 90° to press the bearing and the flap apart (refer to Figure 4).

If you feel the flap move, this confirms that this step has been performed successfully. The affected flap has been visibly moved to the left by approx. 2 to 5 mm (refer to Figure 4) and the bearing is no longer jammed.

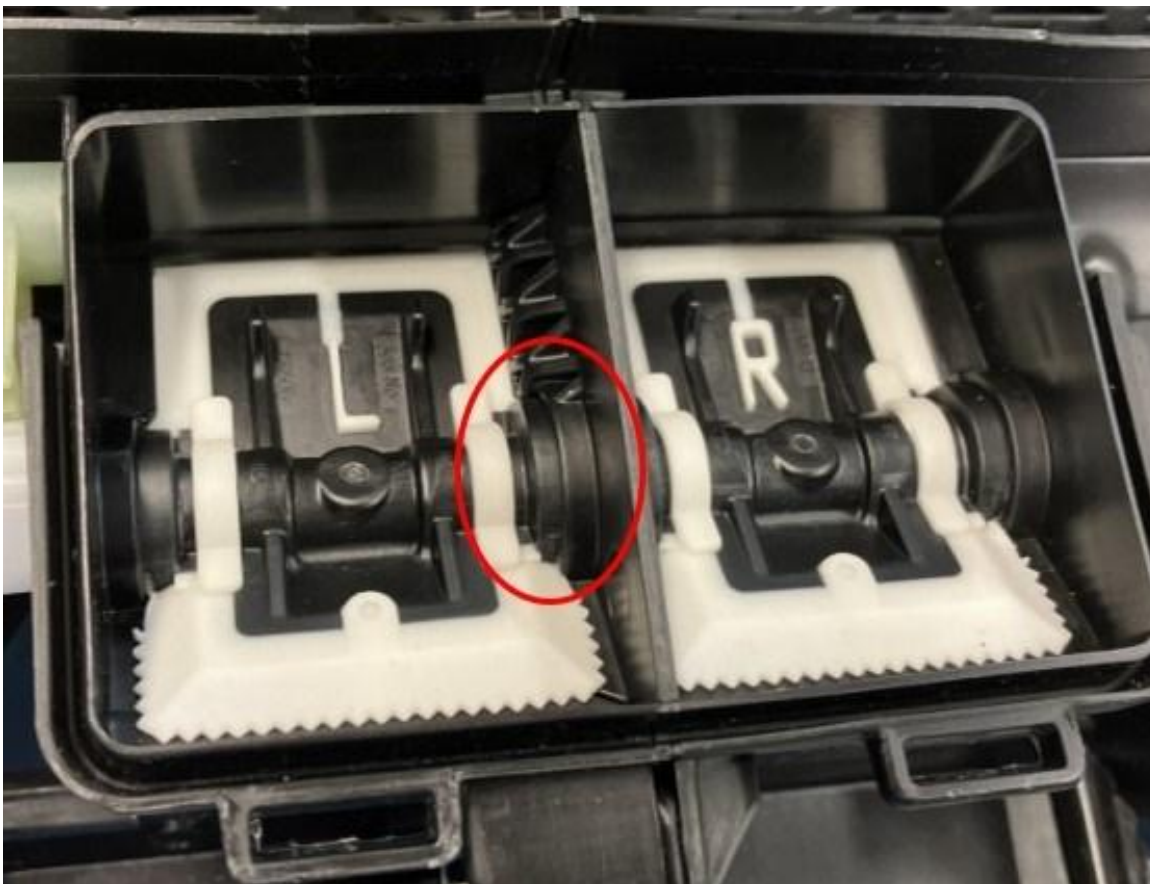
Figure 5. The area to lubricate is circled in red above.

Apply silicone spray to the highlighted bearing on the left flap (refer to Figure 5).
