## Technical Service Bulletin

Transaction No.: **2079294/1**

37 Message in instrument cluster: "Drive system: fault. Please contact workshop", DTC B114E13 or B114F13 in DA 8119

Release date: Sep 23, 2025

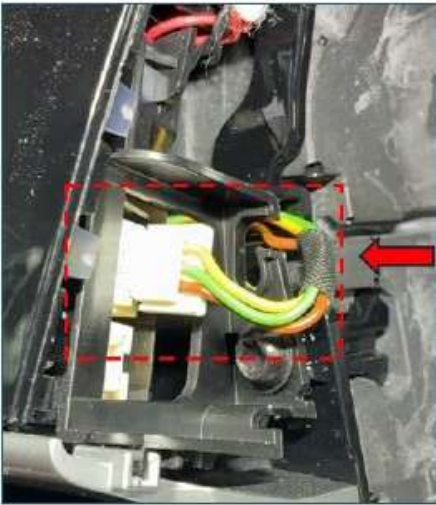
Incorrect wire routing in steering wheel and oversensitive diagnostic parameters in multifunction steering wheel control unit 3 -J453- (diagnostic address 8119).

Figure 1 shows an example of incorrect wire routing.

**Figure 1.** *Incorrect wire routing.*

Unplug the connector and check the wiring harness for damage.

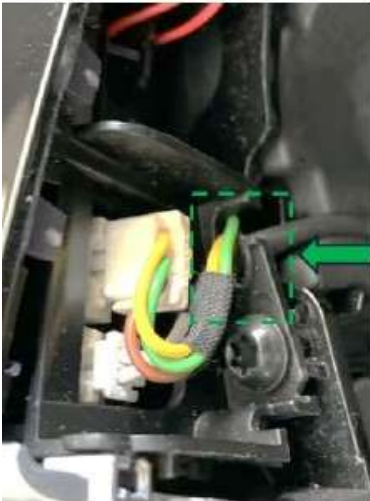
**Figure 2.** *Correct wire routing on left side.*

Route the wires on the left and right sides of the steering wheel so that they are guided through the corresponding retaining lug (refer to Figures 2 and 3).

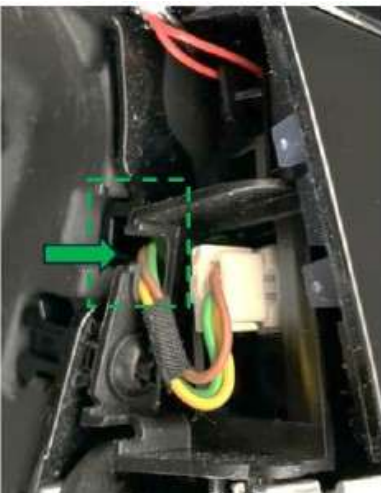
**Figure 3.** *Correct wire routing on right side.*
