Technical Service Bulletin

Topic	55 Service info: extra force required to close hood
Market area	United States 444 Volkswagen of America, Inc. (6444)
Brand	Audi
Transaction No.	2079332/1
Level	EH
Status	Released for publishing
Release date	Sep 15, 2025

Audi A6 e-tron, Q6 e-tron

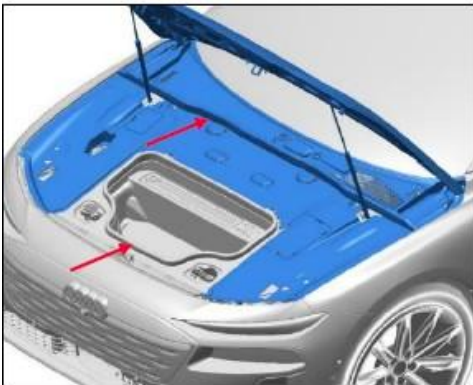
Figure 1. Front compartment.

The hood does not close from an ajar position despite being aligned properly. The air from the front compartment (frunk; refer to image) only escapes very slowly (no additional forced venting in front compartment).

It must be ensured that the front compartment is leak-tight.

This phenomenon is additionally affected by the lightness of the aluminum hood.
