Technical Service Bulletin

Topic	57 Workshop info: manual release mechanism for exterior door handles is triggered
Market area	United States 444 Volkswagen of America, Inc. (6444)
Brand	Audi
Transaction No.	2079351/1
Level	EH
Status	Released for publishing
Release date	Sep 29, 2025

Audi A5, A6 e-tron

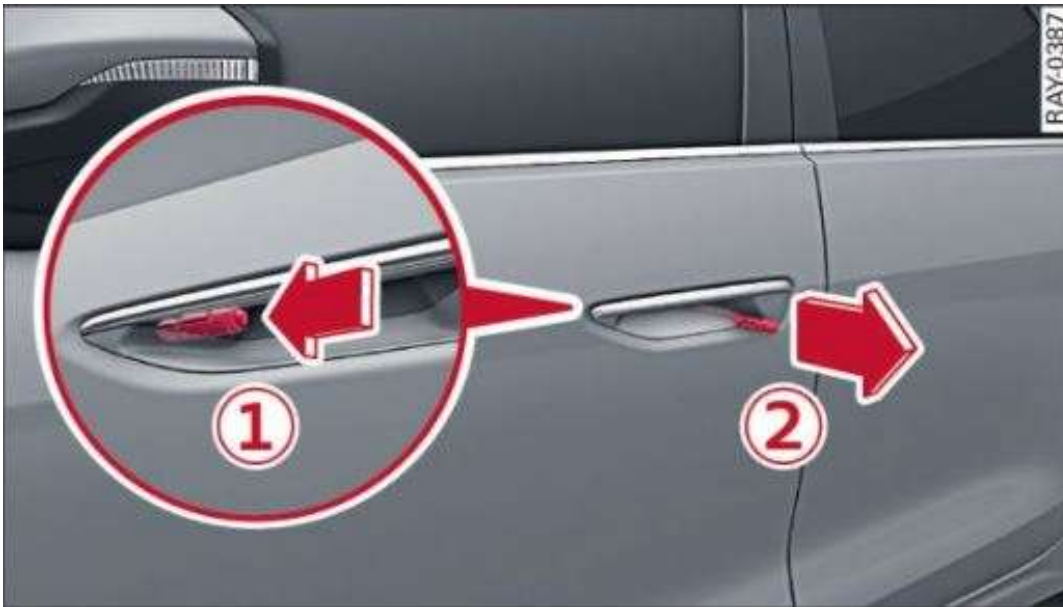
Figure 1. Manual release mechanism for the door handles.

The manual release mechanism for the exterior door handles is ejected for no reason (refer to image taken from Owner's Manual).

There is no apparent reason (e.g. an accident) why the manual release mechanism has been ejected.

There are further technical reasons why the manual release mechanism may be ejected in addition to the reasons stated in the Owner's Manual (an accident, manual release of the pin for the manual release mechanism)

- Vehicle battery is discharged/weak.
- Driver's door unlocked via emergency power supply at front bumper.
- Missing signals from airbag (fallback function relating to crash detection).

- Sudden interruption of a diagnostic session while terminal 15 is switched on.
- Unplugging of control units involved in signal transmission while terminal 15 is activated (e.g. airbag, J1312 control unit for drive system and running gear functions (HCP1), J1273 central control unit for data bus communication (HCP5), J519 onboard supply control unit (HCP4), door control unit, exterior door handle).
- Implausible signal chain of verified messages when programming the VKMS (vehicle key management system).

If there are no further indications as to the cause or if the manual release mechanisms were triggered during the workshop visit, re-insert the pins for the manual release mechanism (refer to Owner's Manual). It is not necessary to perform further checks on the manual release mechanisms.
