Condition

Applicable Vehicles					
Model(s)	Year	Eng. Code	Trans. Code	VIN Range From	VIN Range To
Atlas 4MOTION	2024 - 2026	2.0T (DRKB)	ALL	ALL	ALL
Atlas Cross Sport 4MOTION	2024 - 2026	2.0T (DRKB)	ALL	ALL	ALL

Revision Table			
Instance Number	Published Date	Version Number	Reason For Update
2079347/1	09/17/2025	39-25-01	Original publication.

Customer complaint of oil leak from front of vehicle. Oil leak or residue found on the bevel box.

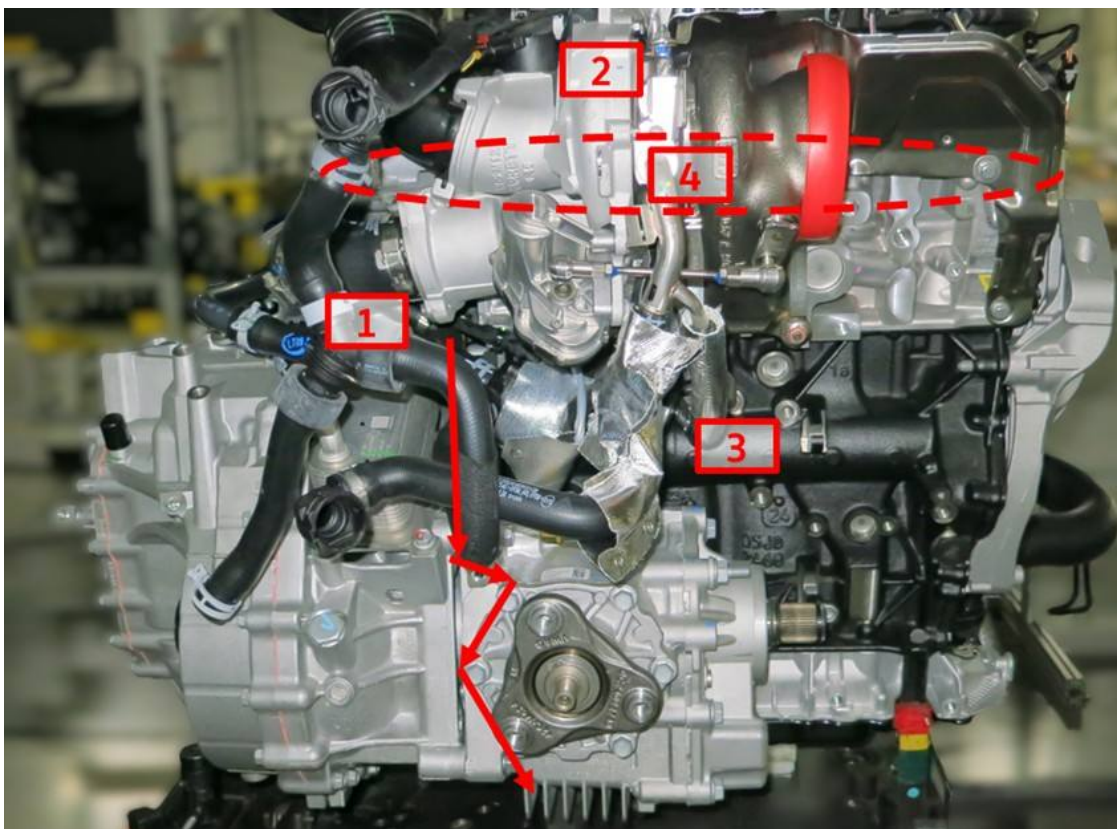
Listed below are known areas of motor oil leakage illustrated on Figure 1:

#	Location	Possible Cause
1	Turbocharger Inlet Pipe	Oil Separator Failure
2	Turbocharger Oil Supply Line	O-ring damaged
3	Turbocharger Oil Return Line	O-ring damaged
4	Cylinder Head Cover	Loose fasteners

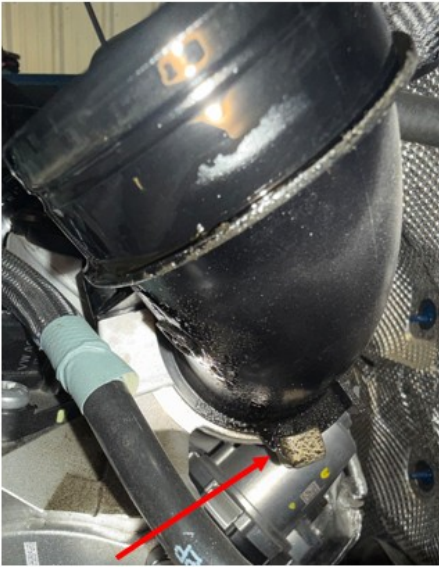
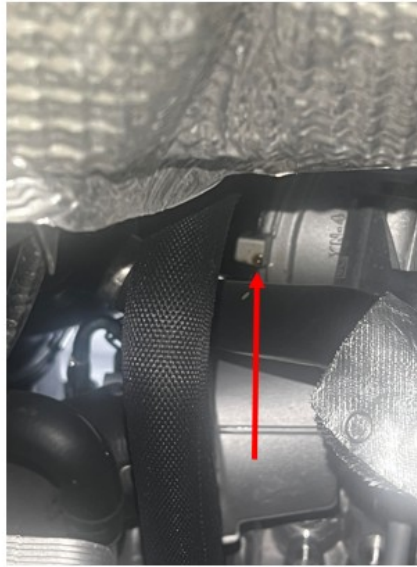
1. Motor Oil Leak/Drip from Turbocharger Inlet Pipe – Oil Separator Failure

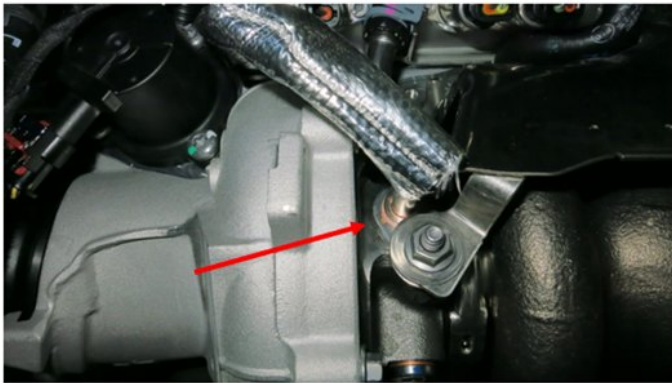
Supply line

2 & 3. Motor Oil Leak/Drip from Turbocharger Oil Supply/Return Lines – Damaged O-rings

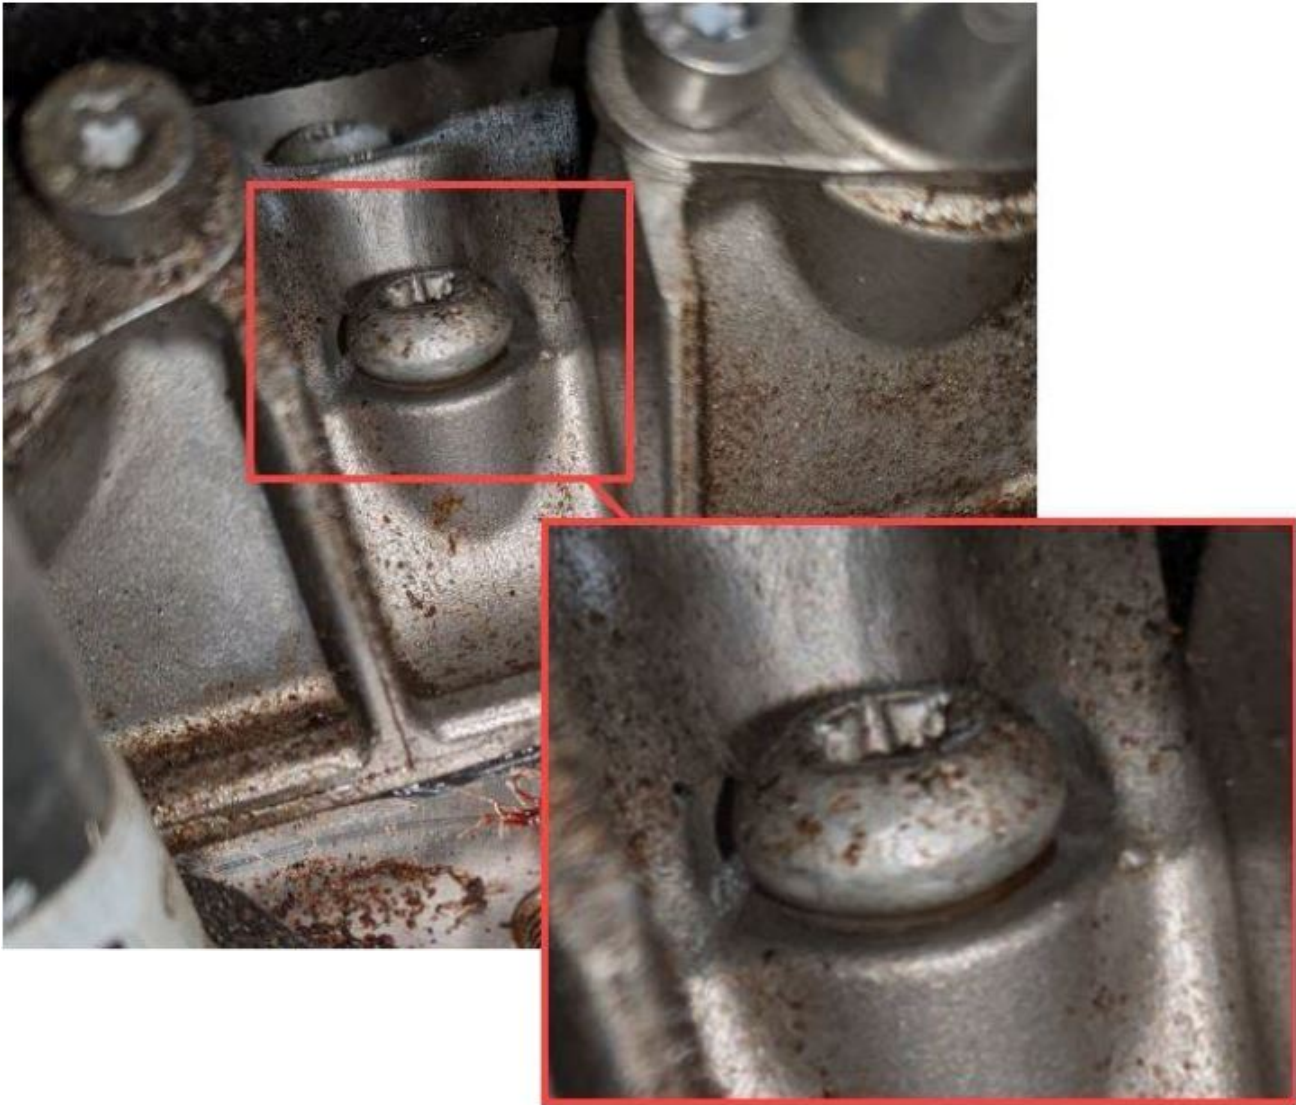
4. Motor Oil Leak/Drip from Cylinder Head Cover – Loose Fasteners

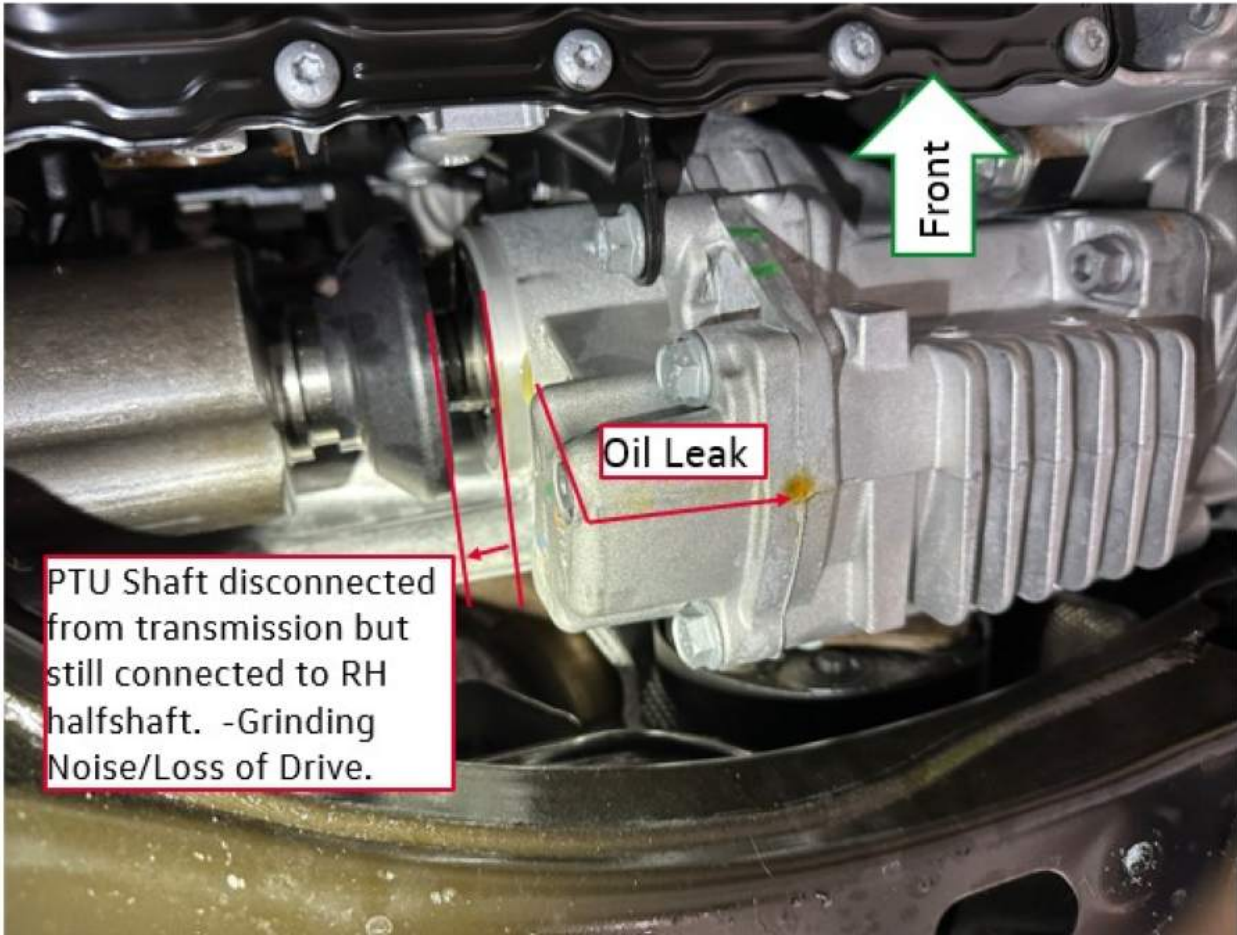
Gear oil may leak from the Bevel Box if the link shaft is not properly clipped or is out of position.

1. Leakage from the passenger side of the Bevel Box can occur when the link shaft circlip is not fully seated in the grooves of the transmission side gear.
2. In some cases, the circlip may be missing entirely.
3. If this condition appears to be present, inspection of the Bevel Box may help confirm whether the circlip is properly seated or missing.
4. If the circlip is missing, verify that it is still not lodged in the transmission side gear. This condition may be documented with photographs. Bevel Box replacement may be considered depending on findings.
5. It may also be useful to inspect the splines on the transmission side gear for signs of damage.

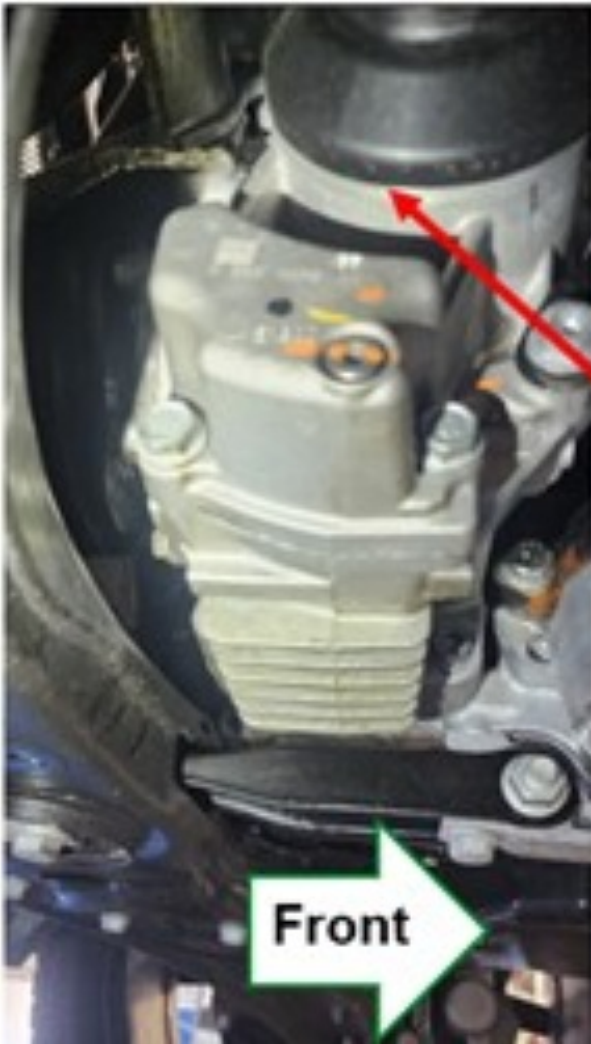
PTU Shaft disconnected from transmission but still connected to RH halfshaft. -Grinding Noise/Loss of Drive.
