INSTRUCTION TO SERVICE

ITS-61475		09/29/2025
SECTION:	290 – Wiring Diagrams/Schematics/Program	
SUBJECT:	Eco-Temp system is not logging A17 code for low suction pressure even though system has low pressure.	
ISSUE:	BCC program error.	
CORRECTIVE ACTION:	Download BCC program (T35-1581) V4.06

ITS-61475

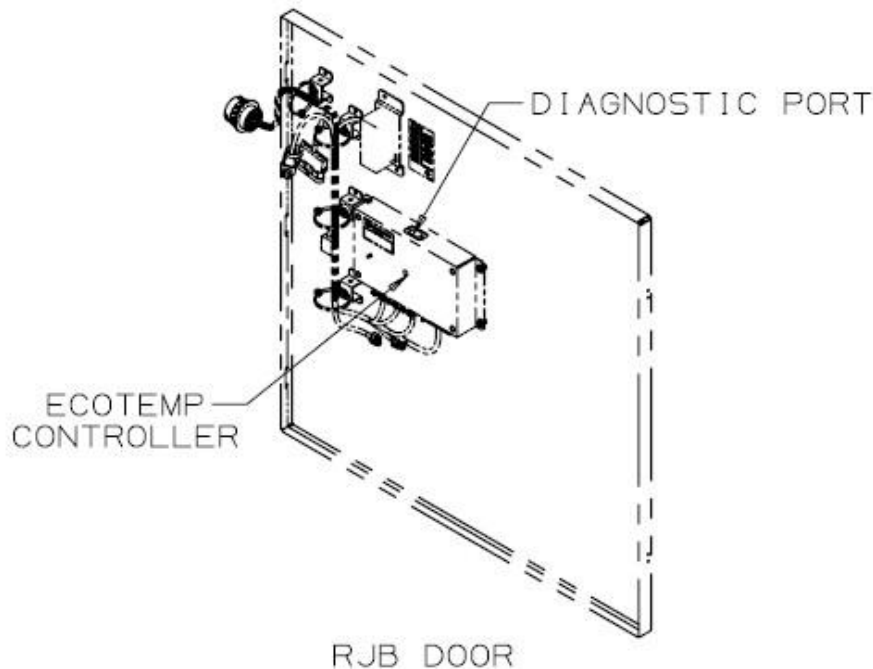
EcoTemp Controller Module Location Reference.

1. Connect laptop to mcc/bcc EcoTemp controller diagnostic port using interface cable, MCI PN: 20-16-005.
2. Launch ECC downloader V2.10 and download software #1143549 (T35-1581 MCI V4.06) to the EcoTemp controller.
3. Apply decal # 1141747 (item #1) over the existing mcc decal after re-programming is completed.
