Service Bulletin

Bulletin No.: PIC6620

Subject: Diagnostic Tip - Charge Port Door Hard to Open

Brand:	Model:	Model Year:		VIN:		Engine:	Transmission:
		from	to	from	to		
Cadillac	OPTIQ	2025		All	All	All	All

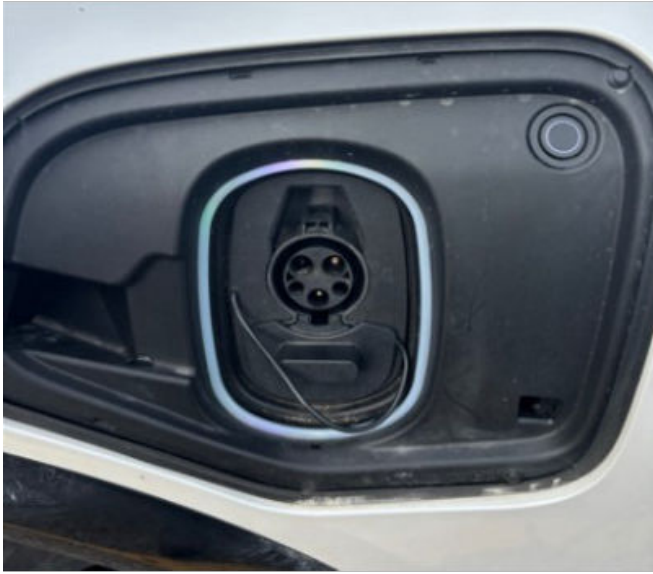
7003479

The button location is up in the top right corner behind the charge port door on the backside panel, see image below.
