# Service Bulletin

Bulletin No.: PIP5927C

**Subject: Diagnostic Tip: Possible DTC P0237 P0101 P1101 or P0299 Reduced Power Potential Damage To Charge Air Inlet Hose At Turbocharger**

Brand:	Model:	Model Year:		VIN:		Engine:	Transmission:
		from	to	from	to		
Chevrolet	Equinox	2023 - 2026		All	All	1.5 LSD	All
GMC	Terrain	2023 - 2026		All	All	1.5 LSD	All

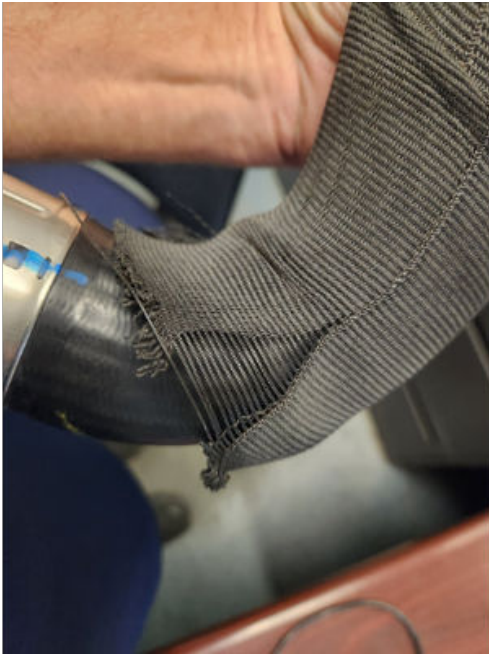
#1

This type of damage would allow the hose to swell under pressure damaging the abrasion sleeve and altering the readings within the boost control system or create a potential air leak.

Pictures below show damage to abrasion sleeve on Charge Air Inlet Hose.

Replace Charge Air Inlet Pipe assembly using latest parts listed in EPC.

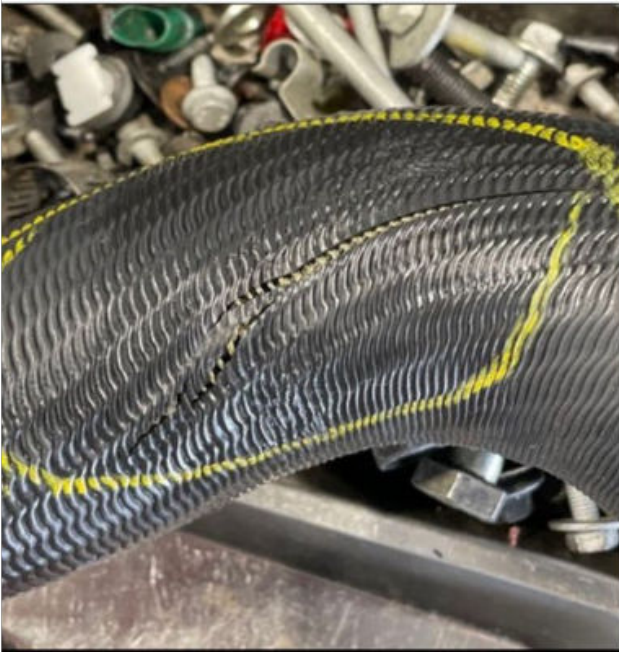
#3 Picture below inside the circled area shows damage to inner hose beneath abrasion sleeve
