## KA-01911 750S - Exterior Door Switch Inoperative

**Topic:** Door switch inoperative

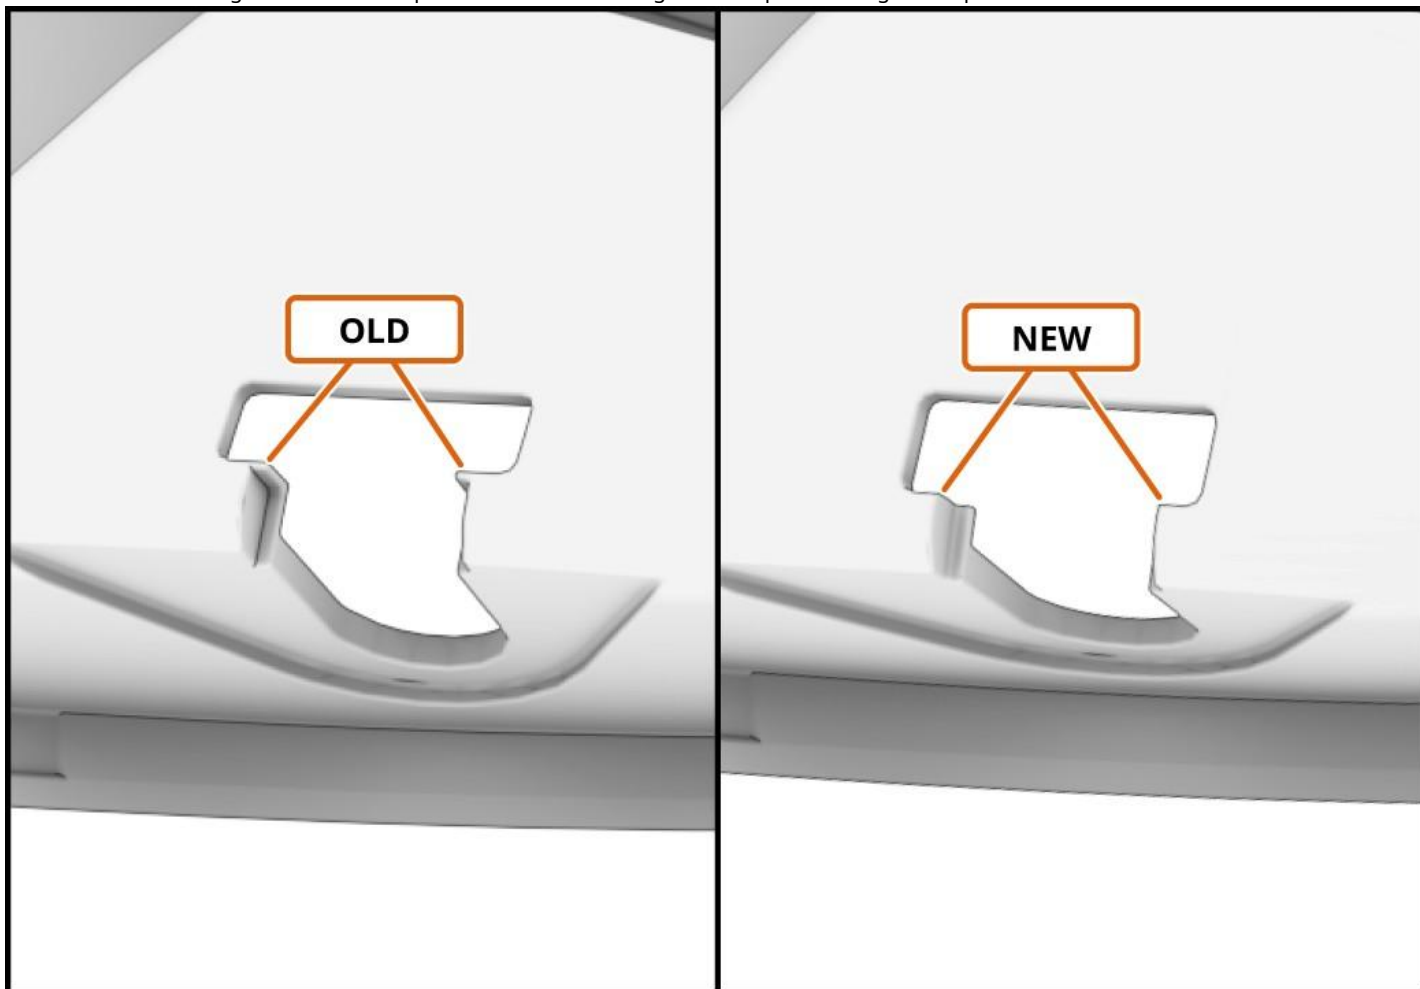
It has come to our attention that some 750S vehicles produced prior to this update may experience intermittent external door switch operation, under specific conditions. When exposed to high ambient temperature for extended periods, thermal expansion of the paddle material may prevent proper contact with the switch rendering it inoperative.

Please refer to the images below for comparison between the original and updated winglet components.

If you find this concern, please order replacement parts as per below parts information and reference MSP procedure – “Door Release Switch – External”.

28AB557CP - WINGLET DOOR OUTER LH

28AB558CP - WINGLET DOOR OUTER RH
