# TECHNICAL SERVICE BULLETIN

## Technical Service Bulletin: 51-1959

## TSB102

**PTL Engineering Inc. Entrance Door Model 3000**

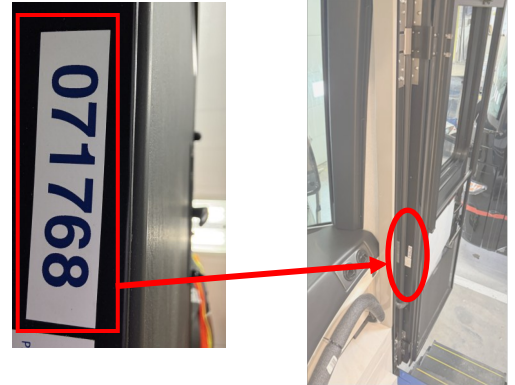
Confirm your door serial number is within #068849 through #072552

Similar to the sticker shown, if your coach serial number is within the range mentioned above, please proceed to Step 1. If your coach door serial number is outside of this range, you can disregard these TSB instructions.

With the door fully open, you can locate the door serial number label on the hinge side, behind the screen door.

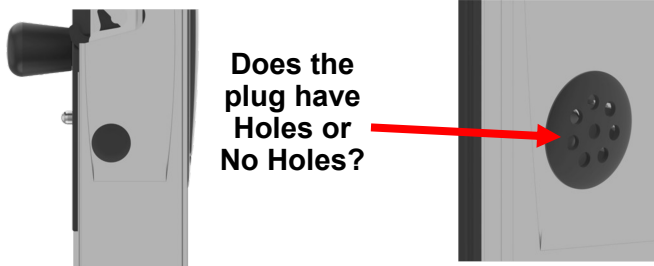
**Step 1:** Inspect the Black Plastic Plug on the door edge to see if there are holes on the top. If there are, the door hardware has already been upgraded, please disregard these TSB instructions.

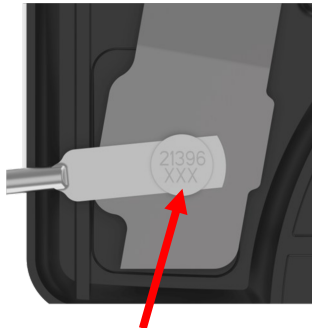
### Part Number and Date Code

**Step 6:** Verify the part number stamped on the inside release as **21396** and the date code is between (32U through 52U) or (01V through 24V). If it is, continue to Step 7.

If the part number or the date code is something other than **21396** and date code is not in the range listed above, this door is not included in this campaign, follow Step 10b and reassemble the existing door hardware.

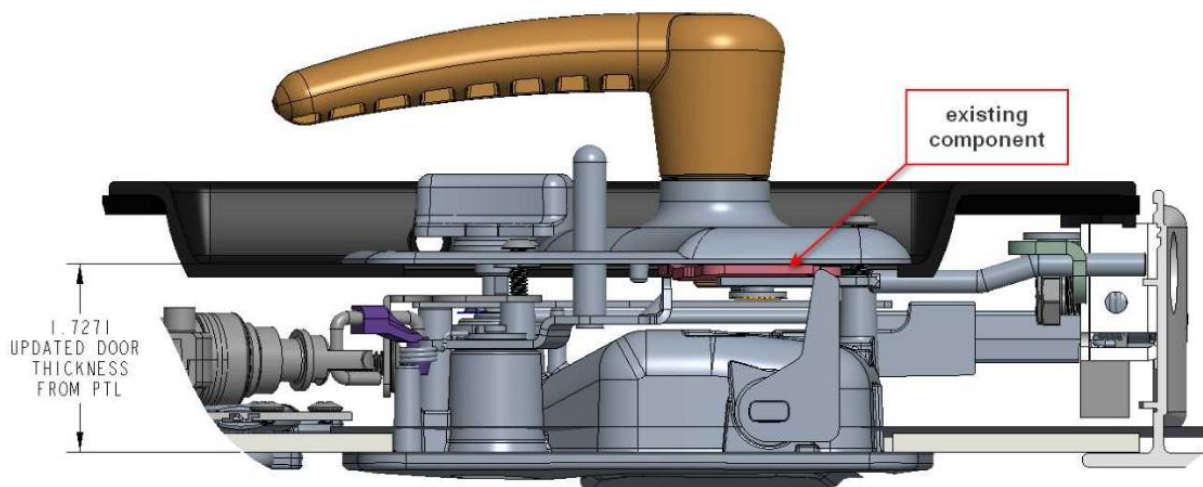
21396-05 / 36285-02 IN 1.7271" PTL DOOR

**Description of the defect:** TriMark manufactured and sold to PTL, a complete RV door hardware system consisting of a 030-0900 Exterior Paddle Handle (P/N's 36285-02 and 36285-04), Inside Release (P/N 21396-05) and Rotary Latch (P/N 17999-01). PTL Engineering has reported that several Motor Coach Manufacturers have encountered issues with motorhome lockouts at their manufacturing facilities. Additionally, there have been several reported lockouts affecting coach owners on sold units. It was found that the pivot arm on the outside handle may pass underneath the release arm of the inside handle, due to multiple potential root causes preventing the door from opening from the outside handle. However, the interior handle is still operational from inside of the motor home.

**Description of the safety risk:** a small percentage of doors exhibit a condition where the exterior paddle handle can bypass the inside release pivot causing a lock-out situation, but the door can still be opened from the inside.

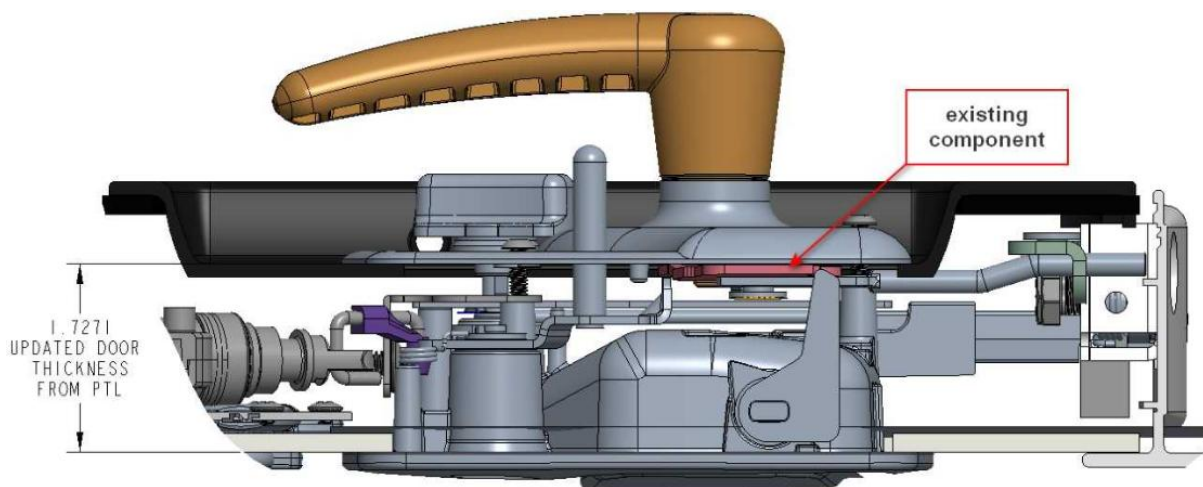
21396-05 / 36285-02 IN 1.7271" PTL DOOR

**Description of the defect:** TriMark manufactured and sold to PTL, a complete RV door hardware system consisting of a 030-0900 Exterior Paddle Handle (P/N's 36285-02 and 36285-04), Inside Release (P/N 21396-05) and Rotary Latch (P/N 17999-01). PTL Engineering has reported that several Motor Coach Manufacturers have encountered issues with motorhome lockouts at their manufacturing facilities. Additionally, there have been several reported lockouts affecting coach owners on sold units. It was found that the pivot arm on the outside handle may pass underneath the release arm of the inside handle, due to multiple potential root causes preventing the door from opening from the outside handle. However, the interior handle is still operational from inside of the motor home.

**Description of the safety risk:** a small percentage of doors exhibit a condition where the exterior paddle handle can bypass the inside release pivot causing a lock-out situation, but the door can still be opened from the inside.
