Insufficient Heating Output Due To Broken Refrigerant Line Between Refrigerant Compressor And The condenser (Hot Gas Line)

Topic number	LI83.20-P-076623
Version	3
Function group	83.20 - Heating
Date	10/6/25
Validity	EQA (H243), EQB (X243)
Reason for change	Remedy

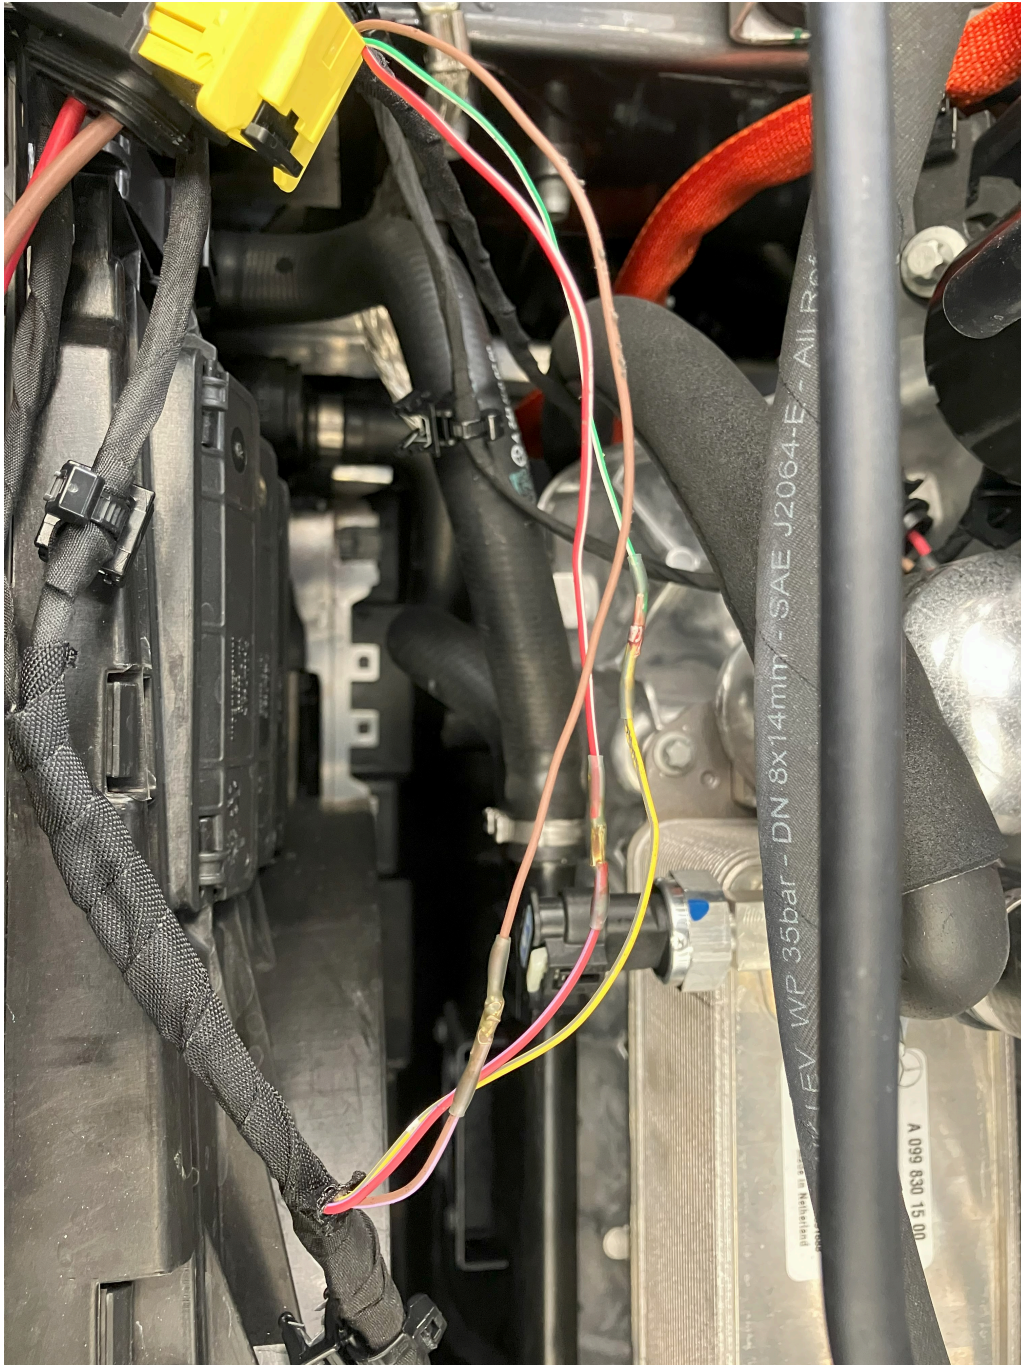
33. In order to use the new refrigerant line A2438308600, the electrical wire of pressure sensor B161/2 must be extended.

- Disconnect plug from pT sensor.
- Remove insulation approx. 15 cm from the plug.
- Extend lines by 425 mm. For this purpose, please observe the Basic data for wiring harness repairs with axial solder connectors (AR54.18-P-0100-06A).
- Wrap wiring harness with complete insulation wrapping.
- Route wire to the newly positioned pT sensor and secure with cable tie to prevent scouring.
