66/25 ENU 7416

Front Seat Ventilation Does Not Function: Observe Specified Procedure (66/25)

Model Line: Taycan (Y1A / Y1B / Y1C)

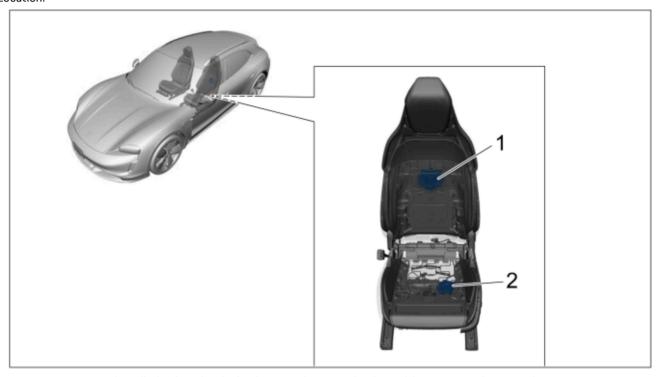
Installation location for backrest surface seat fan for and front seat surface seat fan

- 1 Front backrest surface seat fan
- Front seat surface seat fan

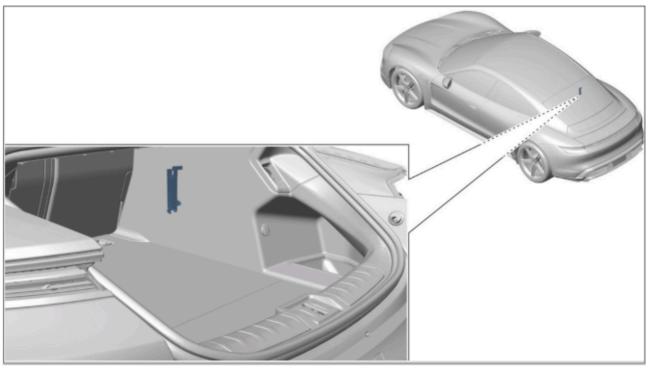
Fuse holder M

The potentially affected fuses (a total of 2 units; for front left seat ventilation and front right seat ventilation) are located on fuse holder M, fuse position 1 (front left seat ventilation) or 2 (front right seat ventilation).

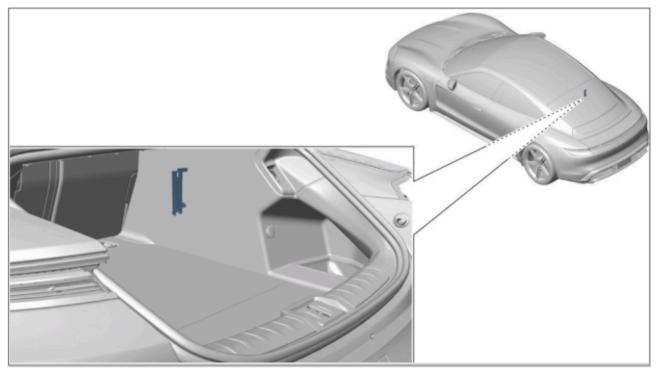
Fuse holder M

The potentially affected fuses (a total of 2 units; for front left seat ventilation and front right seat ventilation) are located on fuse holder M, fuse position 1 (front left seat ventilation), or 2 (front right seat ventilation).

Work Procedure: 1 Check fuse for affected front seat ventilation (left **or** right) for damage and replace if necessary.
