### J1 - Measuring the Capacitance of High-Voltage Power Electronics

| Models | Model Year | Model Type | VIN Range | Vehicle-Specific Equipment |
|---|---|---|---|---|
| Taycan | As of 2020 up to 2024 | Y1A, Y1B, Y1C | N/A | Power Electronics |

**Bulletin #: 2519**

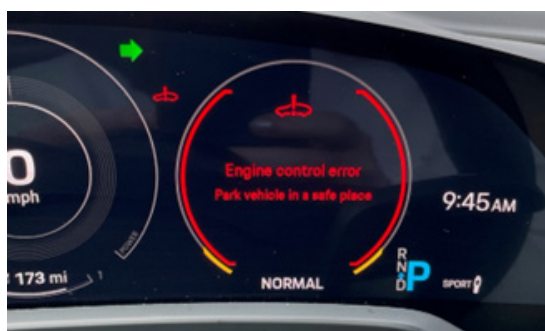
Customer complains of a red “Engine control error” in the instrument cluster (Figure 1). The workshop may find the following faults stored in the front and/or rear high-voltage power electronics CU and/or the DCDC Converter:

Figure 1  
“Engine control error” in instrument cluster”

The power electronics (PE) may lose capacitance over time due to electrical fatigue. This results in voltage fluctuations in the HV system that can cause HV components to shut off in addition to the above-mentioned fault codes.

If the above-mentioned condition and fault code(s) exist, please measure the capacitance of both the front and rear high-voltage PE using a multimeter. Please start with the measurement of the front PE and then proceed to the measurement of the rear PE.
