Technical Service Bulletin

Topic	DIP pop up 'Engine start system: fault' Continental GT/GTC/Flying Spur 18-24MY
Market area	Bentley: worldwide (2WBE),China 723 Volkswagen (Anhui) Automotive CO (6723),China 796 VW Import Comp. Ltd (Vico), Beijing (6796)
Brand	Bentley
Transaction No.	2061362/6
Level	EH
Status	Released for publishing
Release date	Sep 8, 2025

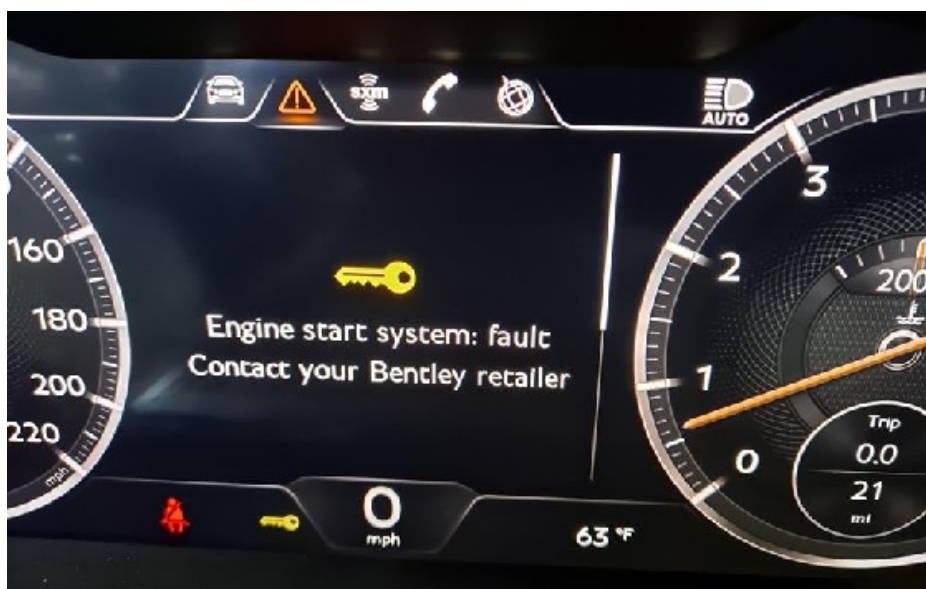
Customer unable to intermittently start the engine with the start button

Or

Engine starts but customer gets a pop up error within the Drivers Information Panel (DIP)

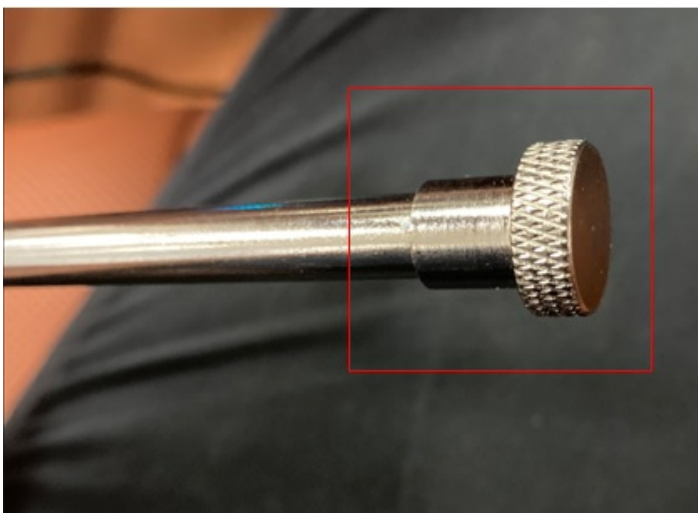
Figure 1

3) Using the workshop tool WT10354 (Force gauge) and selected adaptor highlighted below (Figure 1), slowly press down on the Access/start authorization button centrally (Figure 2) and record the force (N) which each contact point 1 to 3 changes from 'Not operated' to 'operated'

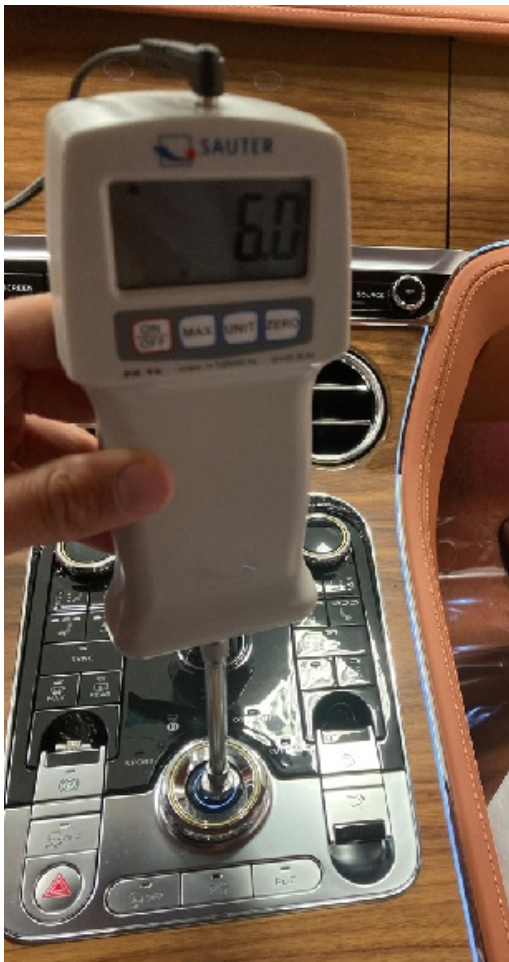
Figure 2

Note: Electrical tape not shown in image for clarity purposes only, please ensure tape is applied

If the results measured are below 13N, or up to and including 15N and all switch positions show a change in state then the switch does not need to be replaced.

If the measured values are show a force higher than 15N while showing a change in state in any contact position then the switch pack will need to be replaced.
