Topic	OBC Charging Efficiency MIL HW / SW Update (NAR Only) Bentayga (Hybrid) 24MY
Market area	United States E05 Bentley USA and rest America (6E05)
Brand	Bentley
Transaction No.	2077790/4
Campaign number	ED44
Note	
Type	
US code

OBC Charging Efficiency MIL HW / SW Update (NAR Only) | Bentayga (Hybrid) |
24MY

Release date: Sep 8, 2025

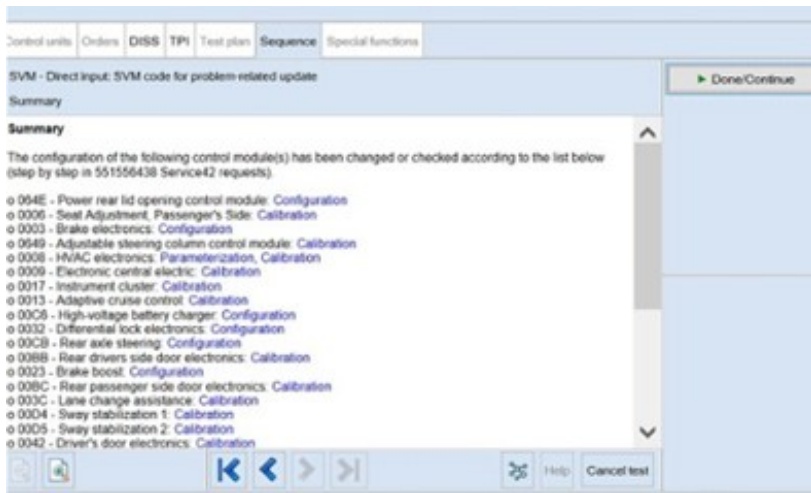
8. If the SVM code completes successfully, ODIS should display as per the image above.

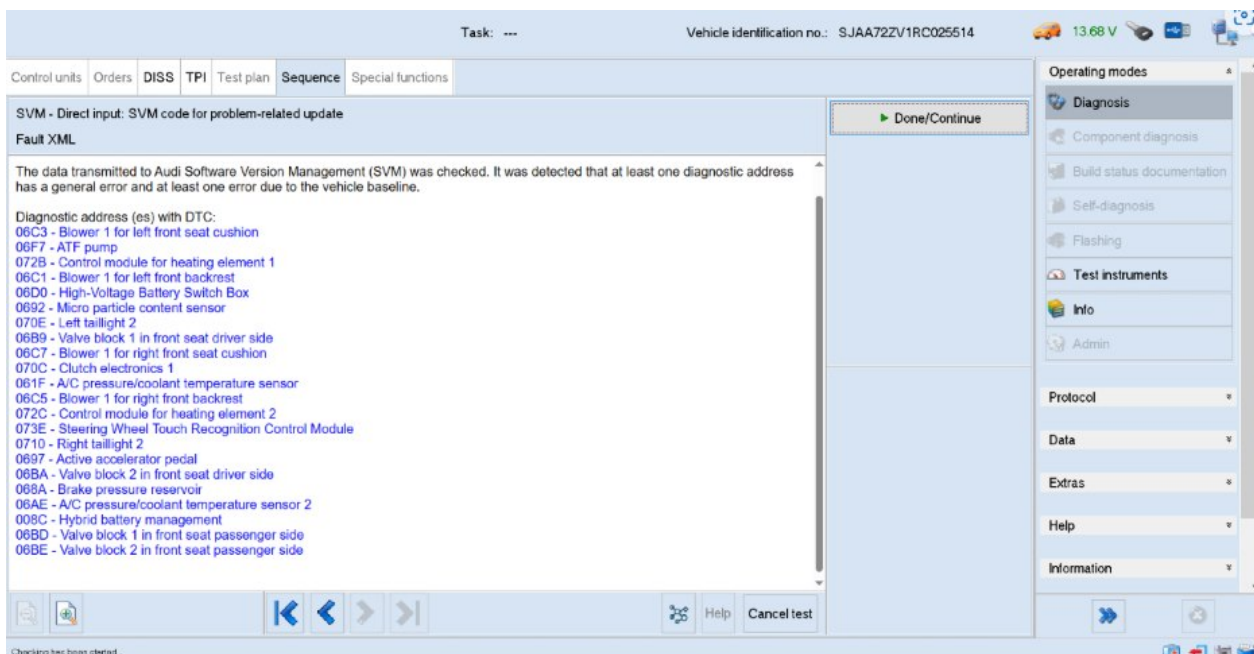
b. If you receive the error '8058' or the screen shown in the image above, please do the following:

c. Locate 00C6 in control unit list

d. Select -> Guided Functions -> Read Identification Data

e. If the software version of 00C6 is now at SW3322 then proceed to step 2.

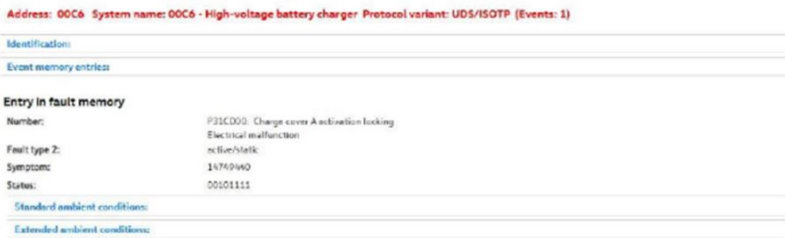
Figure 1

The diagnostic address for the on board charger, 00C6, is storing DTC P31CD00 – Charge cover A activation locking (Figure 1).

The symptom code shown is 14749440.

This DTC is a static fault that can be ignored if the charge flap is functioning normally and there are no warning lights displayed on the driver’s instrument panel.

5. If the DTC shown above is present in 00C6, this can be ignored as per TPI 2076739/-

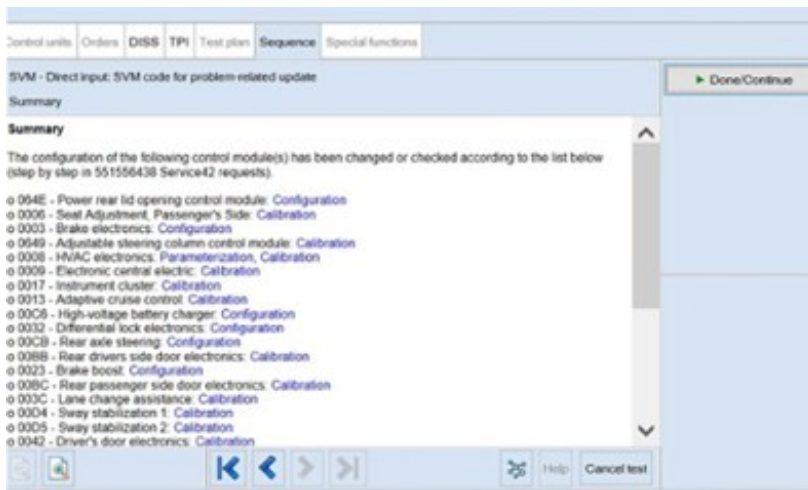
8. If the SVM code completes successfully, ODIS should display as per the image above.
