Technical Service Bulletin

Topic	Failure of the Door Subframe Mounting Housing Continental GT/GTC & Flying Spur
Market area	Bentley: worldwide (2WBE),China 796 VW Import Comp. Ltd (Vico), Beijing (6796)
Brand	Bentley
Transaction No.	2078709/1
Level	EH
Status	Released for publishing
Release date	Sep 8, 2025

Failure of the door subframe mounting housing

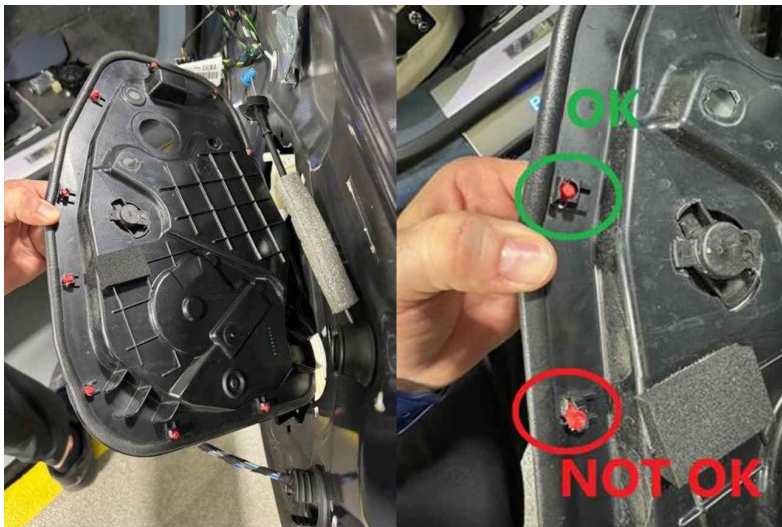
Figure 1

When failure of the door subframe mounting housing occurs (as shown in figure 1), the retailer is advised to order the relevant kit part (see parts information) and carry out the necessary repairs.

1. Remove the relevant door trim panel. Refer to ElsaPro, Repair Group 70
2. Remove the door power latch drive unit. Refer to ElsaPro, Repair Group 57
3. Re-fit the relevant door power latch drive to the new door trim panel (see parts information)
4. Re-fit the new door trim panel, ensuring that the door power latch drive unit has been re-used from the old assembly part. Refer to ElsaPro, Repair Group 70.

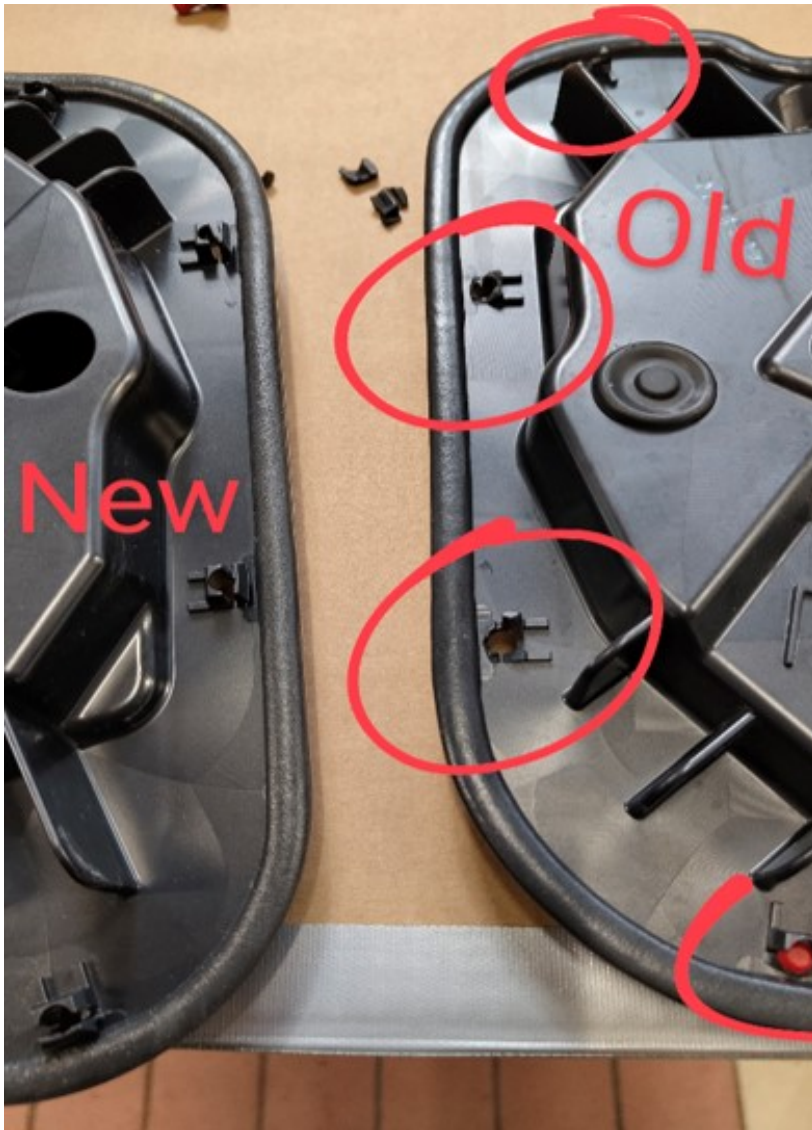
Figure 2 – Comparison between the old part and new part

A new kit part has been created, to prevent replacement of the full assembly (including the latch motor) when the door subframe mounting housing suffers a failure.
